**TAILINGS DAM INSPECTION
CAROLIN MINES
HOPE, BRITISH COLUMBIA**

Athabaska Gold Resources Limited
#200 - 1185 West Georgia Street
Vancouver, B.C.
V6E 4E6

October 27, 1995

952-1483

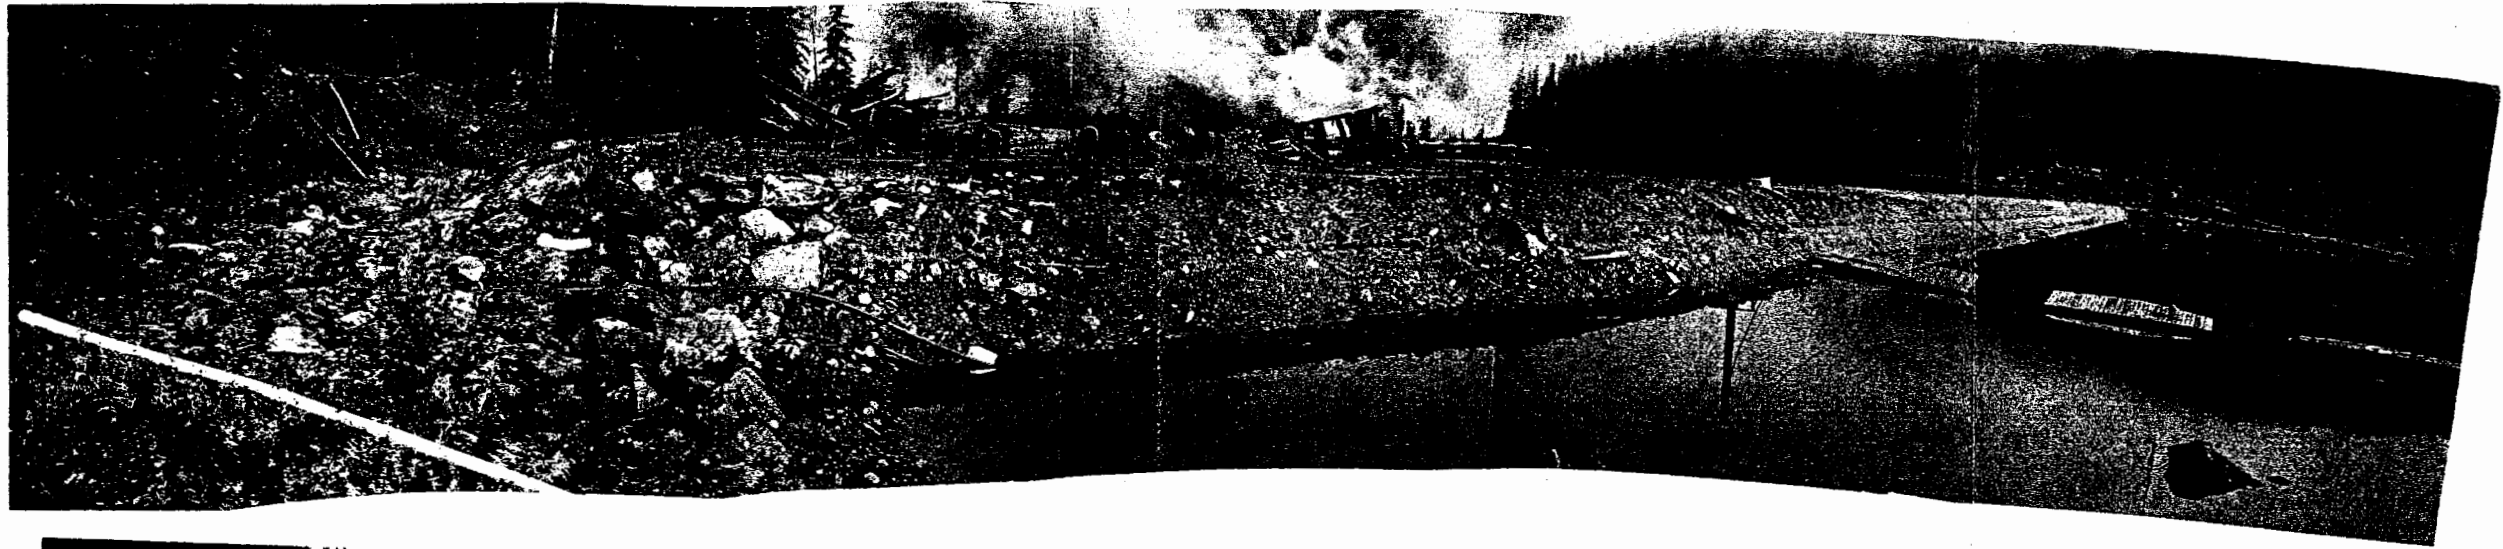
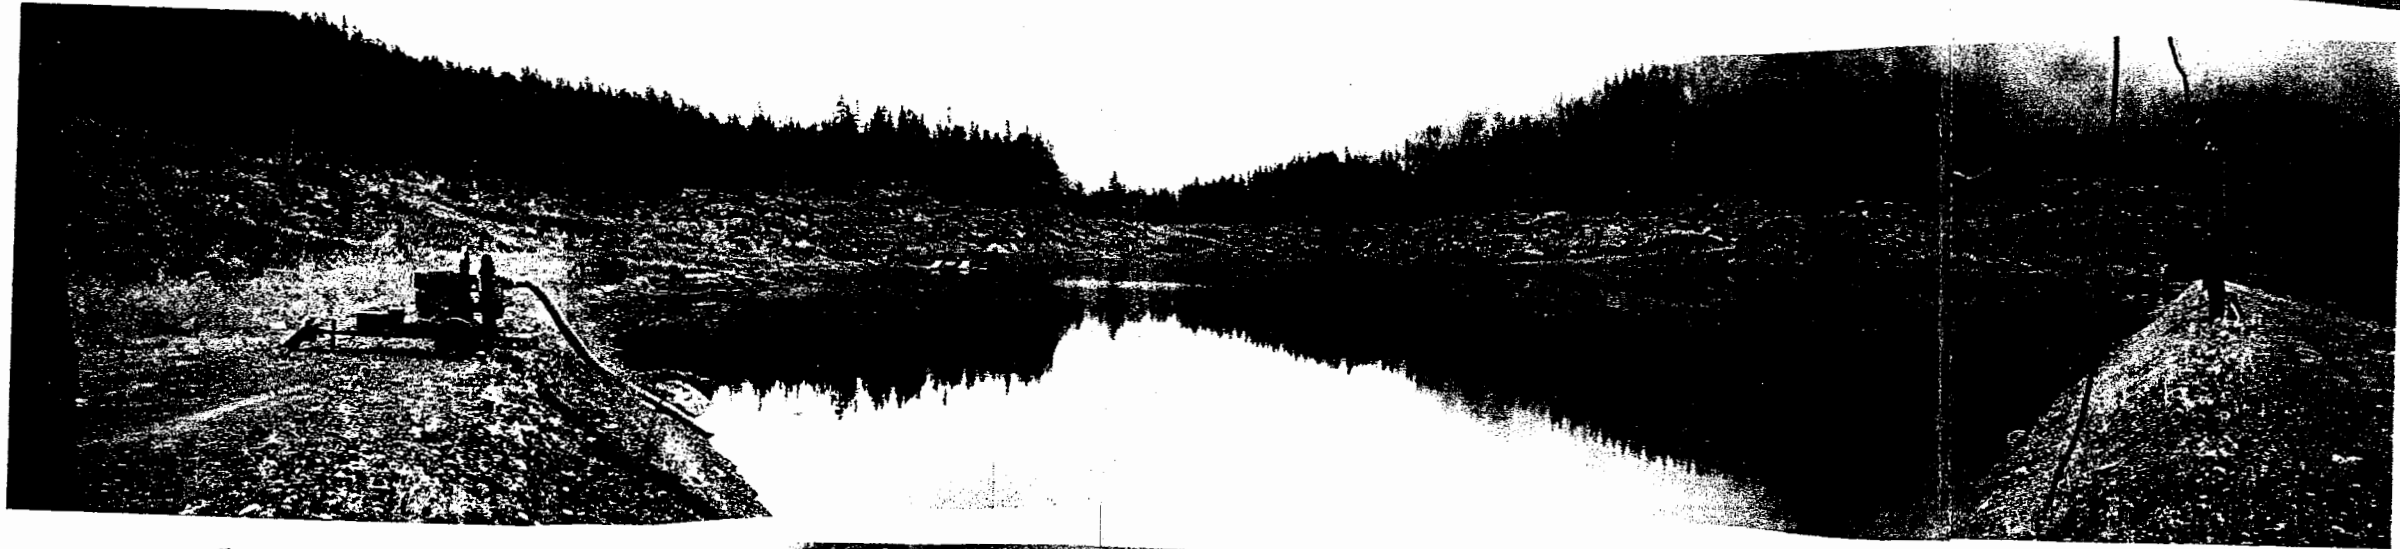
Figure 5 PHOTOGRAPHS OCT. 11, 1995

Only minor surface erosion due to weathering has occurred on the downstream slopes. The slopes are in good condition and do not require maintenance.

The upstream slopes have been exposed to pond water up to elevation 3,206 feet. Only minor erosion has resulted and maintenance is not required.

The emergency spillway at elevation 3,206 feet is lined and coarse rock covered. No erosion was observed due to overflow conditions.

The surface perimeter ditches which divert runoff from the pond area to Fifteen Mile Creek are currently in satisfactory condition. They have however, been recently cleaned and require annual maintenance following spring thaw.

Photographs of the site are given on Figure 5. A comparison of these photographs with those of previous years indicates satisfactory surface performance.

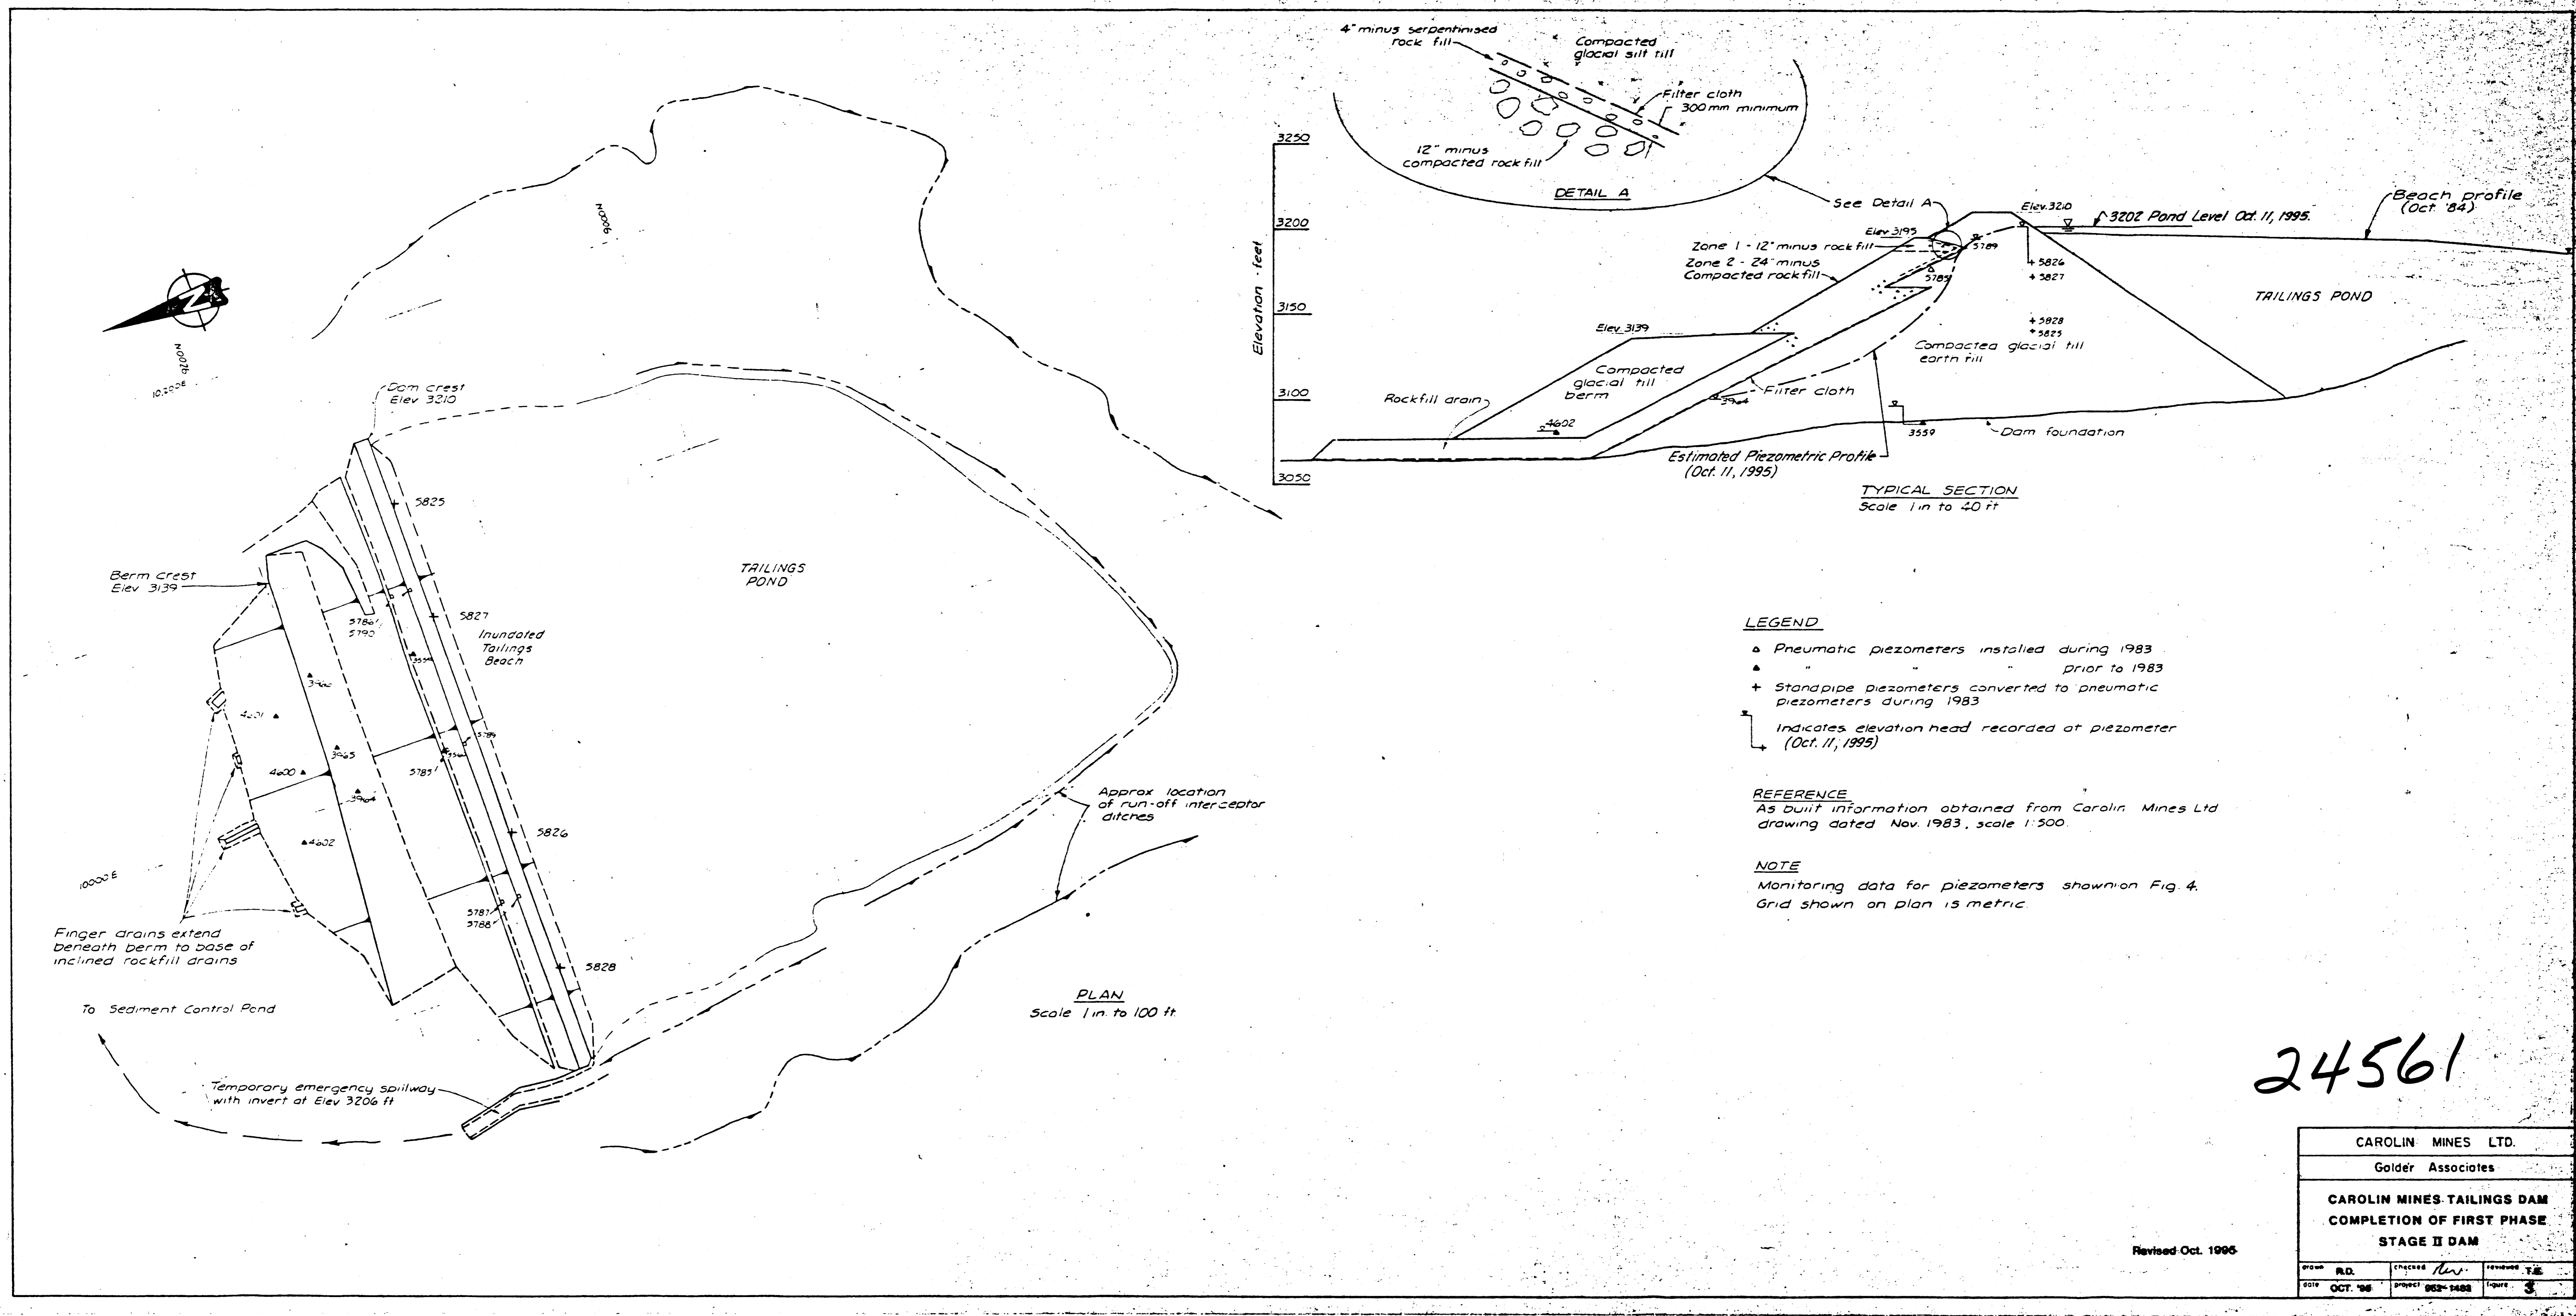
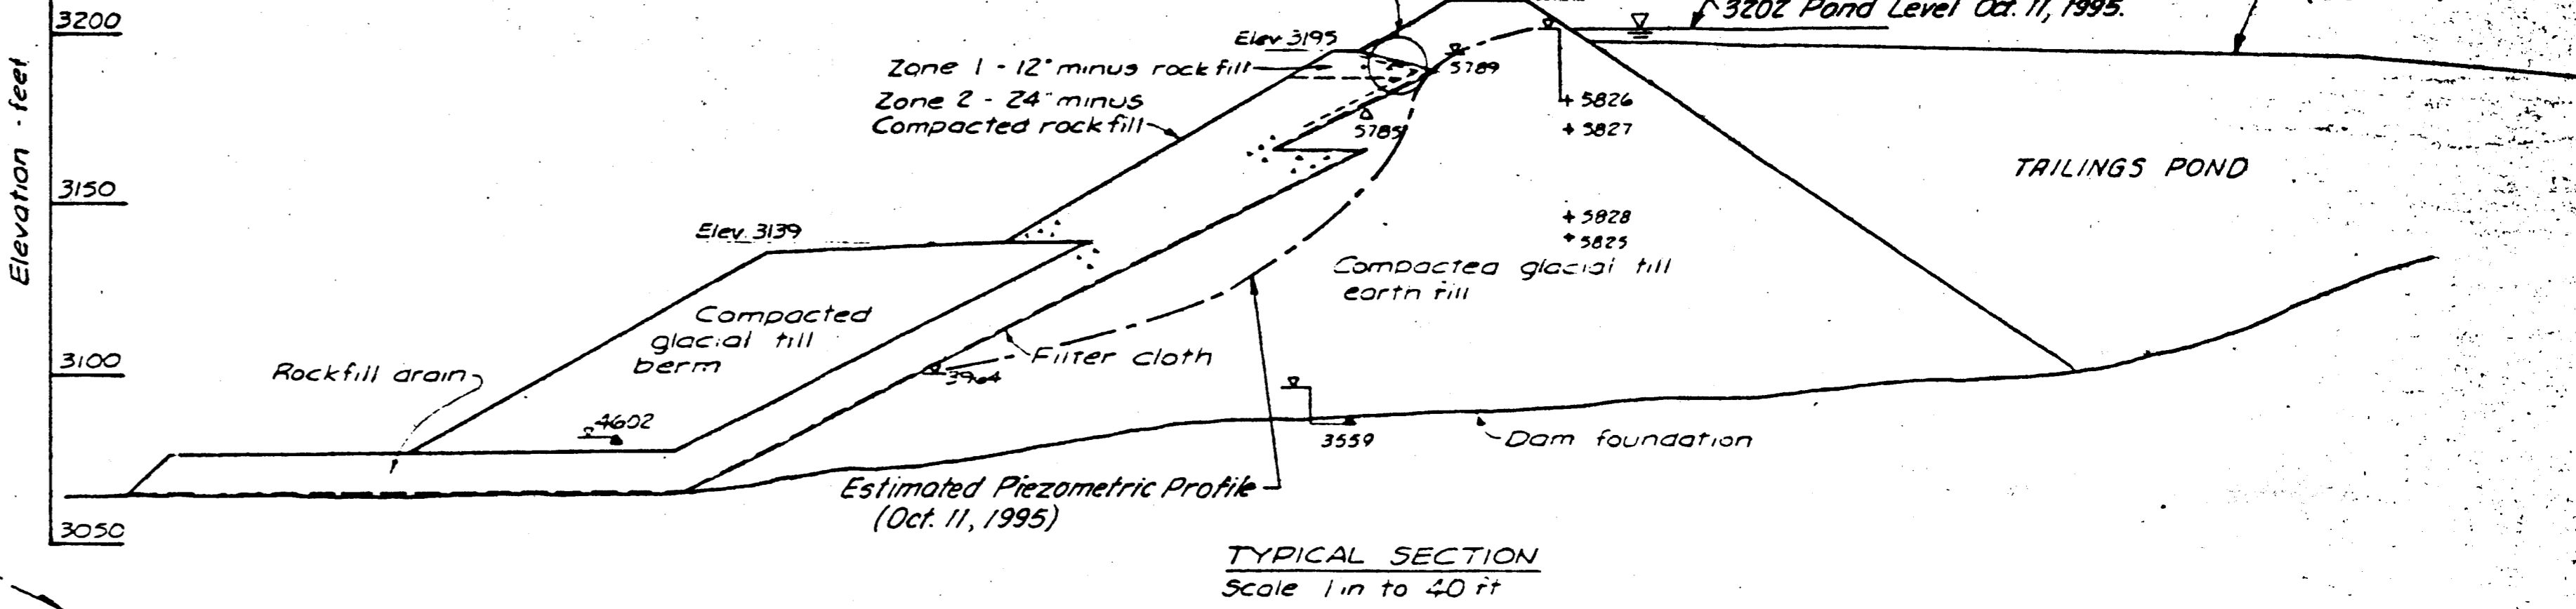
CAROLIN MINES LTD.			
Golder Associates			
CAROLIN MINES TAILINGS DAM COMPLETION OF FIRST PHASE STAGE II DAM			
Drawn	R.D.	Checked	Reviewed
2019	OCT. '95	PROJECT 9524-5482	Figure 3

- The mill effectively ceased operation during 1984 and the final tailings solids beach level is as shown on Figure 3.
- The water storage level behind the dam ranged from 3,190 to 3,203 feet during the period 1984 to 1987 as water quality affected discharge. From mid 1987 to 1989 the pond level was controlled by pumped and siphoned discharge, and was maintained near elevation 3,187 feet.

No mill operation has taken place during the period from 1989 to 1995, and therefore the tailings solids stored remain the same as in 1984 and as shown on Figure 3. The beach is currently inundated but ranges from elevation 3,194 to 3,199.5 feet at its intercept with the upstream dam slope.

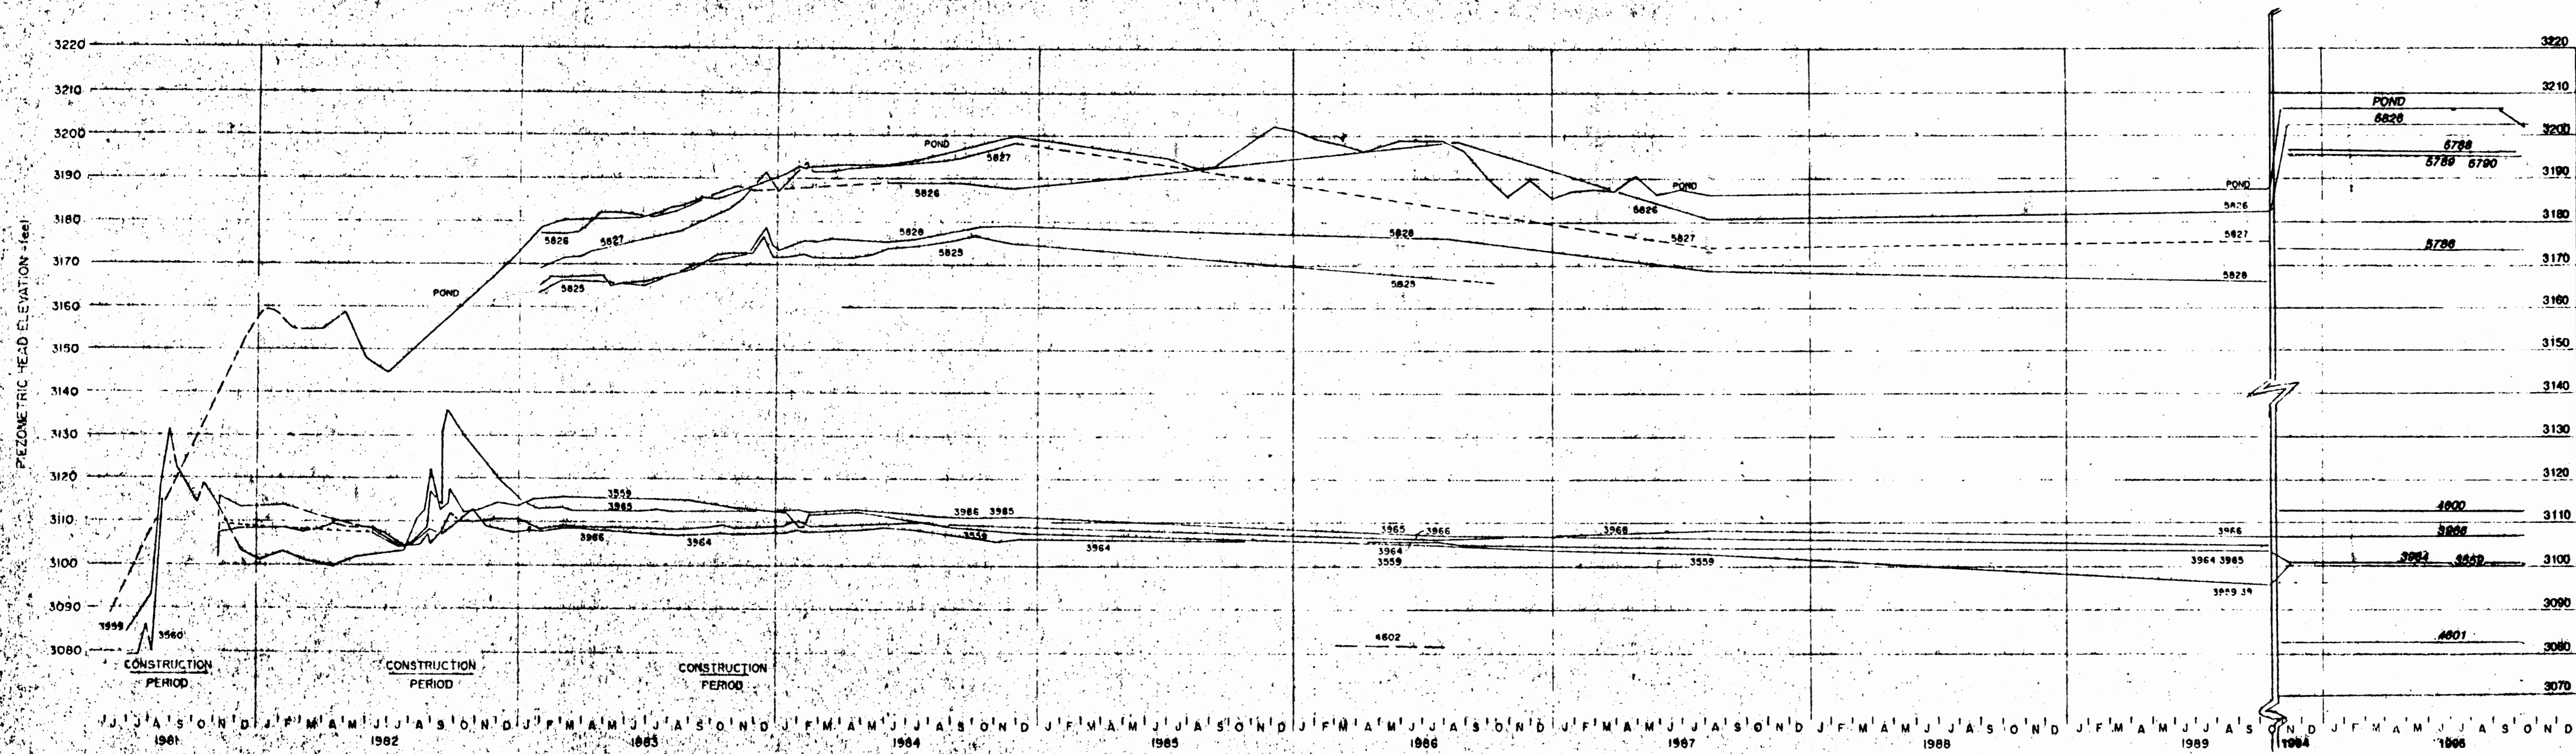
The fluctuation of the pond water level during the 1989 to 1995 period is not well known. The levels shown on Figure 4 indicate that the pond has been at full emergency spillway level since 1993. The available piezometer readings taken on October 11, 1995 are shown on Figure 4 and the seepage phreatic surface based on these results is given. Due to the destruction of several piezometer leads on the dam crest the assumed phreatic surface may not be accurate.

The piezometer readings and phreatic surface are considered indicative of full pond storage to elevation 3,206 feet. The results indicate that seepage is discharging through the upper core section into the upper rock drain. This indicates a high phreatic surface in the central section of the dam core. Additional piezometers are required to replace those destroyed, in the central section of the dam, in order to provide a reliable appraisal.

- 1) Unit locations shown on Figure 3.
- 2) Unit 3560 ceased to function on Aug 20/81.
- 3) Units 4600, 4601 & 4602 located in toe berm do not register significant pressure.
- 4) Units 5785, 5786 & 5787 located beneath rock drain at elev 3173 ft do not register significant pressure.
- 5) Units 5788, 5789 & 5790 located in fill core at elev 3195 ft do not register significant pressure.
- 6) Units 5825, 5827 and 5828 inoperative 1995.

There is presently insufficient piezometric detail to fully define the seepage conditions within the dam. This has resulted because of the destruction of piezometer leads on the dam crest. We recommend that four additional piezometers be installed at this time from the dam crest. This work would be undertaken by means of a percussion drill rig using casing and drilling fluid. The piezometers would be installed to replace piezometers numbered 5825, 5827 and 5828.
