Assessment Report Number 27639

Preliminary Geotechnical Assessment

Dailite 906 Property

Author: Mr. Greg Reid, P.Eng. P.Geo.

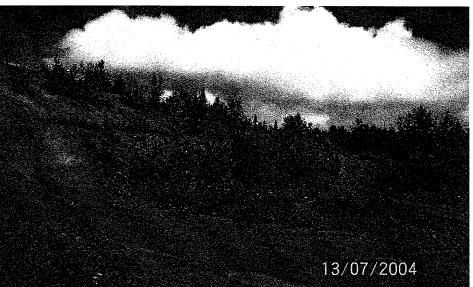
View of former processing area, looking northerly. Note burned car bodies/debris pile in centre of photo.

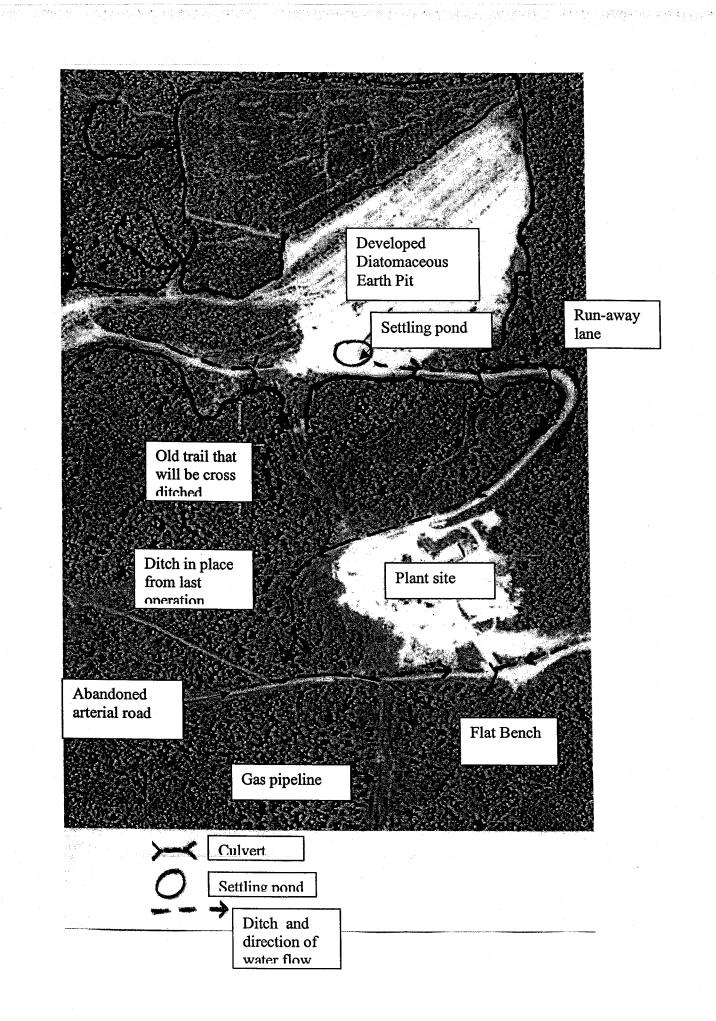
Drainage Plan DL 906

The attached map indicates the location of the ditched, culverts and settling ponds that are either in place or proposed.

Our proposal is to re-establish the drainage patterns in place during the last operation and enhancing them with the installation of drainage culverts at the designated locations.
