GEOLOGICAL & PROSPECTING WORK

LACO MINES LIMITED

CALLING LAKE AREA, HIGHLAND VALLEY

Report on  
GEOLOGICAL & PROSPECTING WORK  
on the Property of  
LACO MINES LIMITED  
CALLING LAKE AREA, HIGHLAND VALLEY,  
BRITISH COLUMBIA

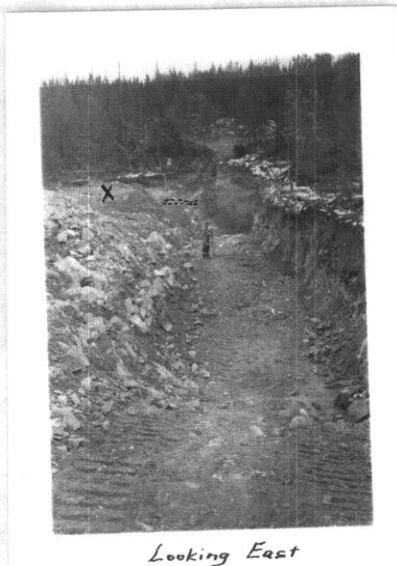
Plate 2

#### Trench #1 (Plate 2, page 11)

This trench, located near the common corner of Nancy 3, 4, 5 and 6, is 210 feet long with a cross trench 100 feet long at the east end. Bedrock is exposed for the full length and comprises highly jointed granodiorite containing occasional bands of sericitic porphyry and several small shears.

Two samples were taken from points A and B respectively.

- A. Channel sample across the mineralized fault assayed 2.6% Cu. over 16".
- B. Chip sample from a 15' x 5½' area of the mineralized network of joint planes. This assayed 0.35% Cu.

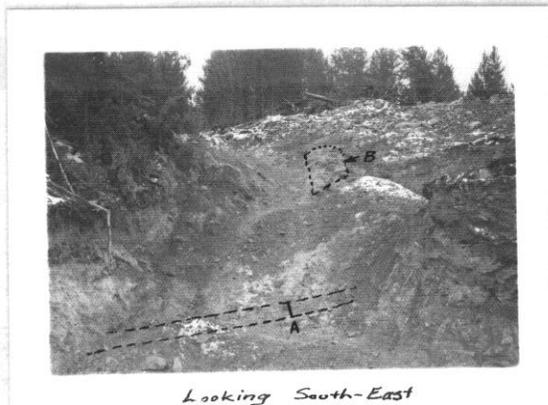
The only copper mineralization of note occurs in a 50 foot wide zone at the south east end of the trench (Plate 3). Even here the

granodiorite is not sufficiently shattered and copper mineralization, as chalcopyrite and malachite, is essentially confined to narrow quartz veins and stringers along a network of joint planes. Best mineralization is in a fault 15 inches wide. The fault contains several quartz veins up to two inches wide and these are well mineralized with chalcopyrite.

Plate 3 is taken looking south-east from X on plate 2.

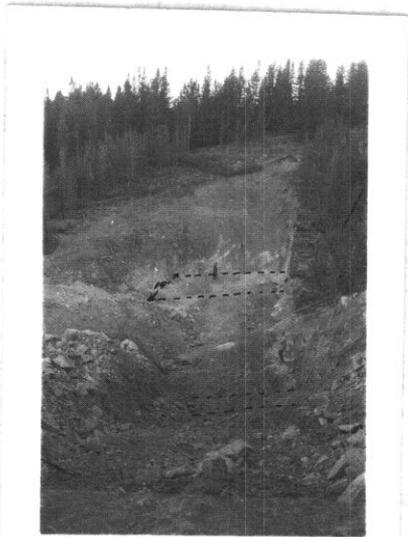
Plate 4

Trench #2 (Plate 4, page 13)

Trench #2 in Nancy 14 is located some 400 feet southeast of the northwest corner of Nancy 14 and is approximately 300 feet long. Maximum depth of overburden is three feet. The trench cuts across the shear extending southwards from the old Empire workings and at a point where minor shears converge on it from the northeast.

It was hoped that this might have produced a broad brecciated area but trenching shows that the shearing is confined to narrow widths with the intervening rock usually only well jointed.

The intervening 100 feet of rock is mostly porphyritic slightly sericitic granodiorite containing sparsely disseminated bornite. Three chip samples taken at points across the 100 foot width

assayed 0.20%, 0.15% and 0.15% Cu respectively.

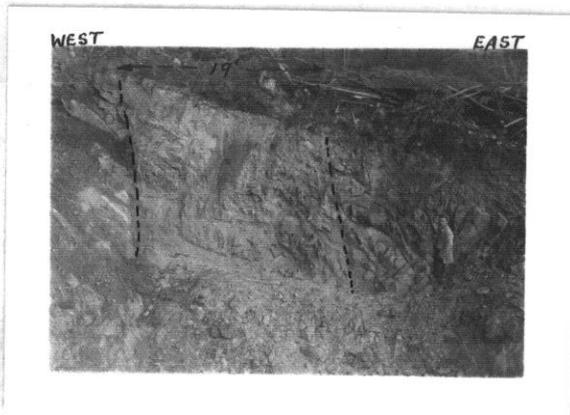
Plate 5

The main shear (Plate 5) located near the western end of the trench is 19 feet wide. It dips almost vertically and comprises a grey sericitic porphyry slightly veined with quartz. The quartz veining, as irregular concentrations and small stringers, is largely concentrated in the westernmost four feet of the shear and decreases notably towards the eastern edges. Mineralization comprises bornite, malachite and a little molybdenite. Malachite occurs as a heavy green staining in the upper three feet of the zone, immediately below the overburden. Below this depth bornite is the only copper mineral. Bornite is mainly associated with the quartz with lesser amounts disseminated through the porphyry. Best values were therefore to be expected in the westernmost four feet of the zone. Assays from channel samples taken across the full width of the shear as exposed on the northern wall of the trench are given below. An additional 200 pound bulk sample was taken across the full width from the south wall.

The smaller shear 100 feet to the east of the main one is eight feet wide with a dip of  $60^{\circ}$  to the east. It comprises four bands of silicified sericitic porphyry varying in width from 3" to 18" separated by porphyritic granodiorite. These bands contain a little bornite and some malachite staining. A chip sample was taken across the full eight feet.

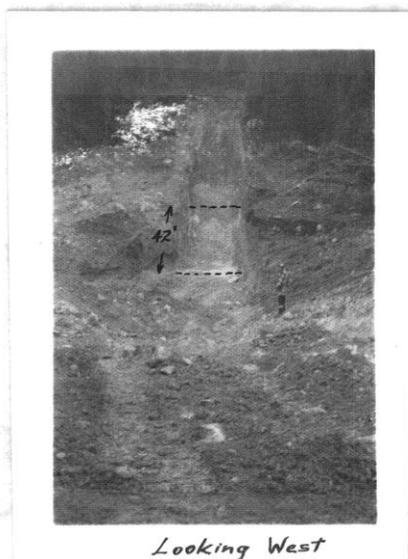
Plate 6

Trench #4 (Plate 6)

In view of the encouraging signs in Trench #2, Trench #4 was located 700 feet south of #2. It is in a wider part of the gully where it was hoped that this fact, together with the lack of out-

crops, perhaps meant more intense shearing.

This trench is 220 feet long. Maximum depth of overburden is ten feet in the centre of the gully. The assumed continuation of the main shear from #2 was intersected in the western half of the trench. The shear at this point is 42 feet wide and has a vertical dip. Unfortunately mineralization is negligible. The only copper mineralization in this trench is a minor amount of malachite staining in a small shear and along jointing east of the main shear.

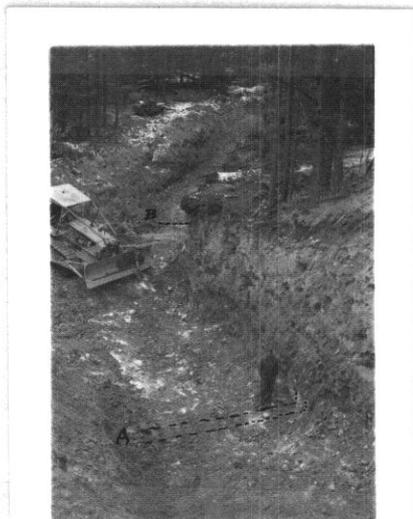
Plate 7

### Trench #3 (Plate 7)

This trench is 1000 feet south of the old Kathleen workings. It was positioned to intersect an expected wide shear zone suggested by exposures in diggings several hundred feet to the north. Unfortunately results were discouraging.

The trench is 200 feet long in an east-west direction across the Kathleen fault. Overburden is up to 12 feet deep. Bedrock comprises granodiorite which is well jointed but otherwise little

disturbed except in the vicinity of the Kathleen fault. The Kathleen fault was intersected 60 feet from the east end of the trench. (Plate 7, A). The fault is marked by a five foot wide band of jointed, brecciated and silicified sericitic porphyry. (Plate 8). The only notable copper mineralization occurs within the silicified portion of the Kathleen fault. Maximum width of mineralization is two feet and the vein of high grade mineralization is no more than one foot wide. Mineralization comprises bornite and chalcopyrite together with a little molybdenite. Two channel samples were taken across this band.

Seventy feet from the west end of the trench is a band of sericitic porphyry one foot wide containing a quartz vein one and a half inches wide (Plate 7,B). The quartz vein contains approximately 2% Cu as bornite and chalcopyrite.

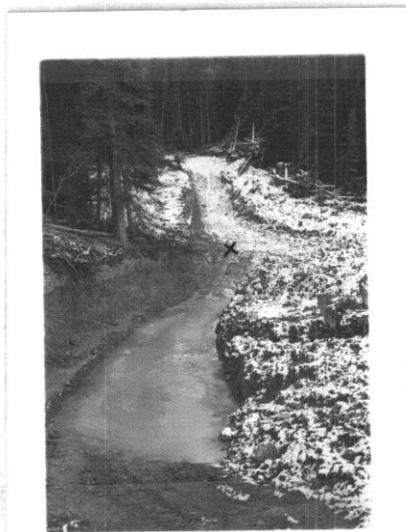
Plate 9

Trench #5 (Plate 9)

Trench #5 is located in the south central part of the property near the eastern boundary in Nancy 13.

Consideration of the various aspects of mineralization in the area suggested that the eastern side of Nancy 13 would be favourable ground for possible copper mineralization. The reasons were that the main shears crossing the property appeared to be converging on this area and scarcity of outcrop and low ground suggested comparative ease in erosion perhaps as the result of much shearing and severe jointing of rocks.

Trench #5 is approximately 300 feet long. After four days of bulldozing, work was stopped here for the season. Bedrock had just been exposed at one point (X) on the eastern slope and from this it could be assumed that total depth of overburden in the centre of the trench would be approximately 20 feet.

Bedrock exposed was a jointed granodiorite with a little malachite staining along jointing.
