ASSESSMENT WORK REPORT

MONICA GROUP

IDEAL BASIC INDUSTRIES INC.

JULY 1976

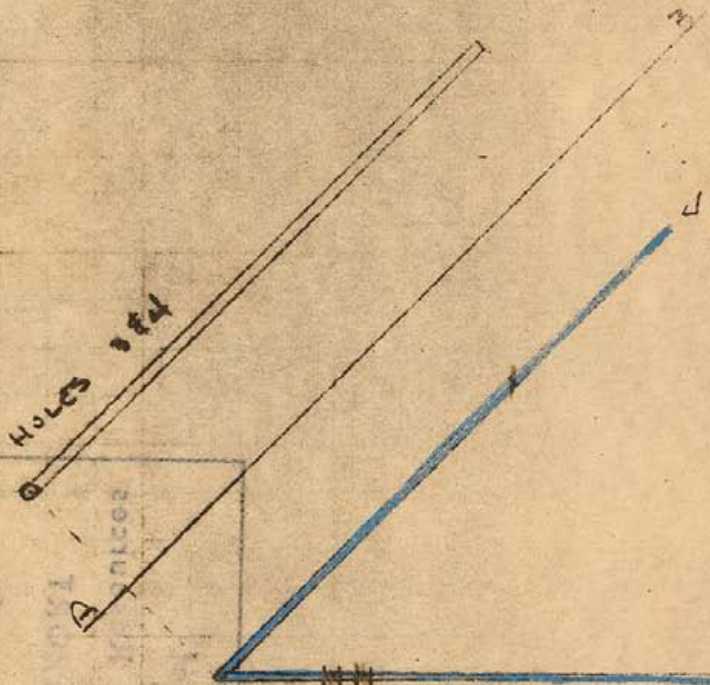
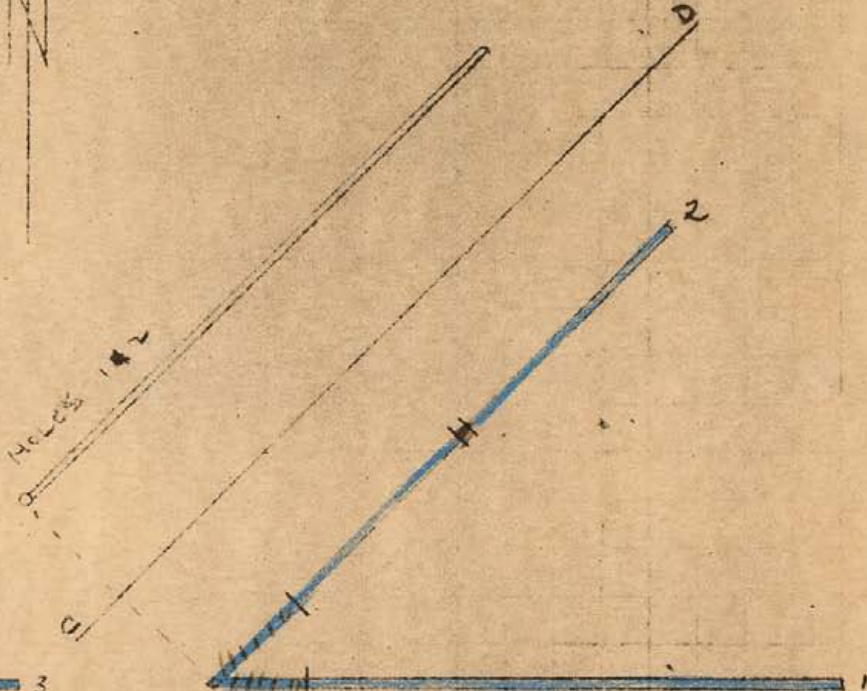
ASSESSMENT DRILLING  
 MONICA GROUP  
 BASIC # 8 M.C.

A second hole was collared in the same spot and drilled horizontally in the same direction. Sparse sulphide mineralization was encountered to 19 feet, the dyke was intersected at 55 - 57 feet and the remainder of the hole was limestone to 101 feet.

Two more holes were collared 130 feet west on the same bearing. Number 3 at -45 degree cut minor sulphides 17 - 19, 22 - 24 and 2" at 65 feet. The remainder of the hole was limestone to 100 feet. Number 4 hole drilled horizontally was in limestone for the entire 100 feet with one seam of sulphide at 85 feet.

Four holes (one reported previously) drilled in the sulphide showing yielded negative results. The mineralization is mainly pyrite and apparently the area showing in the quarry face is not indicative of its extent. A grab sample was taken and sent in for analysis. This is found in appendix 1.
