**ASSESSMENT REPORT
ON THE
1991 GROUNDWATER MONITORING PROGRAM
(CINOLA GOLD PROJECT - HIGH WEST AREA)**

**SKEENA MINING DIVISION
Graham Island, Queen Charlotte Islands,
British Columbia**

**Dan Charbonneau, P.Eng.
STEFFEN, ROBERTSON AND KIRSTEN (B.C.) INC.
Suite 800 - 580 Hornby Street
Vancouver, B.C.
Canada, V6C 3B6**

DECEMBER 1991

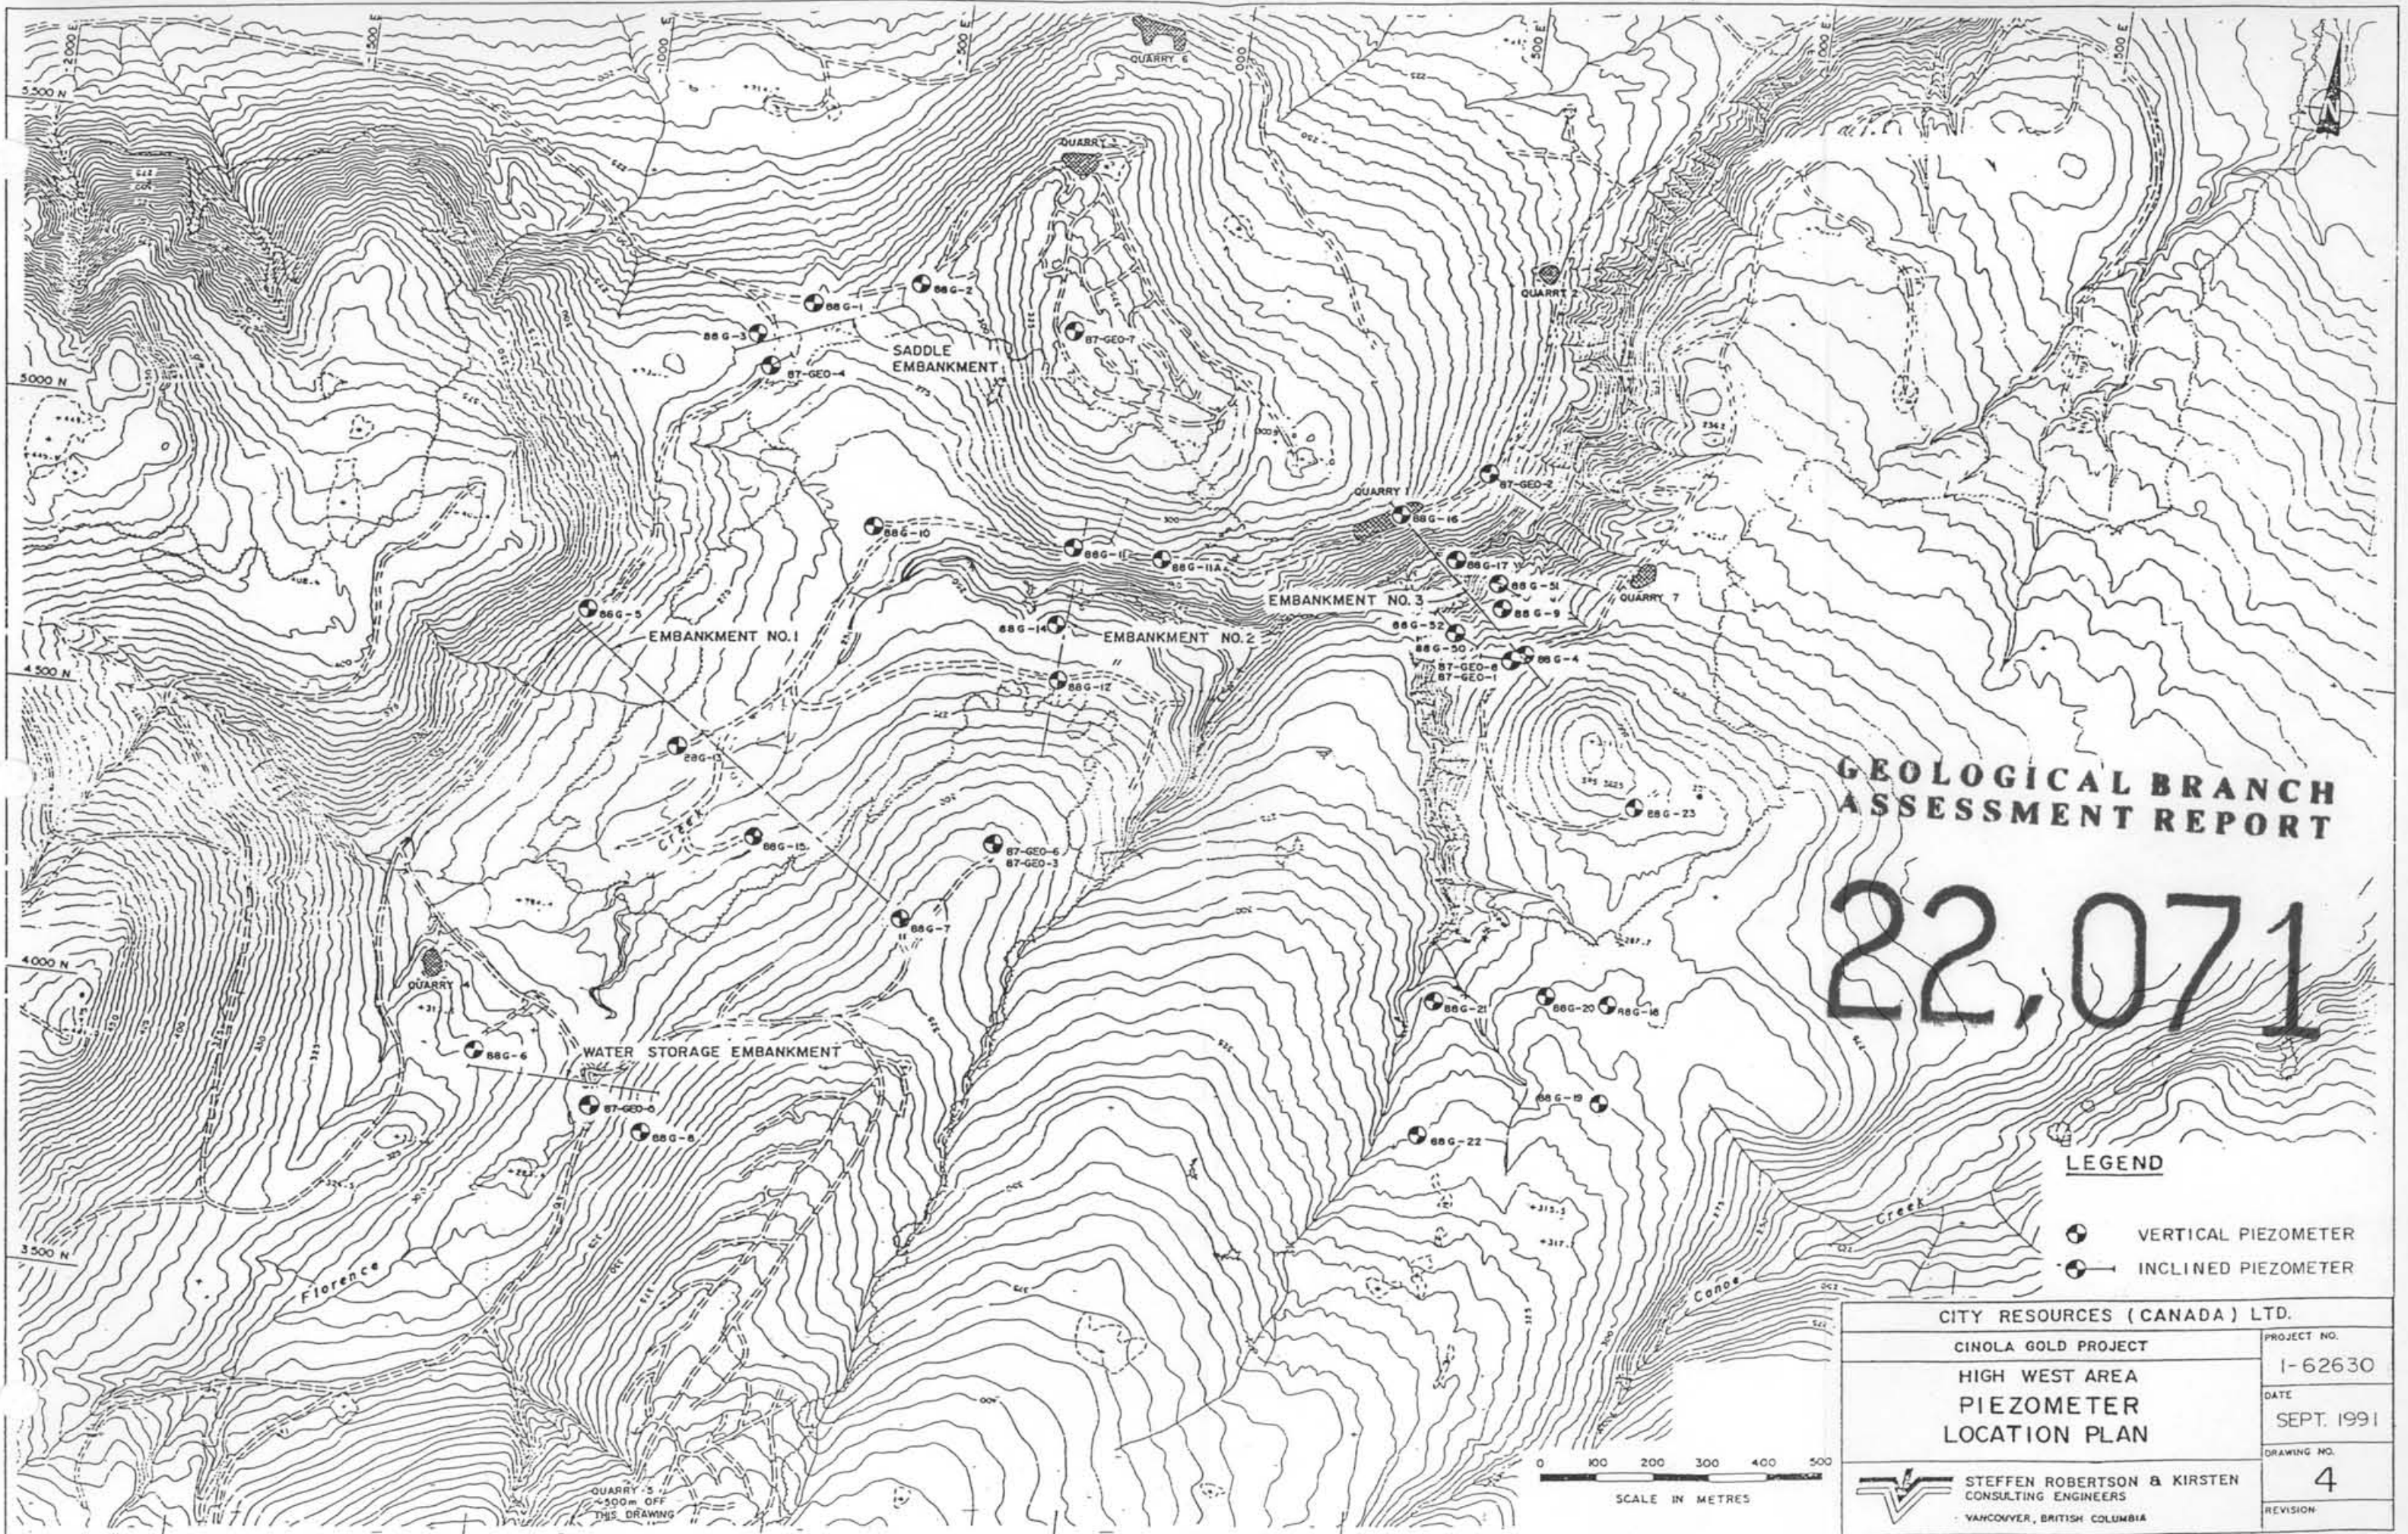
CITY RESOURCES (CANADA) LTD.	
CINOLA GOLD PROJECT	PROJECT NO. 1-62630
HIGH WEST AREA PIEZOMETER LOCATION PLAN	DATE SEPT. 1991
STEFFEN ROBERTSON & KIRSTEN CONSULTING ENGINEERS VANCOUVER, BRITISH COLUMBIA	DRAWING NO. 4 REVISION

The piezometer nest locations are shown on Figure 4. They were installed during two drilling programs; the first in April 1987 (drill holes 87-Geo-2 to 87-Geo-8) and the second from July 1988 to October 1988 (drill holes 88G-1 to 88G-23 and 88G-50 to 88G-52). Piezometer monitoring consisted of locating

Of the original 34 piezometer rests, all but six (88G-10, 88G-11A, 88G-12, 88G-13, 88G-15 and 87-Geo-4) were located and one (87-Geo-2) was identified as destroyed. Records (1988) indicate that the six piezometers not located were destroyed by logging activity. Two piezometer nests (88G-11 and 88G-23) have been sheared off to the road surface, but are still open and seem to be functioning, as the water levels measured correspond within the range of values previously recorded. Neither of the sheared piezometer nests seem to be acting as a surface runoff drain. Both piezometers in 88G-23 are clear but the piezometers and casing of 88G-11 are blocked above their respective completion zones, probably by sand and gravel that has been pushed and fallen down the casing and piezometers. The top of piezometer 2 at 88G-16 has been broken off inside the casing and is difficult to locate.

Some of the piezometers seem to have some sediment at their tips, but not enough to block the tips, However eight piezometers (88G-1 casing, 88G-5 piezo. 3, 88G-19 piezo.1, 88G-20 piezo.1, 88G-21 piezo.2, 88G-23 piezo tip =17.3 m, 87-Geo-3, and 87-Geo-6) when sounded were between 0.4 m and 1.3 m above the installed depth of the tip, but have water level readings within the range of previous readings.

Three piezometers (88G-2 piezo.2, 88G-11, both piezos.) were sounded greater than 3.5 m above their respective installed tip depths and also have water level readings within the range of previous readings. Two piezometers (88G-50, 88G-52 piezo tip=15.5 m) were sounded to depths above their respective completion zones and were dry. Piezometer 88G-50 was blocked with a brown silty clay that stuck to the probe.

All the water level readings were consistent with previous readings except in the vicinity of the proposed embankment no. 3; water level readings in 88G-16 piezometer 1 and the casing which were respectively 8.91 m and 3.65 m above the highest previously recorded readings. The trend of the water level readings at 88G-9 seem to indicate a very low permeability aquifer, as they slowly rise from April 1988 to the present reading. Also at 88G-51 piezometer 56.5 m (tip), there is not enough data to be certain, but the water levels seem to be slowly rising to the present level of 3.62 m.

Near the proposed embankment no. 3, piezometer nests 88G-4 and 88G-9 indicate upward gradients. Near the proposed embankment no. 2, 88G-14 is artesian and at the site of 88G-15 there is now a spring, which may be from the broken piezometer nest which was previously recorded as artesian.

Further monitoring should be conducted in late 1992 or early 1993 to keep the database up to date.
