Adanac Drilling Report on the  
Adera 9, Adera 11, Hobo 66, Hobo 75, Hobo 76,  
Clair 2 Fr and Jan Mineral Claims

Atlin Mining Division

Owned By:  
Adanac Mining and Exploration Ltd.

Preliminary Site Investigation Report

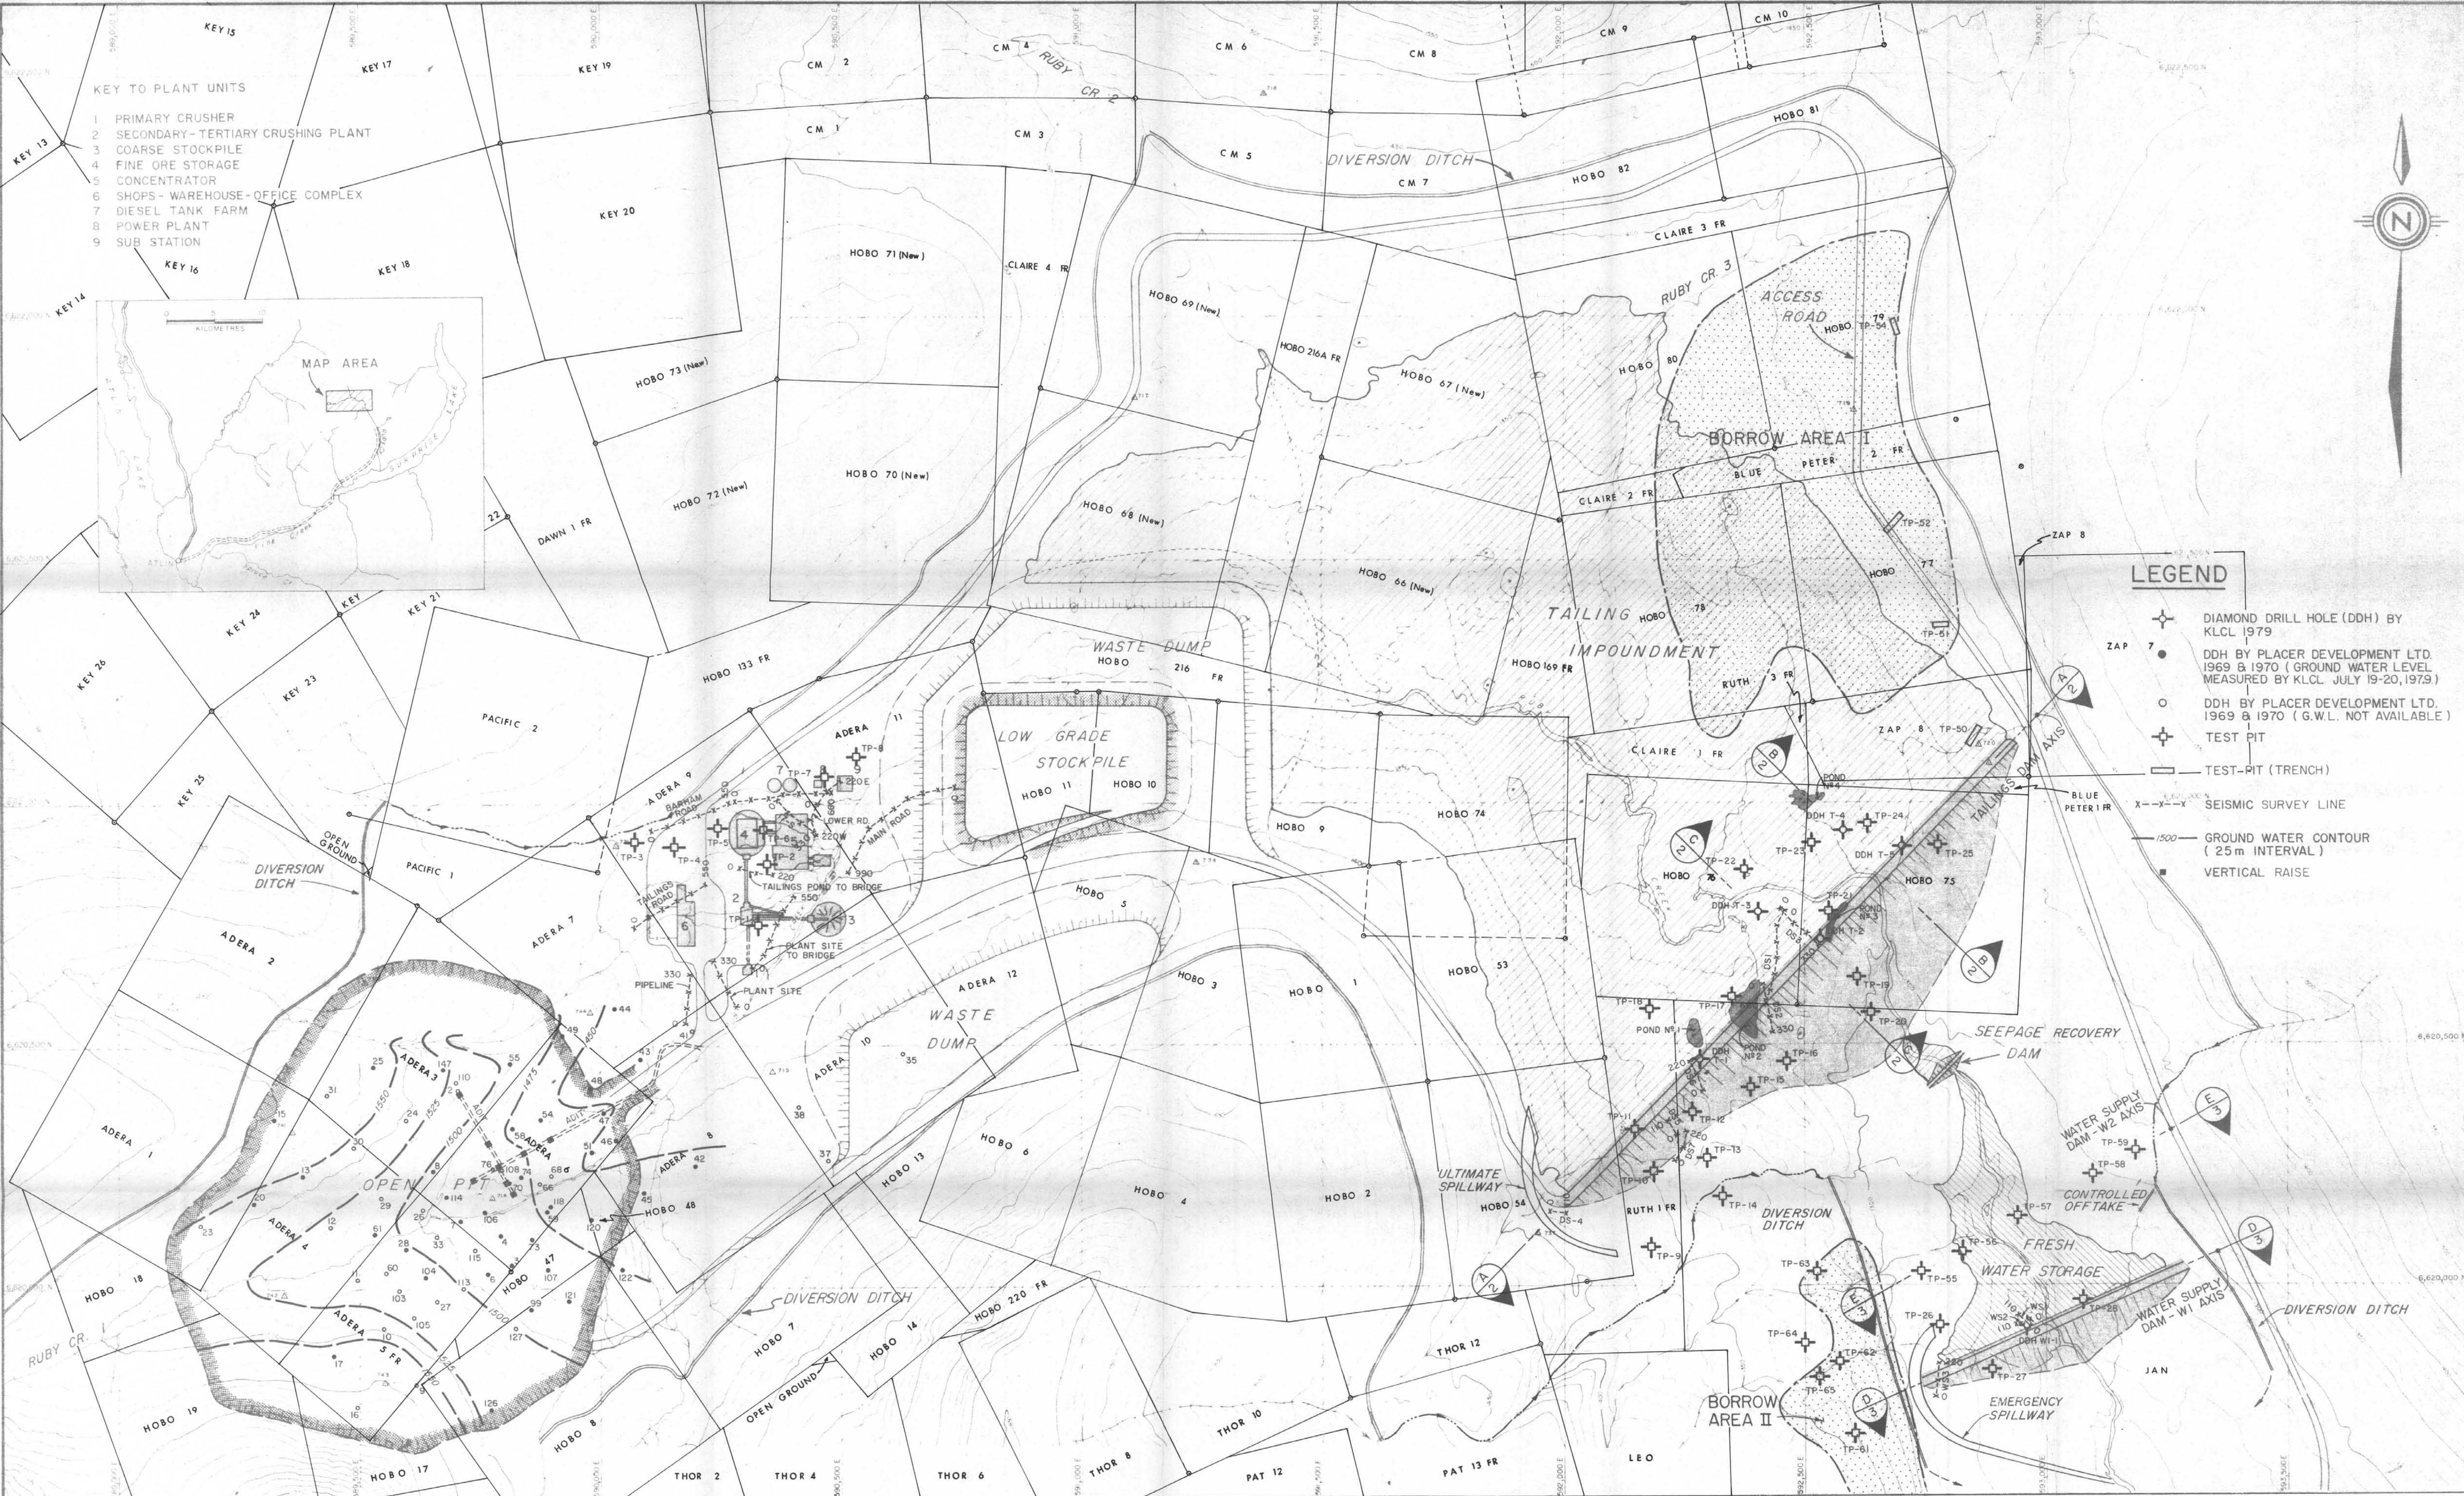
REV.	DATE	REVISION DETAILS	SCALE	
DESIGN	V.K.G./K.L.	DRAWN F.C.	DATE Sept, 1979	SCALE As shown
PROJECT		ADANAC - SITE INVESTIGATION		
TITLE		LAYOUT AND BOREHOLE / PIT LOCATION PLAN		
DATE OF ISSUE	PROJECT NO.	DWG. NO.	REV.	
Sept. 29, 1979	VA 2538	E-2538-1

- ⊕ DIAMOND DRILL HOLE (DDH) BY KLCL 1979
- DDH BY PLACER DEVELOPMENT LTD. 1969 & 1970 (GROUND WATER LEVEL MEASURED BY KLCL JULY 19-20, 1979)
- DDH BY PLACER DEVELOPMENT LTD. 1969 & 1970 (G.W.L. NOT AVAILABLE)
- ⊕ TEST PIT
- TEST-PIT (TRENCH)
- SEISMIC SURVEY LINE
- GROUND WATER CONTOUR (25m INTERVAL)
- VERTICAL RAISE

As illustrated on drawing number 1, enclosed in the pocket, holes PS-1 and PS-2 were located in the planned plant site, holes T-1 to T-7 were within the tailing impoundment basin and hole W-1 was at a potential water storage site. The principal purpose of the drilling program was to determine the suitability of the areas for the purposes intended. In this regard most of the holes received critical scrutiny in the overburden portion of the drilling. The subsoil investigations were carried out under the direction of Klohn Leonoff Consultants Ltd. Pertinent portions of their report entitled, "Adanac Mine, Preliminary Site Investigation Report for Placer Development Limited" dated September 28, 1979, have been included as a supplement to this report.

The groundwater level contours are shown on Drawing E-2538-1. Groundwater measurements indicate a water table which generally follows the ground contours. The water table is encountered at less than 15 m below ground level except with drillhole Nos. 25 and 44 where the water level was found to be 25 and 22 m respectively below ground surface. A number of drillholes in close proximity to the adits are blocked and could not be read. Of the remaining holes, the adit does not appear to drawdown the water significantly. A drawdown of water level in Molly Lake would significantly reduce water levels in the pit area.

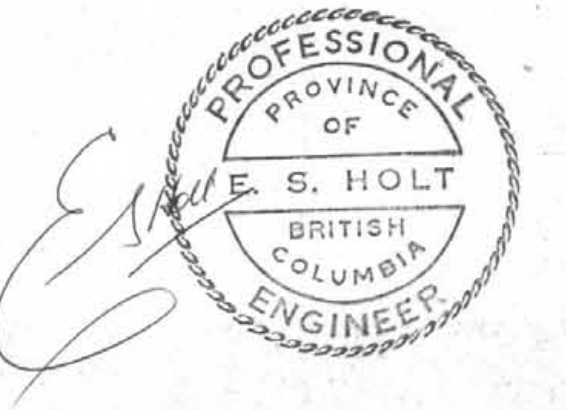
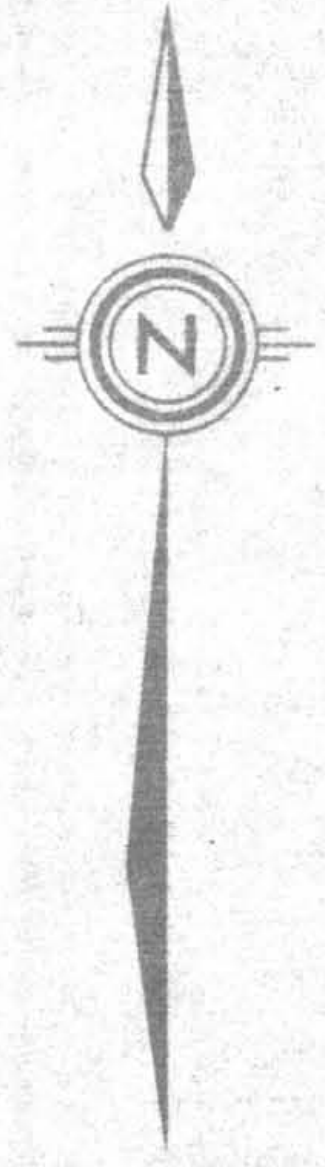
Layout and Borehole/Pit Location Plan prepared by Klohn Leonoff Consultants showing pit locations relative to drill holes and claim boundaries.

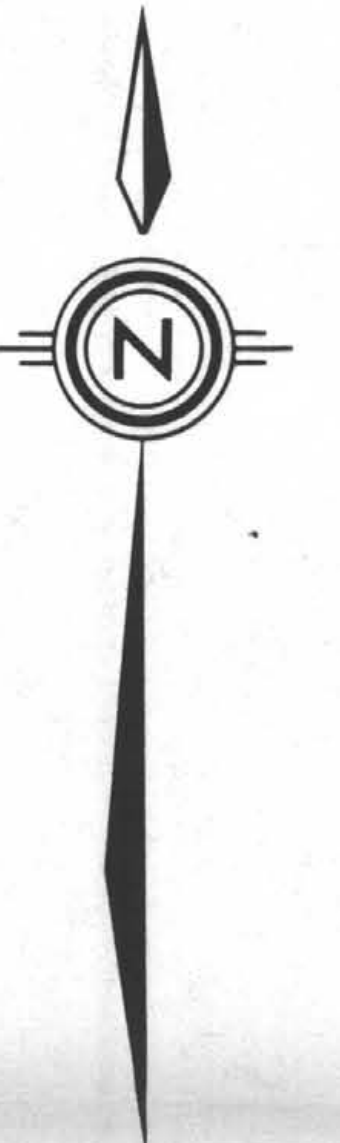
PLACER DEVELOPMENT LIMITED  
ATLIN MINING DIVISION **PART 20B**  
ADANAC MOLYBDENUM PROJECT  
**GENERAL OPERATING PLAN**

General Operating Plan (scale 1:5,000) showing the drill hole locations (coloured red) in relationship to the claim boundaries.
