**Report  
On  
Testing & Analysis Investigation of Red Rock  
For  
Pacific Bentonite  
Claims Ben 1 & Ben 2, Record No. 8939 & 8940**

**In The  
Kamloops Mining Division  
Latitude 50 45N Longitude 121 35W**

**By  
N. Skermer, P. Eng.  
Consulting Geotechnical Engineer**

**December 1997**

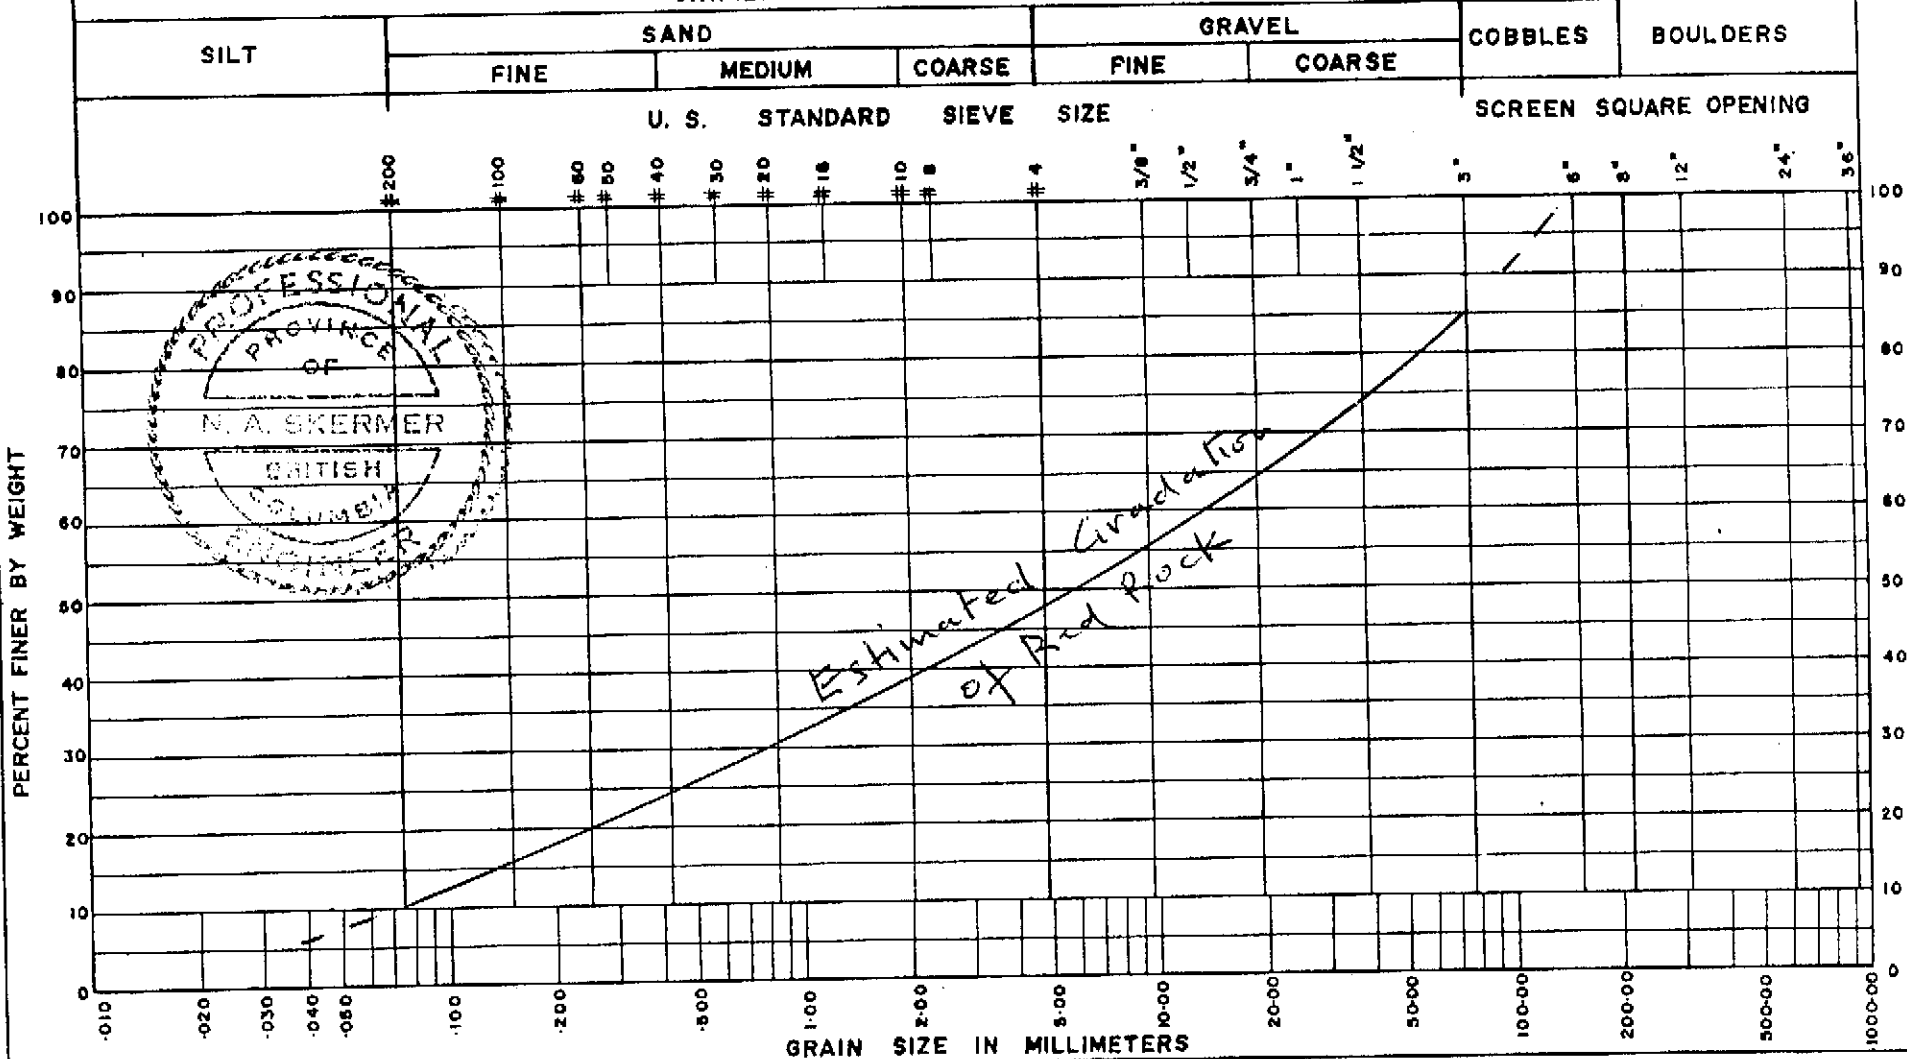
Figure 2  
GRAIN SIZE DISTRIBUTION

Without crushing, therefore, the material as excavated yields a product classified as a silty, sandy gravel, see Figure 2. No residual clay is present. The size range is from less than 10 percent silt (No. 200 sieve) upto gravel (50 mm) with occasional cobbles upto 200 mm, see Photo 1.

*Estimated Gradation  
of Red Rock*

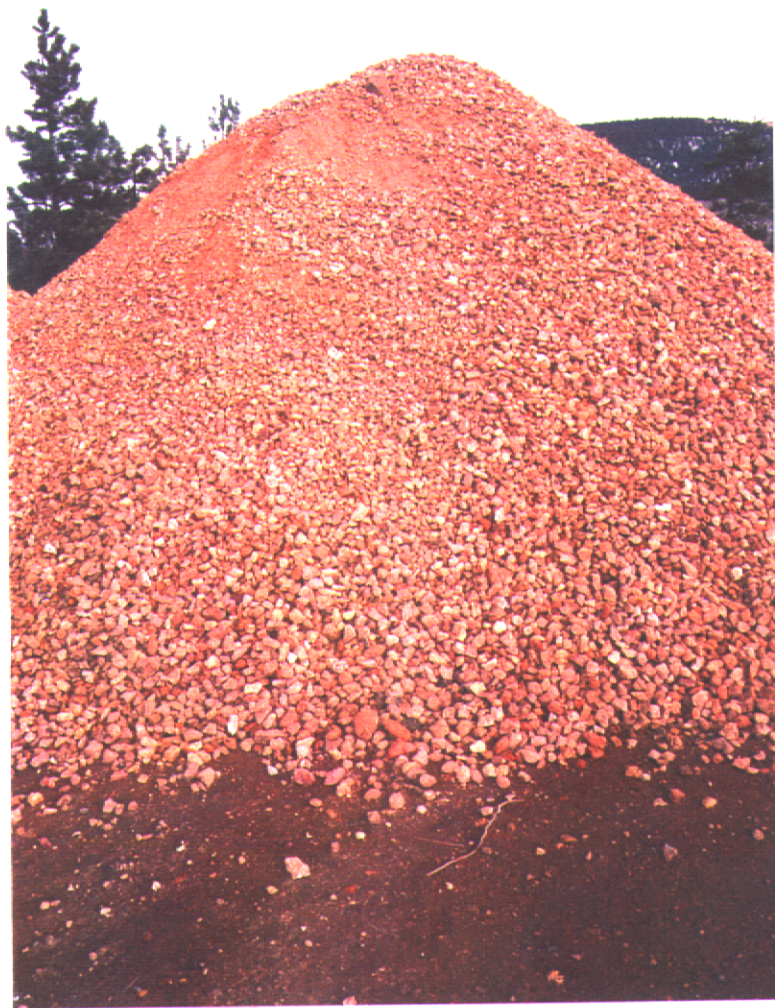
Photo 1

Of particular importance the particle shape is angular to subangular, and equi-dimensional, see Photo 1. No platy or flake-shaped particles could be detected. Despite the angularity of the particles, the material does not possess sharp edges.

Hat Creek Red Rock
