DOME CREEK SLATE PROPERTY
GEOLOGY

November 1999

DOMECREEK STRUCTURAL SLATE LTD.
4767 Upper Sumas Mountain Road, Abbotsford, B.C.

ASSESSMENT & GEOLOGICAL REPORT
DOMECREEK SLATE PROPERTY

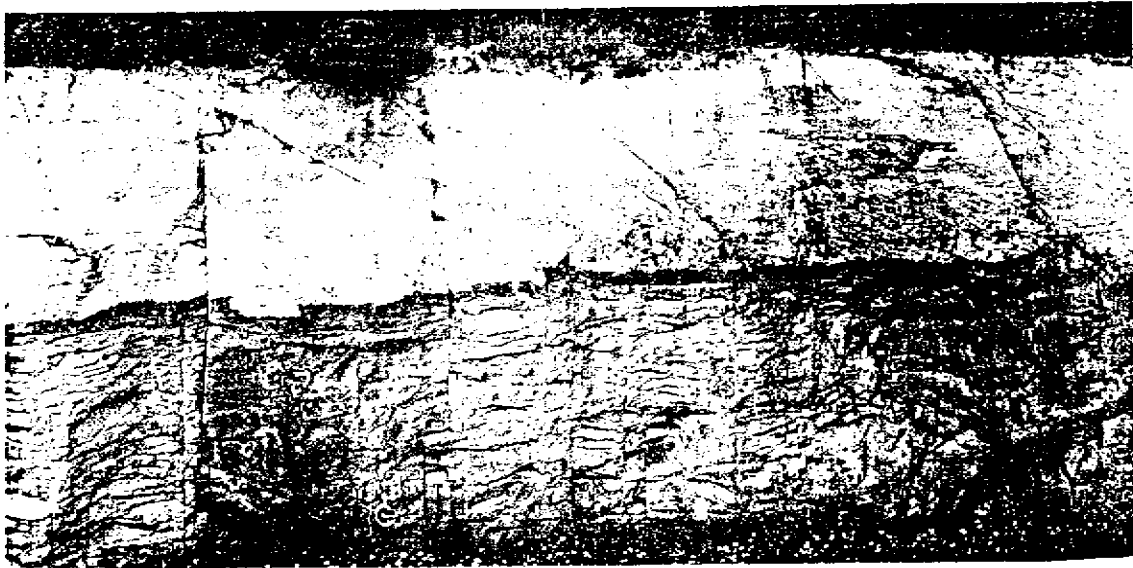
Plate 1. Outcrop of slate on the Yellowhead Highway
From top to bottom: western end, middle segment and eastern end.

In the Dome Creek Property area the most prominent part of the Yankee Belle Formation is the slate itself. It outcrops at the north side of the highway at a location 3.5 km from the Dome Creek bridge. The outcrop is almost 300 m long, green and locally rust stained. It forms a steep wall sloping southwesterly at 60° to 65° towards the highway (see Plate 1). A detailed description of the outcrop is attached as Appendix 3. The slope of the wall is formed by the slate's cleavage which masks the dip of the formation that ranges from 45° to 55° to the southwest. A short distance to the northwest a small outcrop of slate was found in the forest about 200 m from the highway outcrop. Beyond that point no other outcrop has been found as the slate is buried by sand and clay overburden. No slate was found in the valley of Dome Creek and in the area west of Dome Creek, on strike with the outcrop, there is nothing but hills of sand.

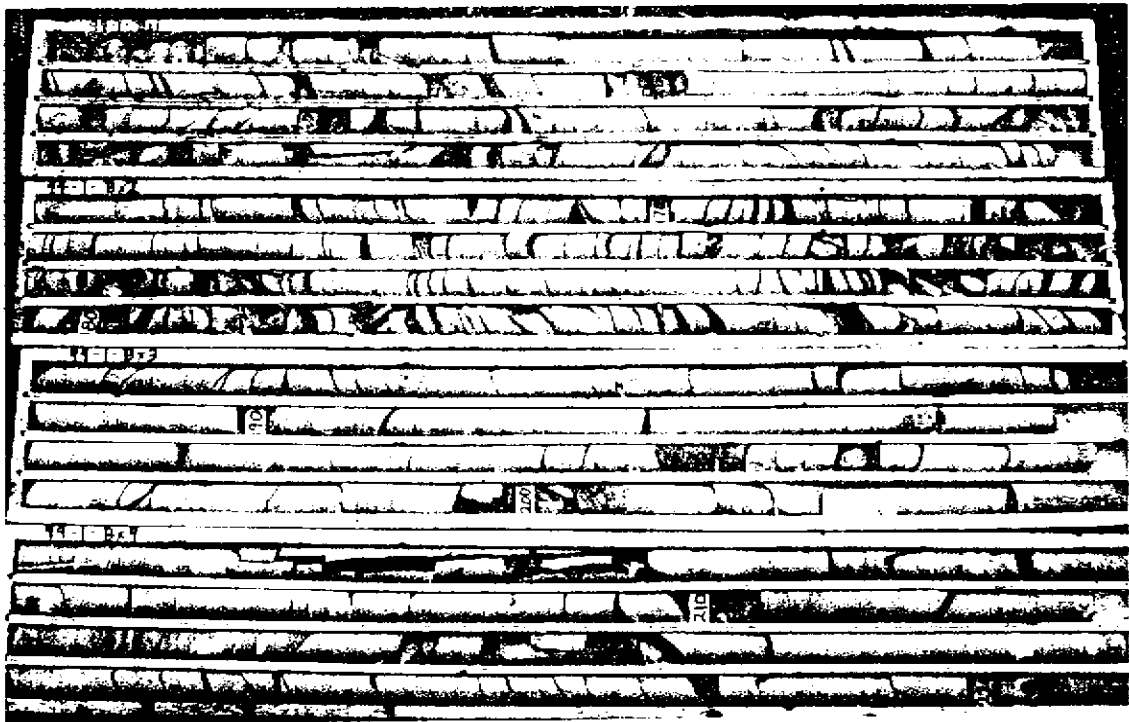
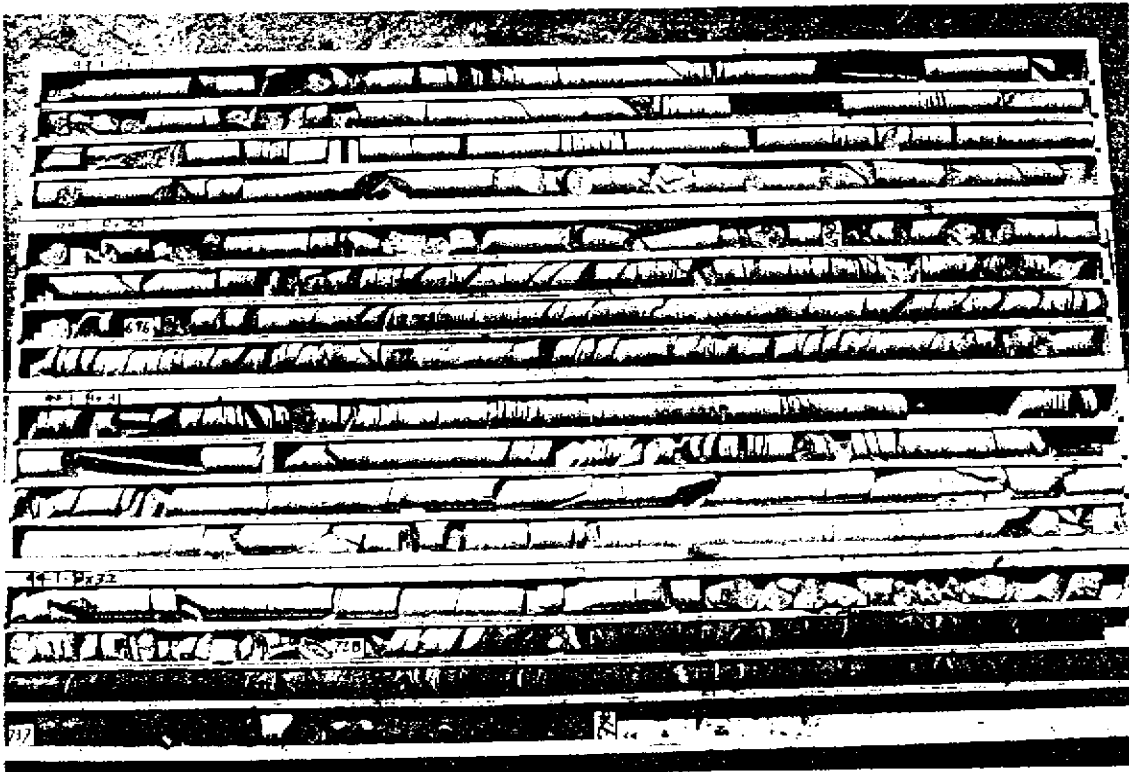
Plate 2. Core from hole DC 99-1C.

Top: The uppermost part of the Upper Slate Zone (core before splittability testing)
Bottom: The lowermost part of the Lower Slate Zone, including the limestone marker and underlying black shale (core after splittability testing).

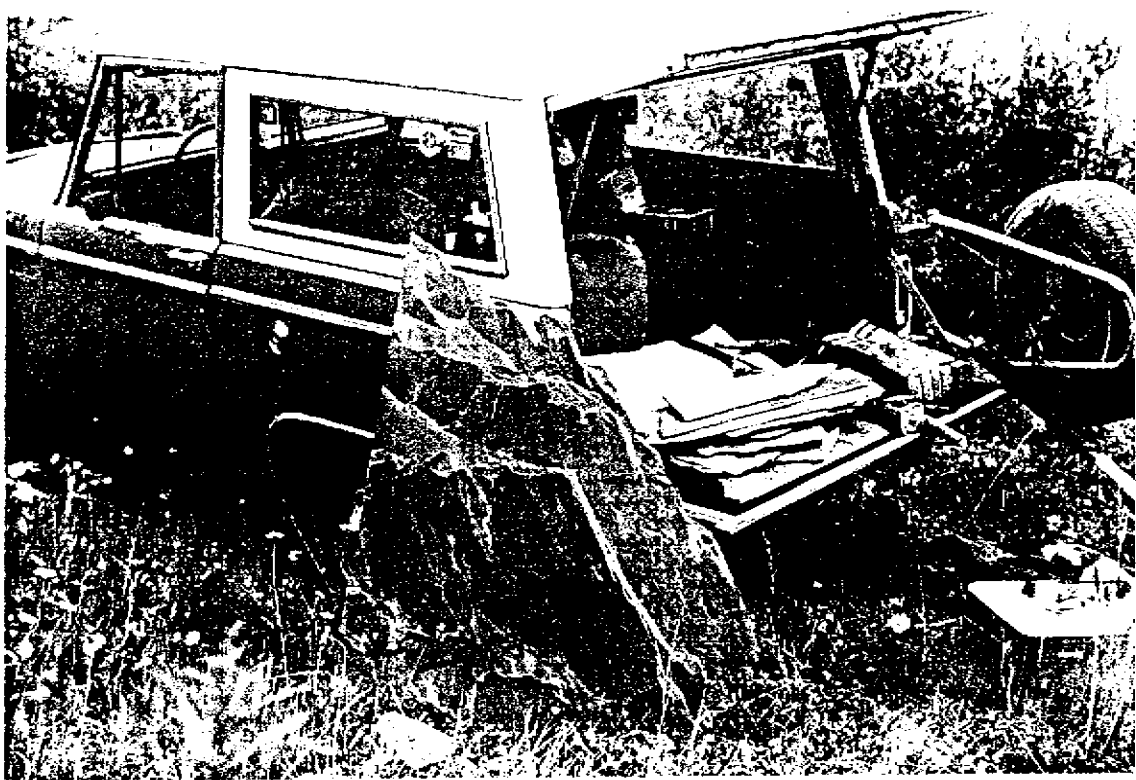
Plate 4. Splitting slate at the highway outcrop

Freshly excavated slate splits best because it still contains original formation moisture. Although the outcrop at the highway was exposed in 1967 it was not difficult to split several large blocks into thin plates.
