**COAST MOUNTAIN HYDRO CORPORATION
 FORREST KERR HYDROELECTRIC PROJECT**

**GEOTECHNICAL INVESTIGATIONS AND
 INTERPRETATIVE GEOTECHNICAL AND
 TUNNELLING CONDITIONS**

(REF. NO. 13844/1-1)

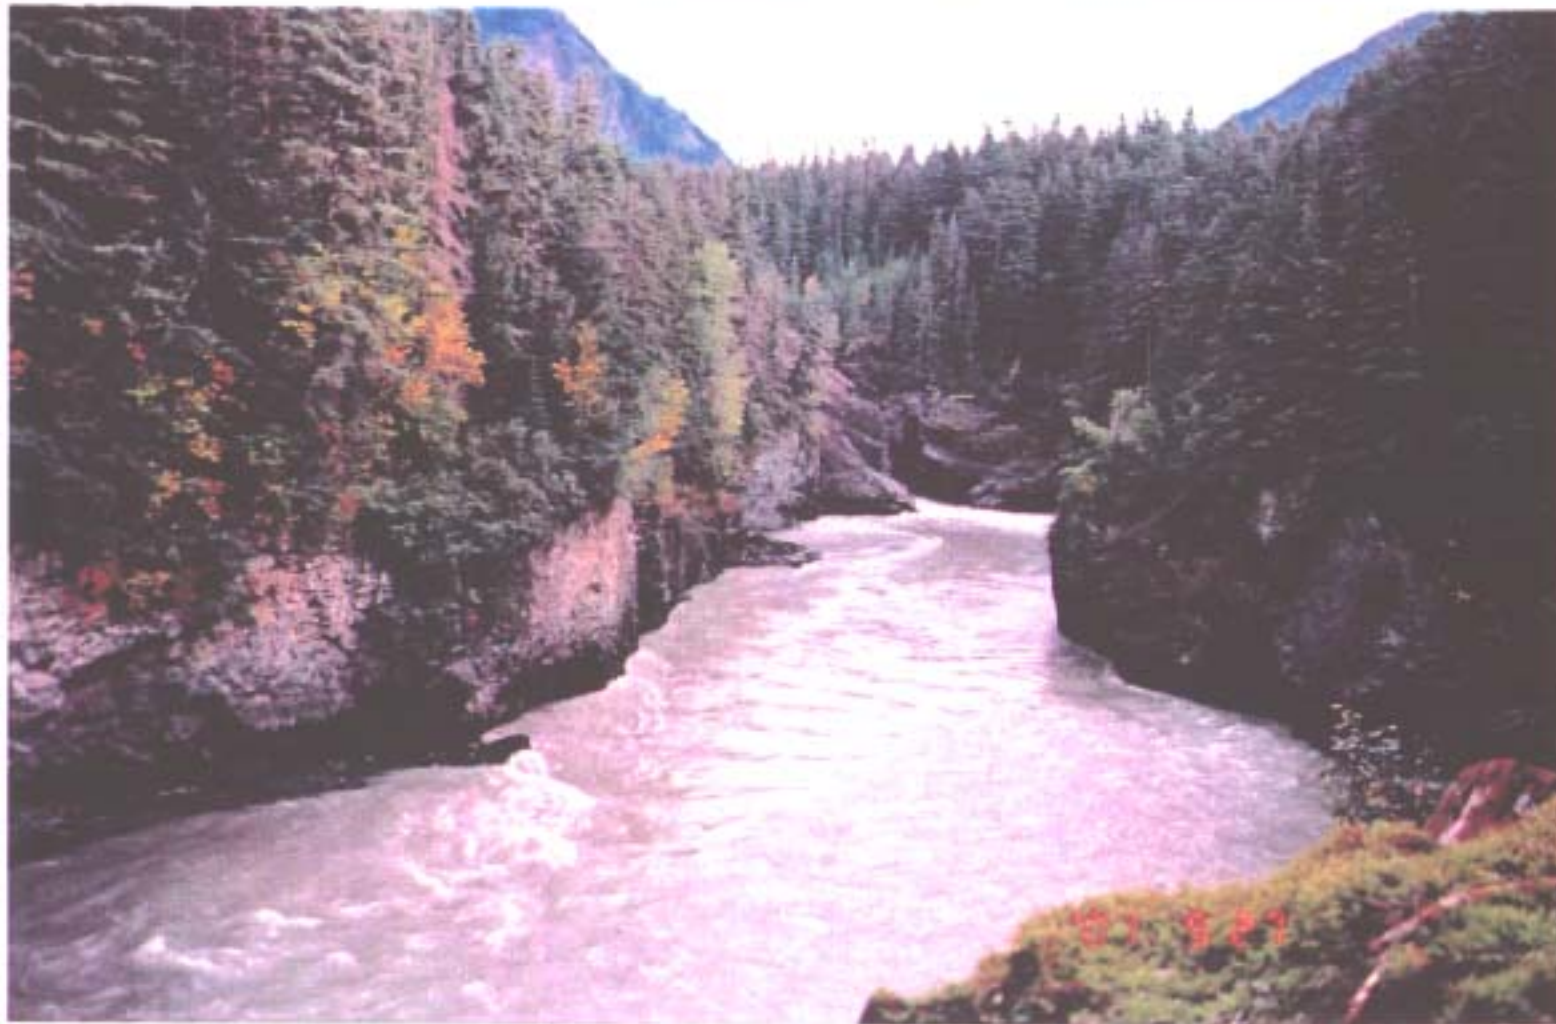
PHOTO 4.1 – Good Rock Conditions exposed along the Banks of the Iskut River near the Intake Area

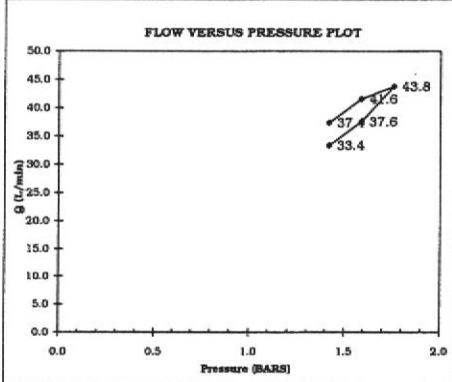
INTERPRETATION: LUGEON VALUE = $\frac{\text{WATER TAKE (l/min)}}{\text{STAGE LENGTH (m)}} \times \frac{10 \text{ (BAR)}}{\text{TEST PRESSURE (BAR)}}$

STATIC WTR LEVEL DETERMINATION: LUGEONS: MAX Lu= **43.26** PERMEABILITY, cm/s: MAX k= **4.3E-04**

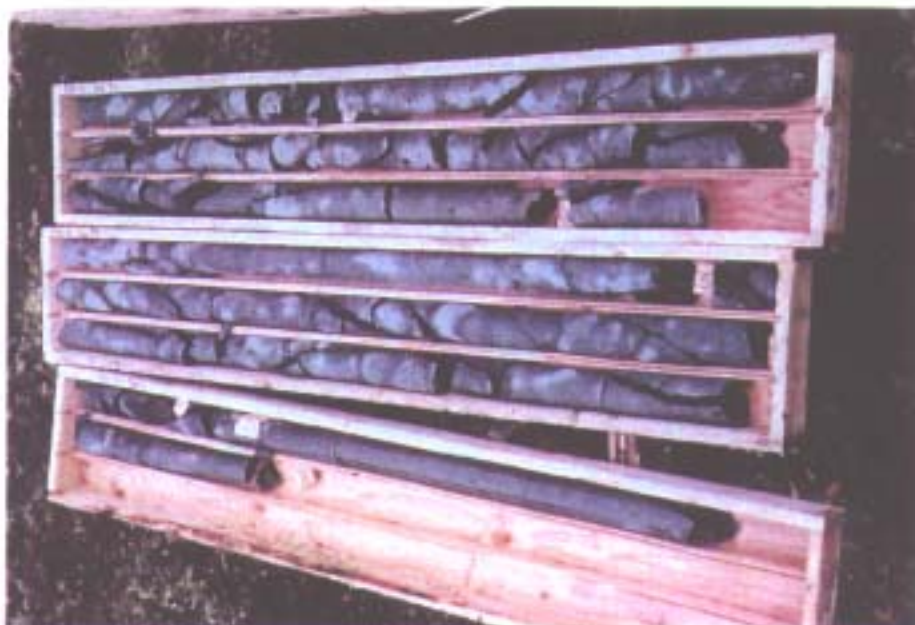
PHOTO 2 – GT01-A Box 4 to 6

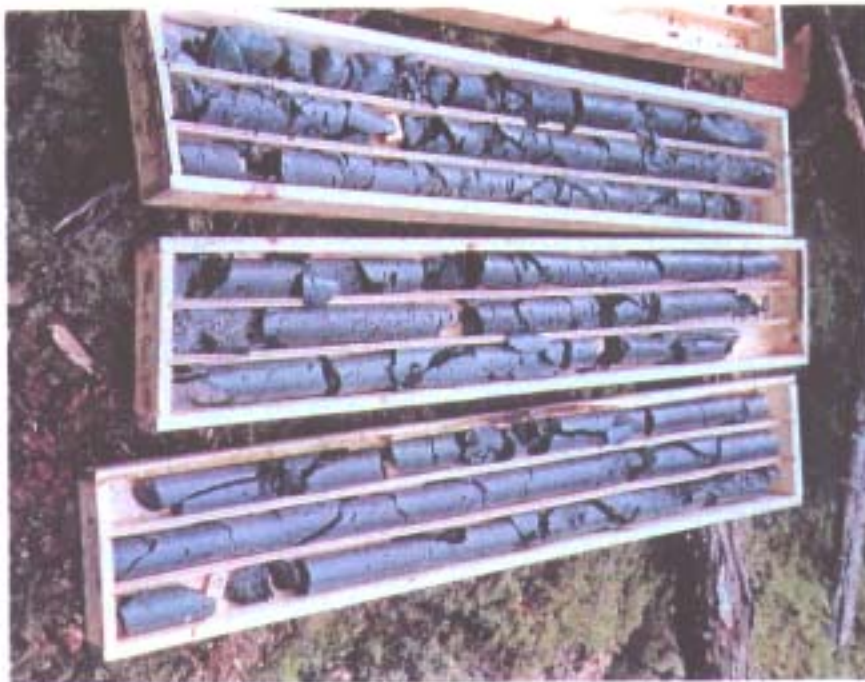
PHOTO 3 – GT01-B Box 1 to 3

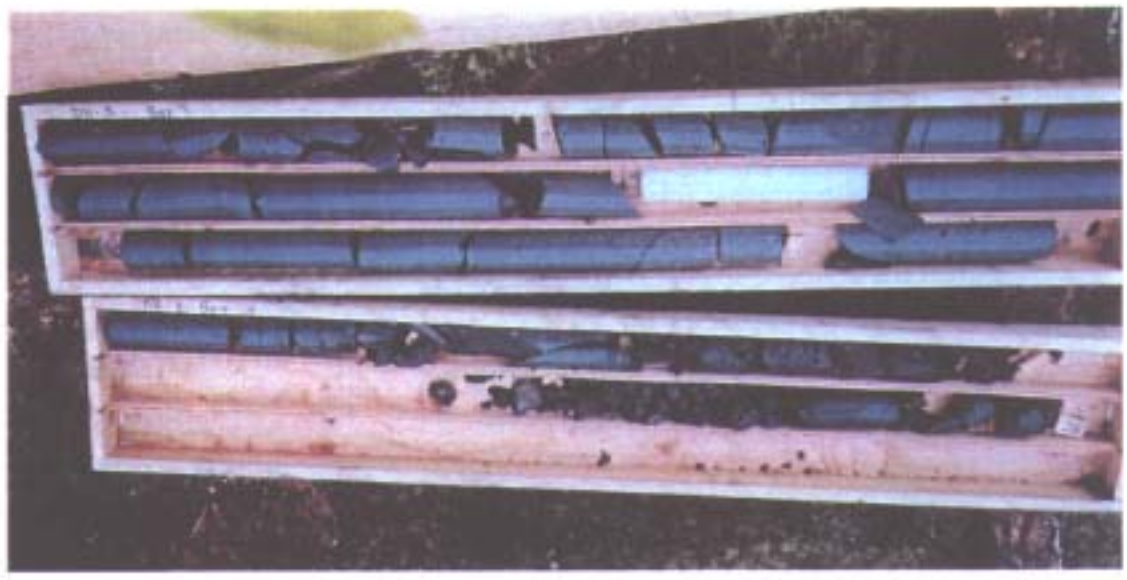
PHOTO 5 – GT01-B Box 7 to 8

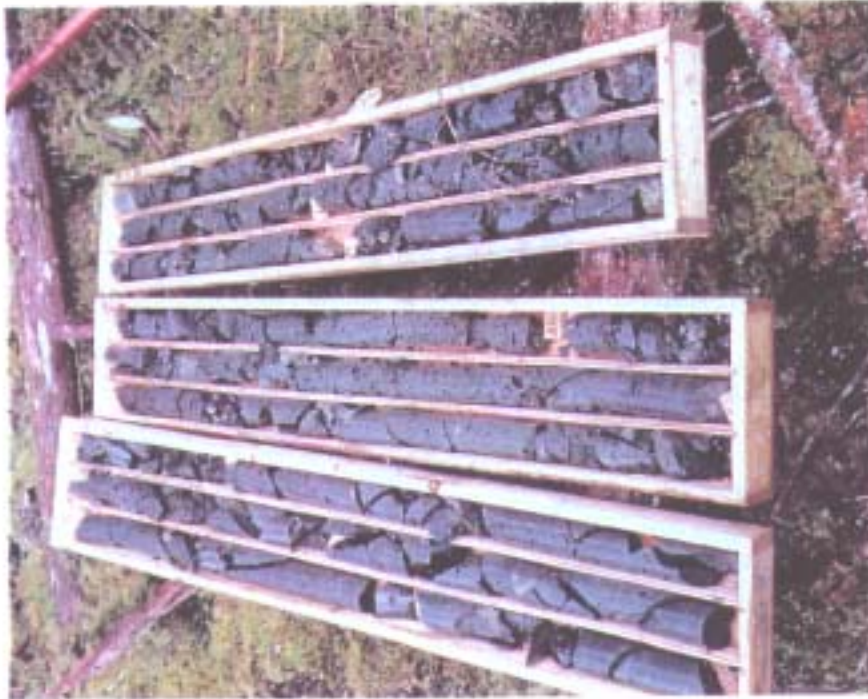
PHOTO 6 – GT01-C Box 1 to 3

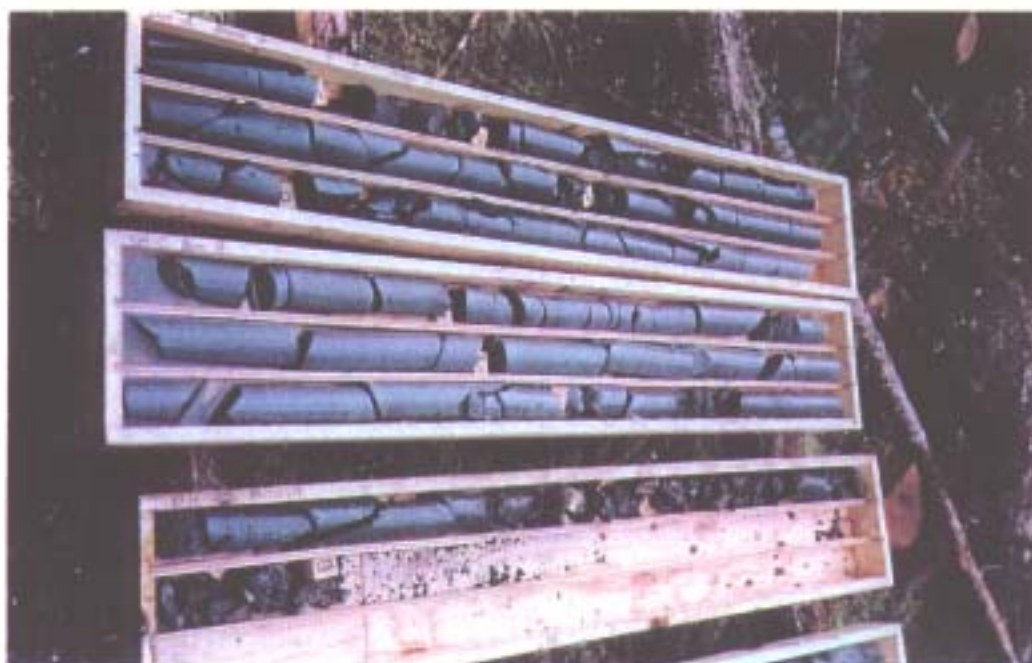
PHOTO 8 – GT01-C Box 7 to 9

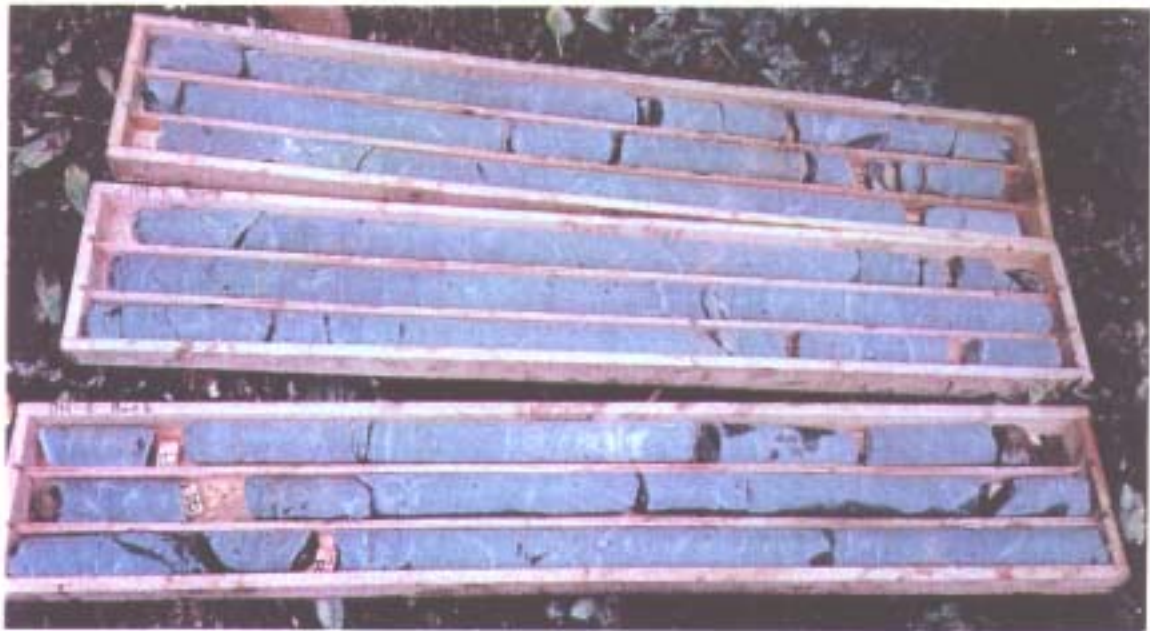
PHOTO 11 – GT01-E Box 4 to 6

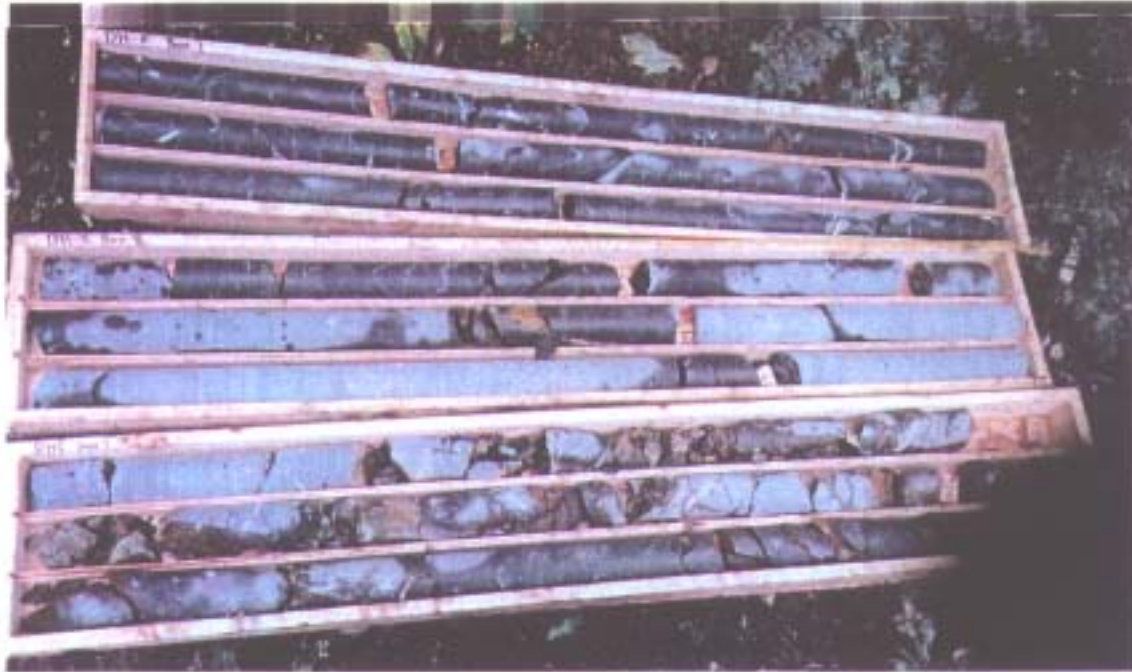
PHOTO 12 – GT01-E Box 7 to 9

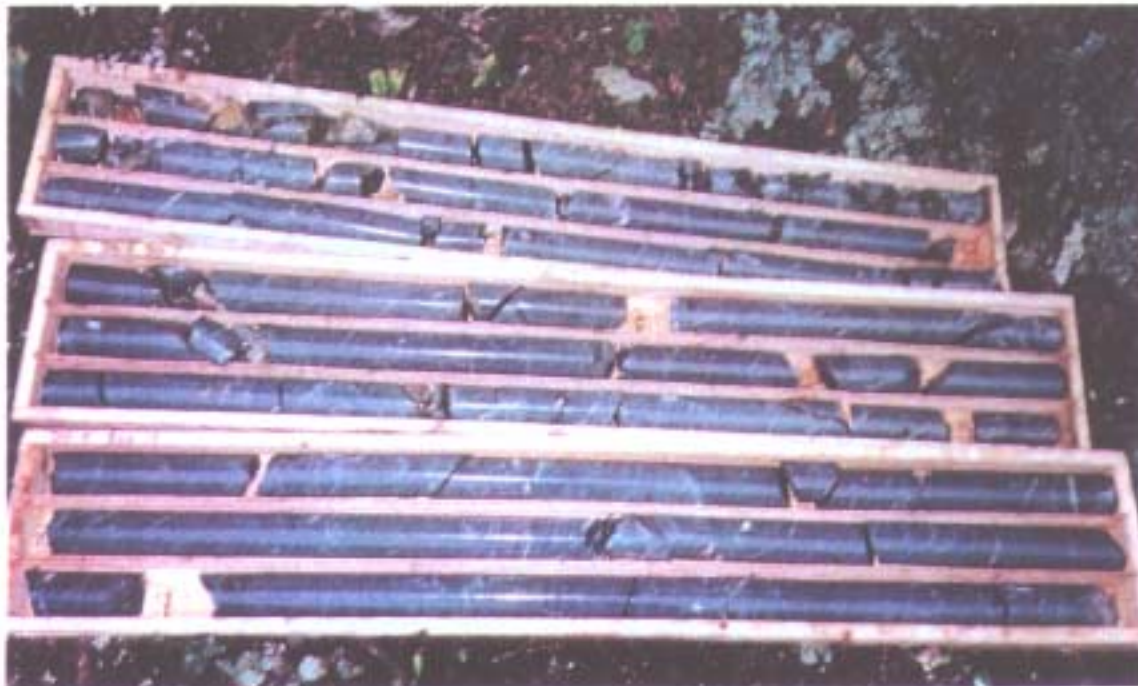
PHOTO 13 – GT01-E Box 10 to 12
