**ARIS Summary Report**

**ASSESSMENT REPORT:** 27552

**Property Name:** Gold

PROSPECTING REPORT

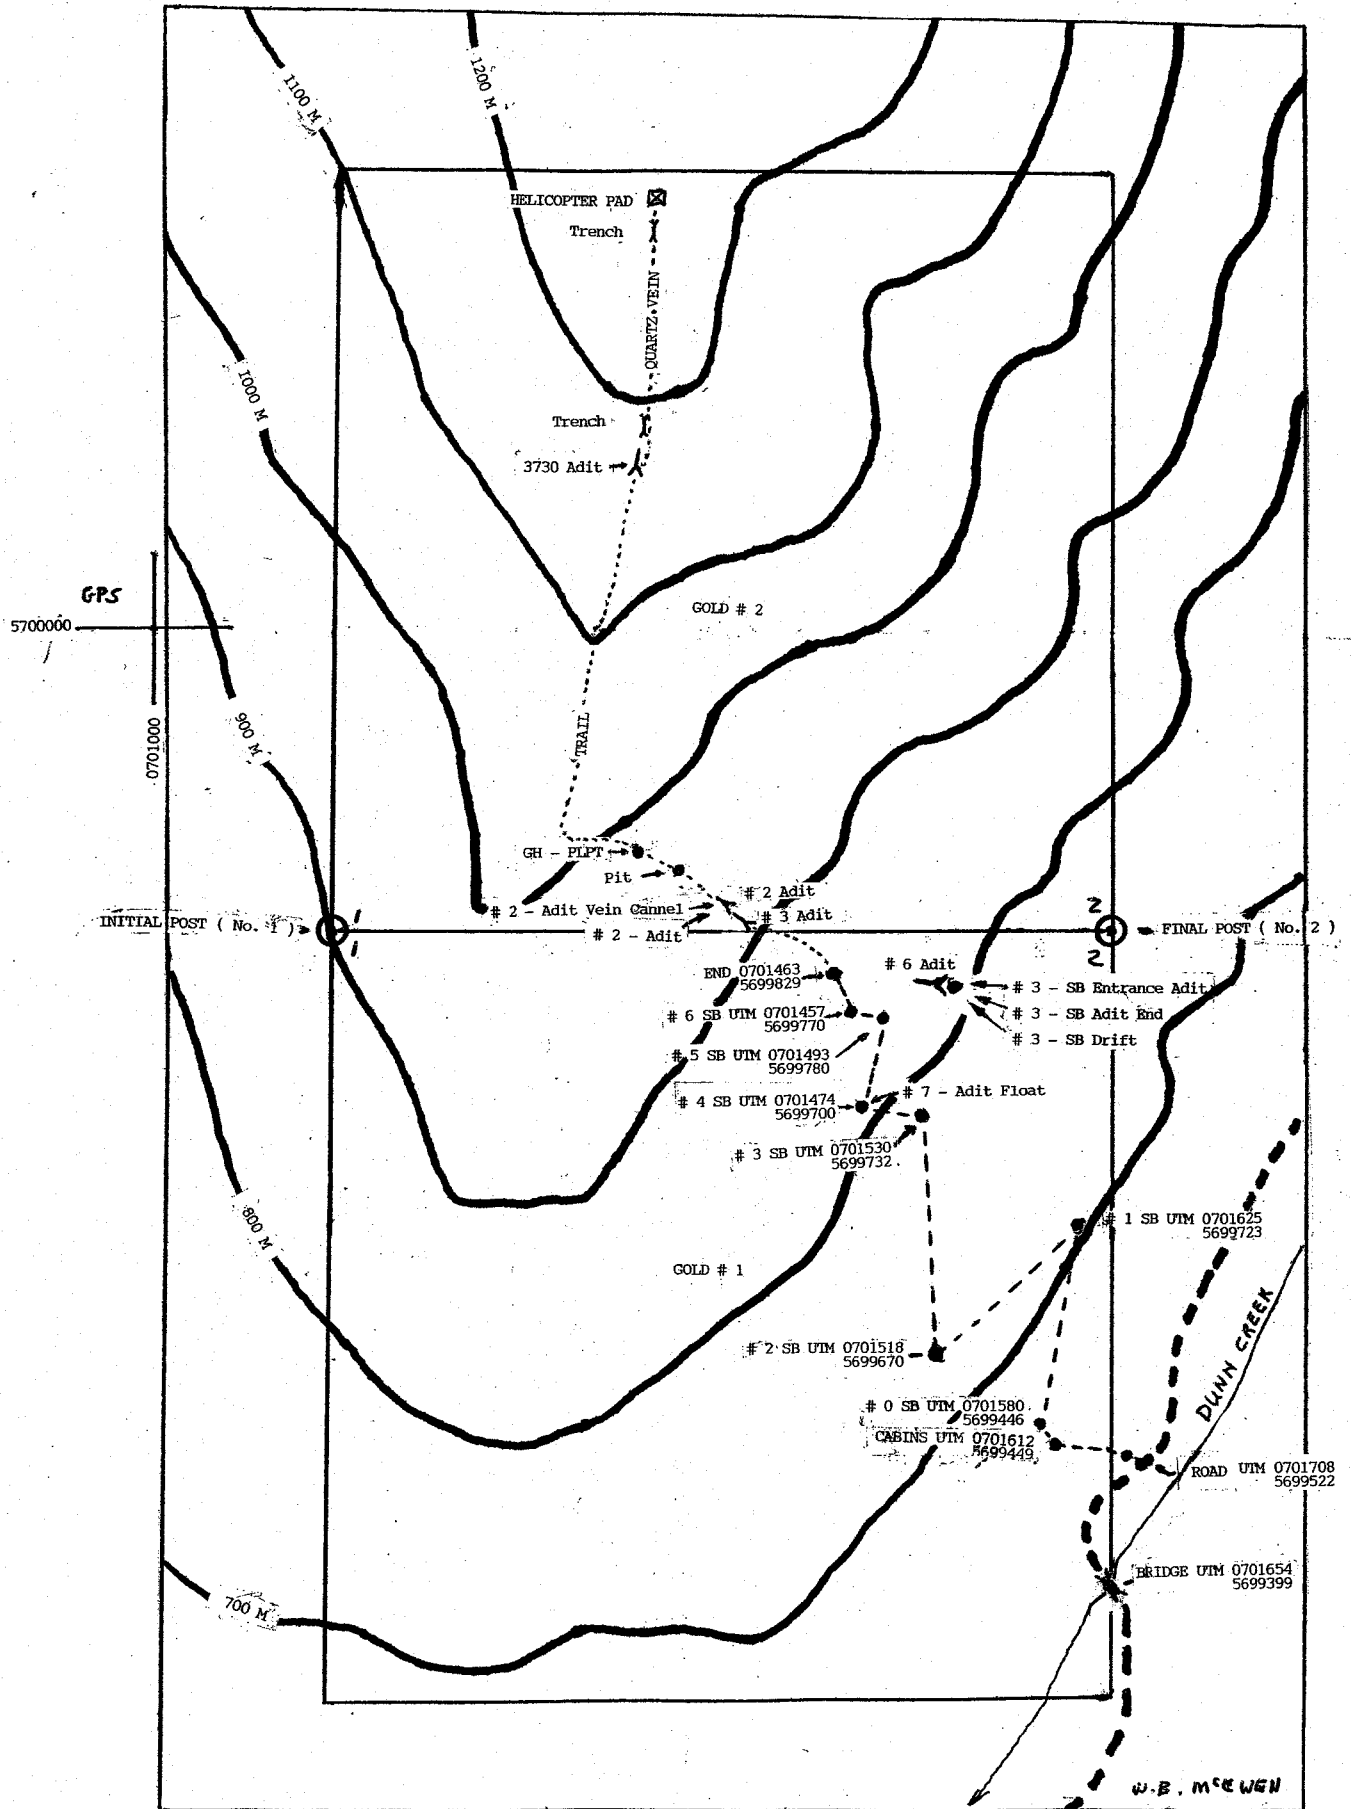
Map 4  
Sample Site Locations

Map 4 shows the sample site locations and general fetures of the claims. A final note by the author is that he believes that this property was just in the development stages when the advent of WW II broke out. Further exploration and expenditure may reveal a property with some economic potential. This is obviously a system that is high grade in the series Lead, Zinc, Silver plus or minus Gold.
