ASSESSMENT REPORT
Physical and Geochemical
on the
KENVILLE MINE PROPERTY

Min File No. 082FSW086
NTS 82F/6W
Latitude: 49⁰ 28.3' N
Longitude 117⁰ 22.7' W
Nelson Mining Division
British Columbia, CANADA
Tenure Number 515974
Lot Numbers 101,102,2550,2551,
2557,2559,3691,3927,4757,4758,
4787,4788,4789,3926,3928

By **W. G. Botel P Eng.**

Dated: Oct 17, 2006.

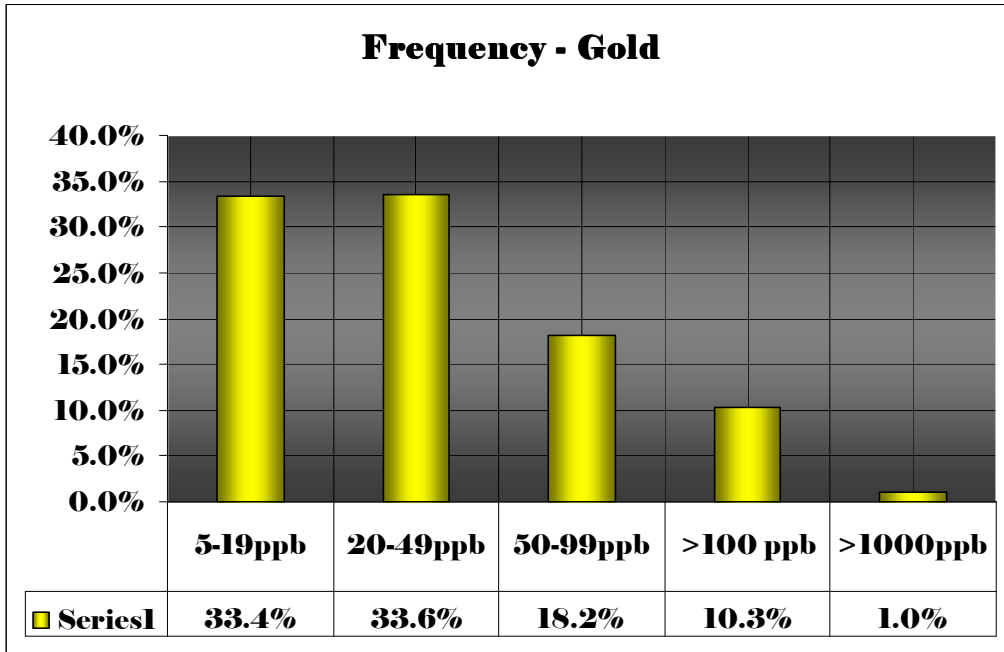
Figure 4

Gold: 5 - 19 ppb (165), 20 - 49 ppb (166), 50 - 99 ppb (90), 100 - 999 ppb (51), > 1000 ppb(5)
Highest value: >1000 ppb Au

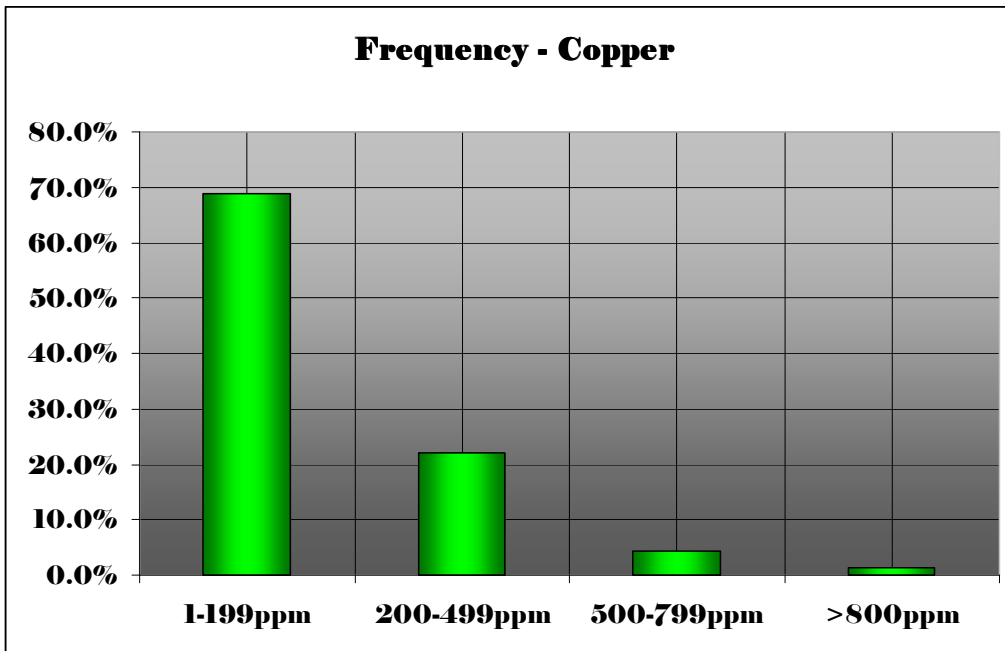
Figure 5

Copper: 1-199 ppm (340), 200-499 ppm (109), 500-799 ppm (21) > 800 ppm (7)
Highest value: 1131 ppm Cu

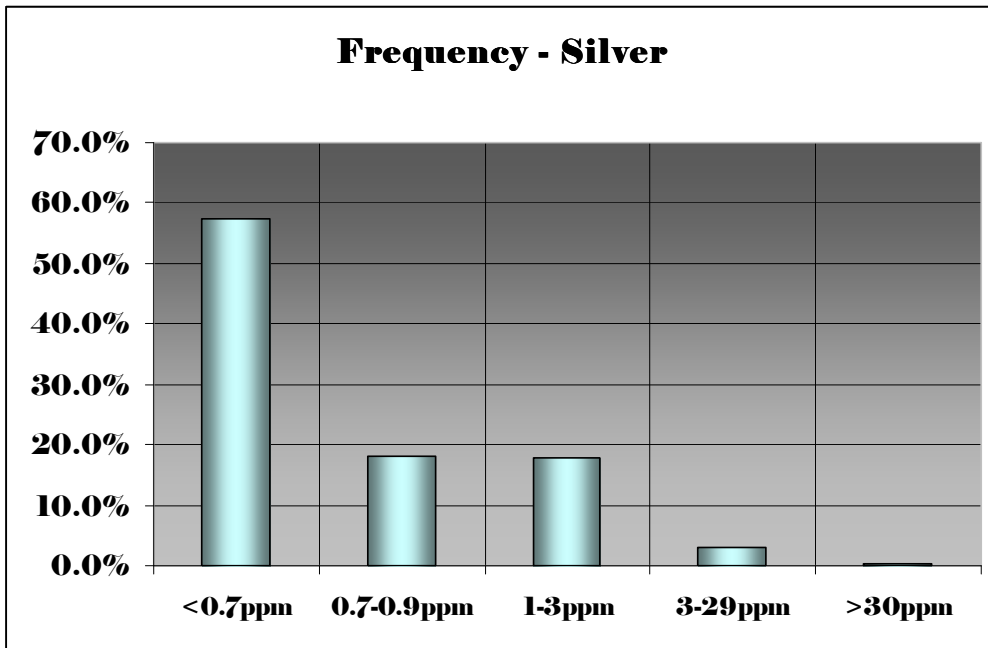
Figure 7

Silver: <0.7 ppm (283), 0.7 – 0.9 ppm (90), 1 – 2 ppm (88), 3 – 29 ppm(15), >30 ppm (1)
Highest value: >30 ppm

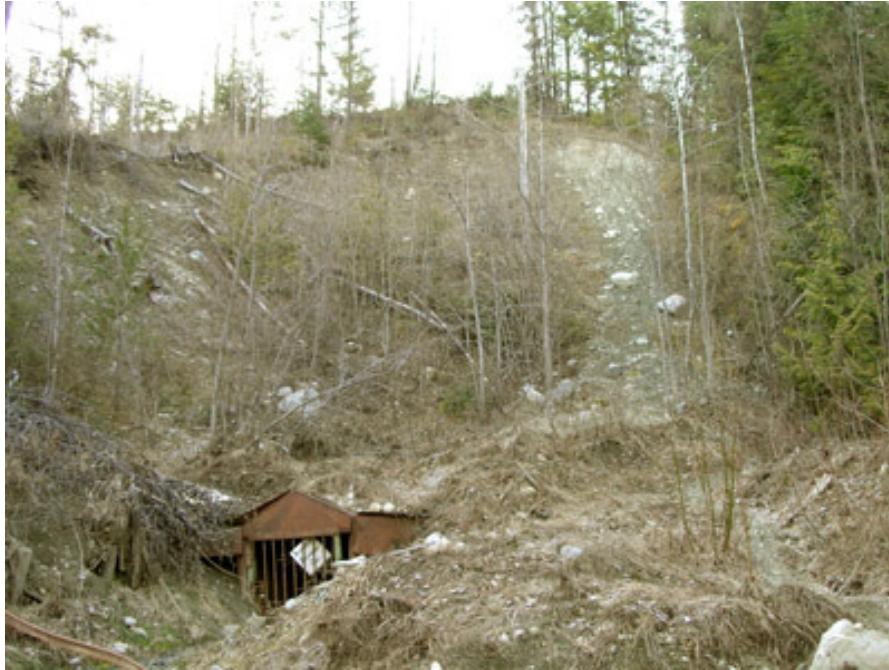
An unstable bank sloughed over the mine adit closing access. This sloughing had been ongoing over a period of years and finally made access impossible.

Under a directive from the Mines Branch, the adit must be made safe and opened, or made safe to shut down the mine as proscribed by the Mines Act.

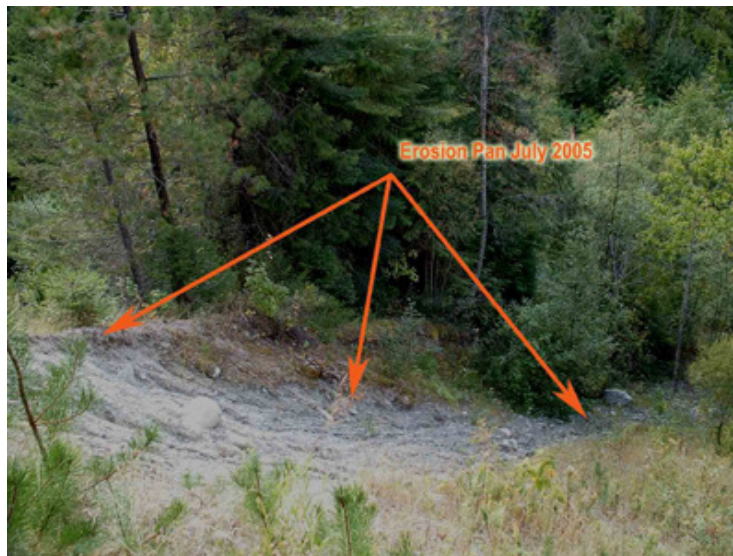
The photo to the left was taken in August of the previous year (2005). It is only a matter of time until the adit is completely buried.

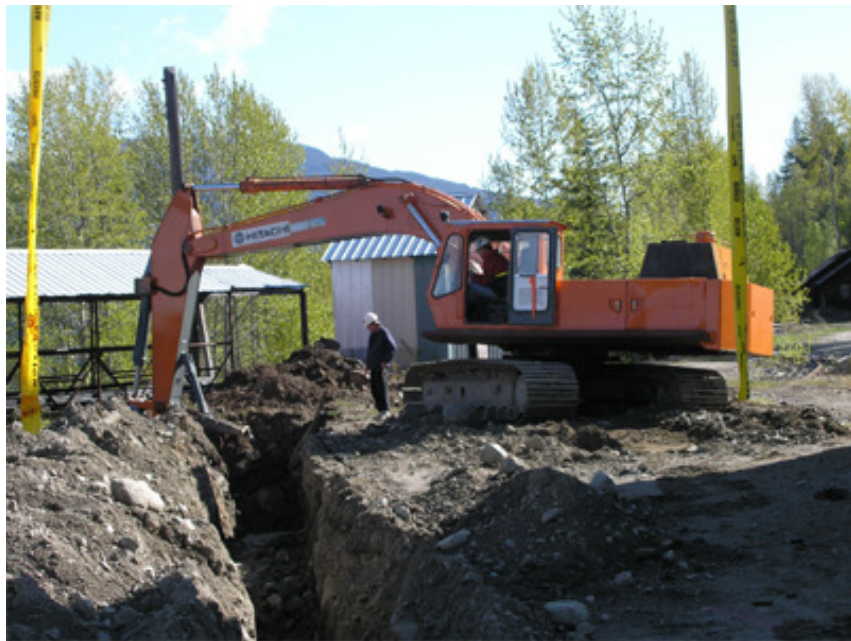
The diversion of mine water away from Eagle Creek was necessary to maintain water purity for water users downstream. Future work in the mine would soil the water and create a serious problem if not attended to on the onset.

New ditching was installed prior to opening the adit in to prevent potential flooding downstream. Ditching was completed using the Hitachi excavator in the morning and the diversion was ready to take place. A temporary filter made up of enviro-cloth and straw bales was installed prior to the diversion to minimize silting.

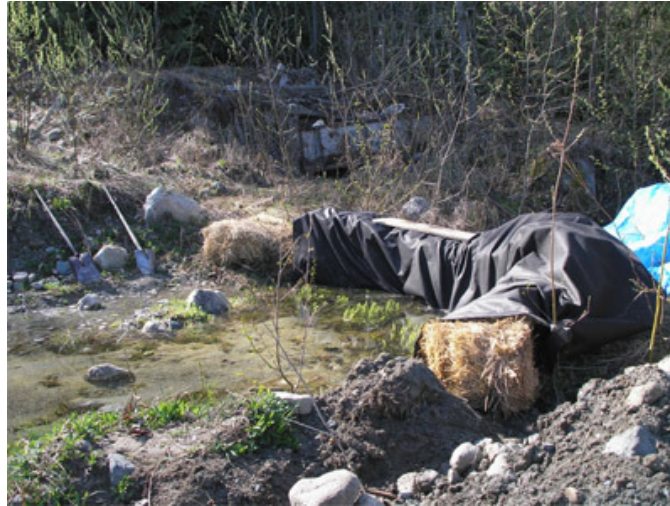
With the filter in place, the mine water was relocated back to the flow away from Eagle Creek. Care was taken to prevent silting. The opening was done by hand, and was completed without incident.

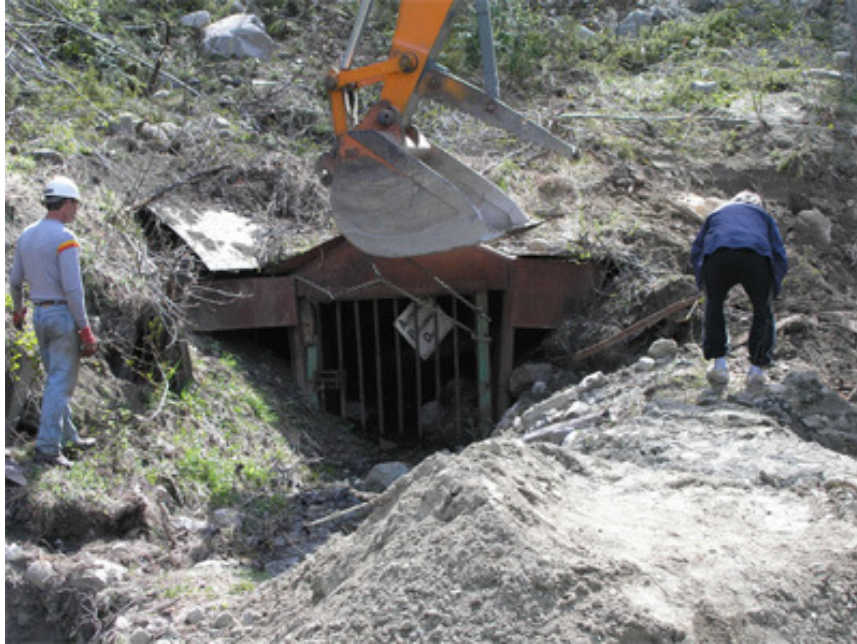
Opening the adit involved removing the steel door assembly and the steel cladding over the false set. With wiggling and persuading the gate came free. The adit was caved in behind the false sets and the water was backed up behind the caved dam about 2 meters deep.

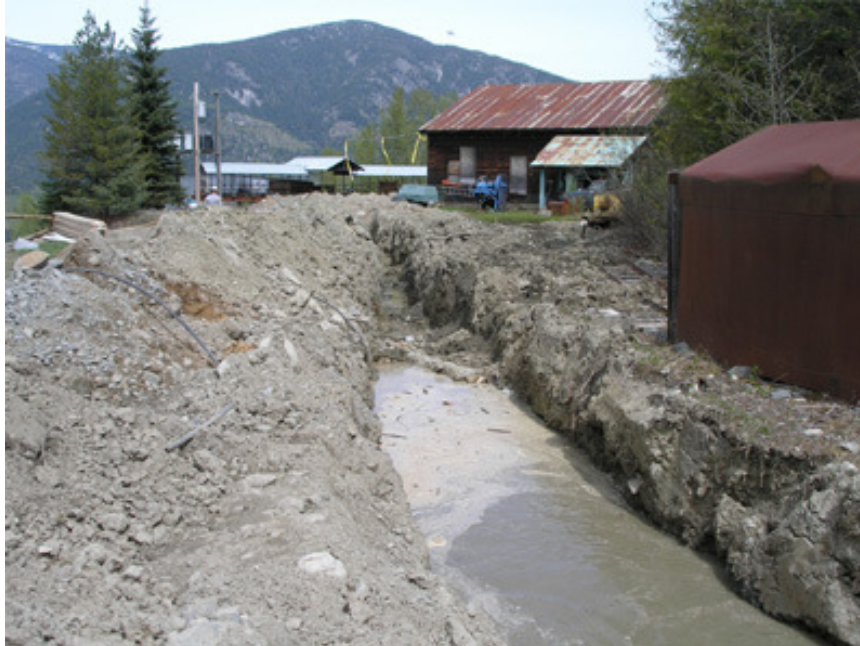
The water was released slowly and it spilled into the 125 meter long ditch away from Eagle Creek. There was enough ditch to easily drain off the backed up mine water.

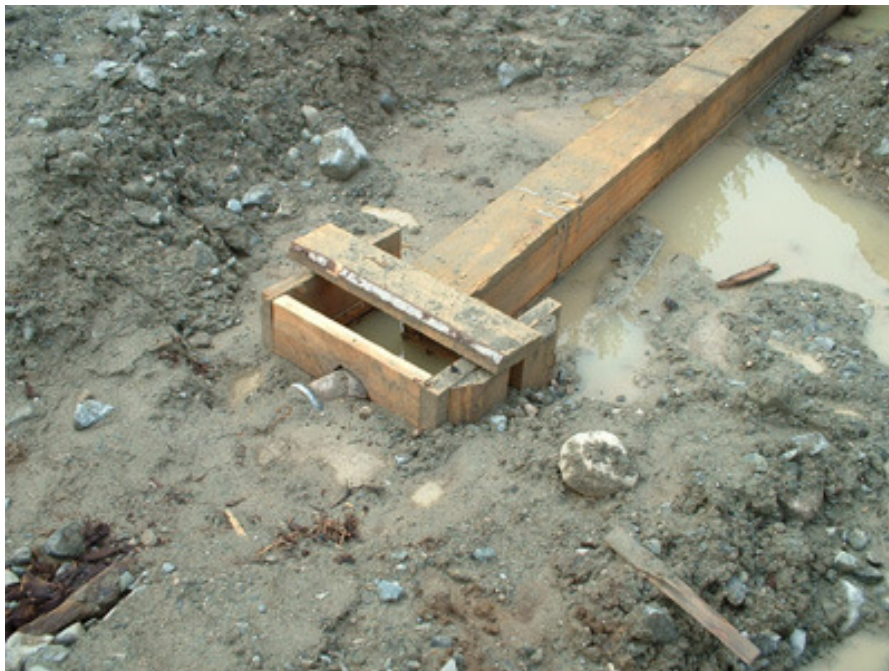
The wooden drainage (flume) was constructed of 2x6 and 2x8 boxed and reinforced with metal strapping. A cleanout box was installed at the junction of the usable 6" pipe beside the shop. Using the Hitachi excavator and slugging, the culvert sections were swung into place and connected. Aluminum sheet was used to make a collar allowing the sections to be connected.

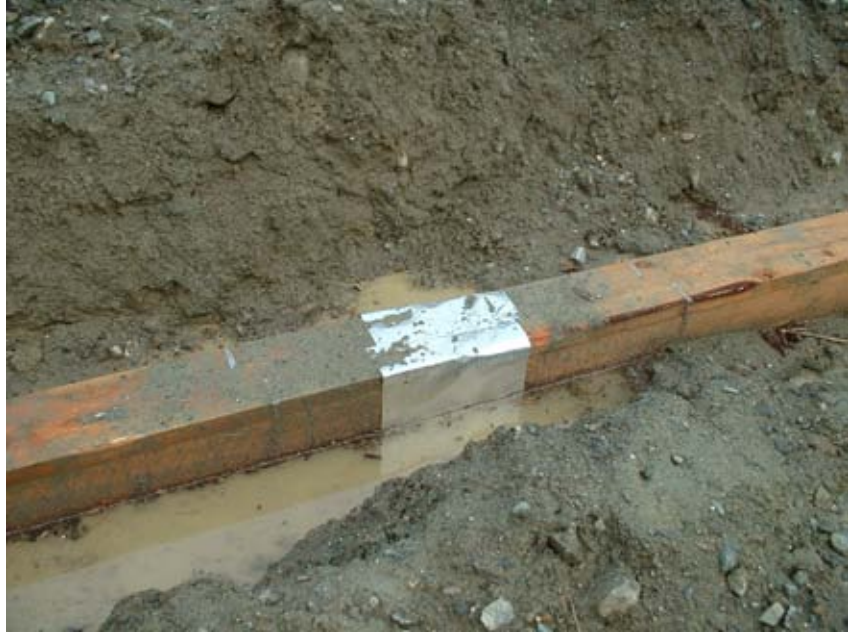
Grade was established by the water level in the trench, and the sections were coupled together. About 75 meters of culvert was placed in the trench.

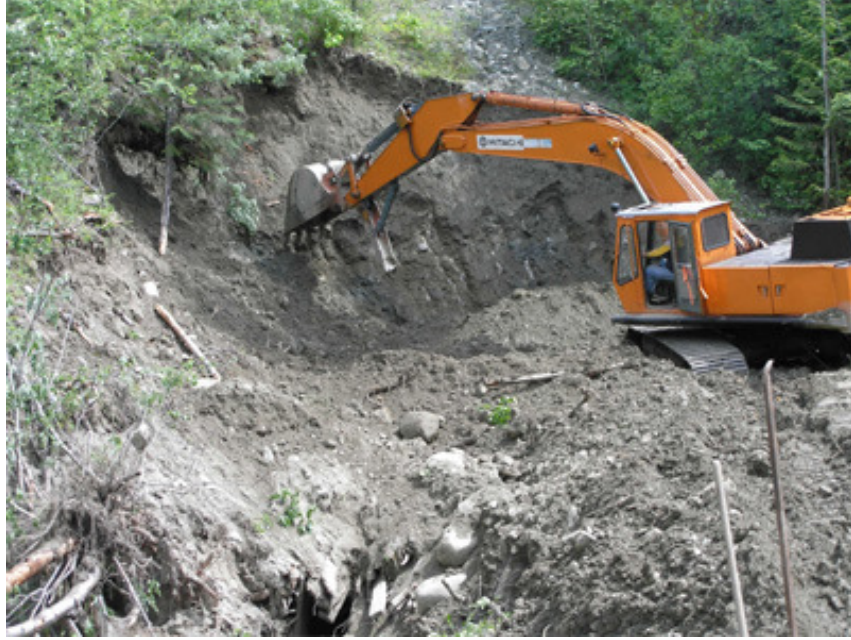
After reaching bedrock on Wednesday June 7, the excavator was trapped in the saturated clay and boulders.

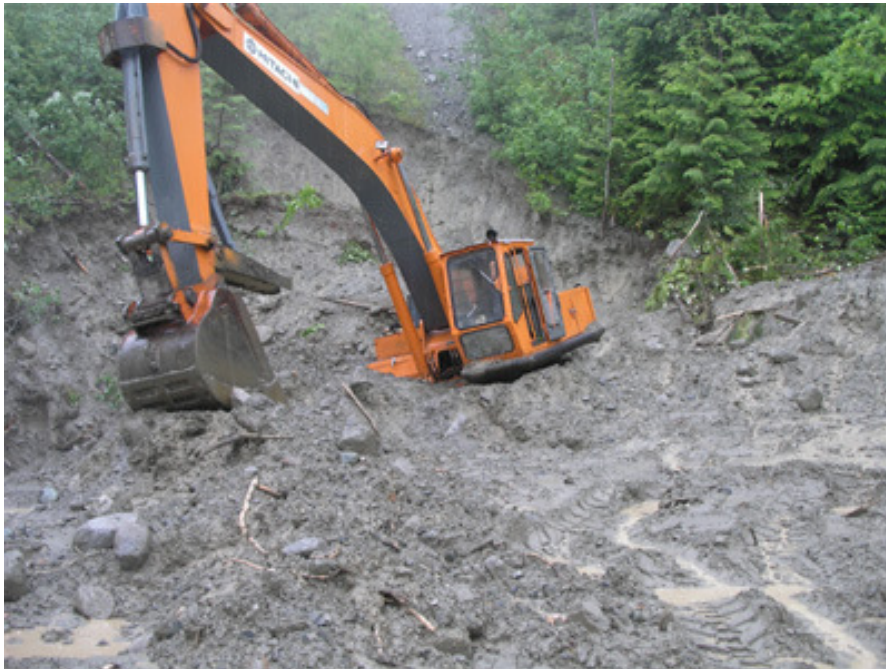
The rain had turned previously solid footing into a mud-glue that captured the machine. Miners Roy and Stan suggested a “leave of absence” to let us dig out and returned to Kimberly to allow a timely dig out to the face.

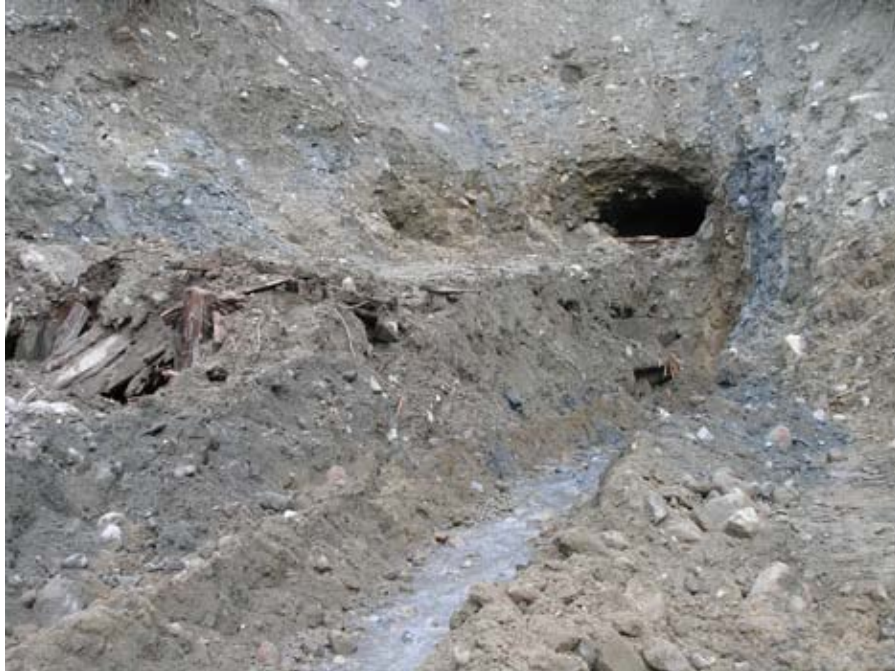
The old adit is cleared to ease debris removal from the old timbers. The sides are “tight lined” to prevent slough of the clay, so there is a large amount of wood to be cleared. One side of the old adit has been cleared off, and the mine water ditched away to slow down the mud production from the floor. There are 8’ timbers buried in the picture above.

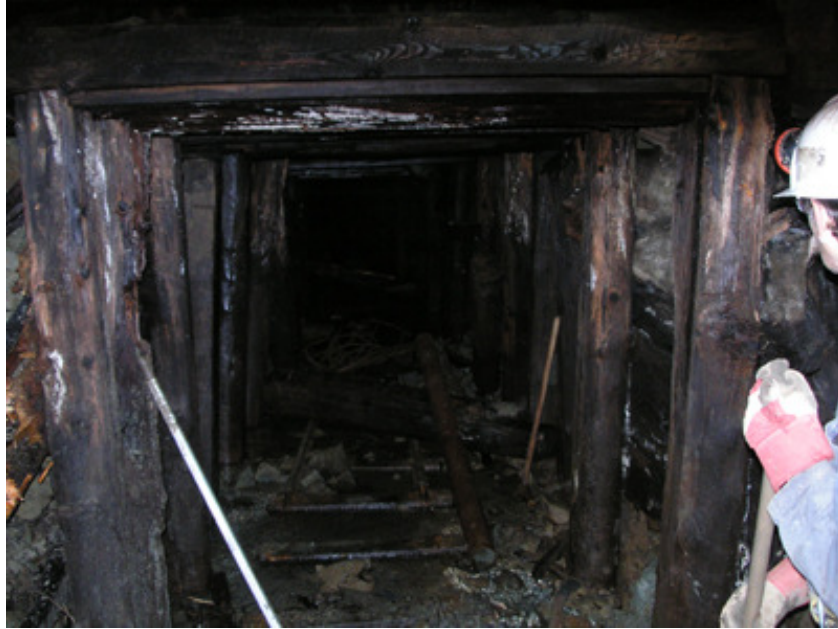
The old timber sets are clearly in need of replacement. There is more rehabilitation needed, but the focus is on getting the adit covered and re-stabilize the slope.

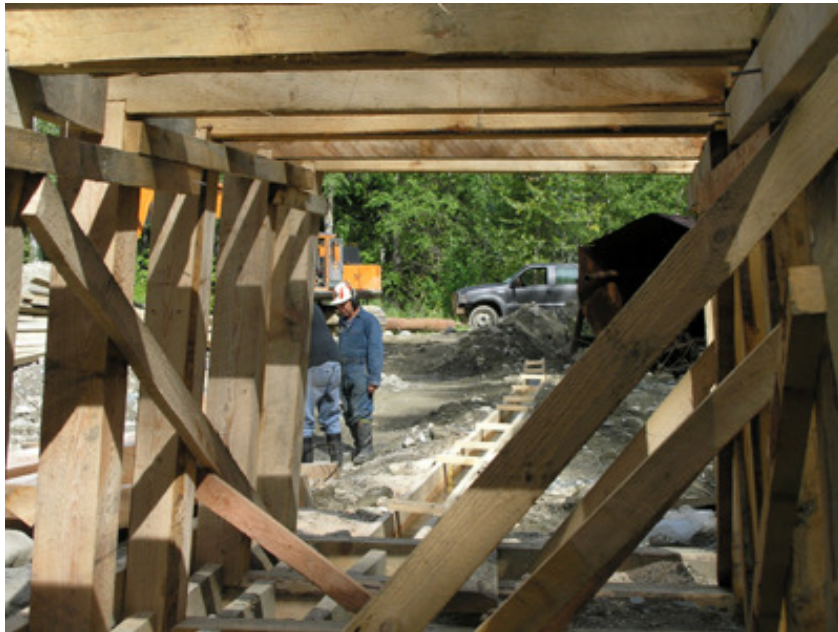
Cross bracing is installed to keep the sets square.

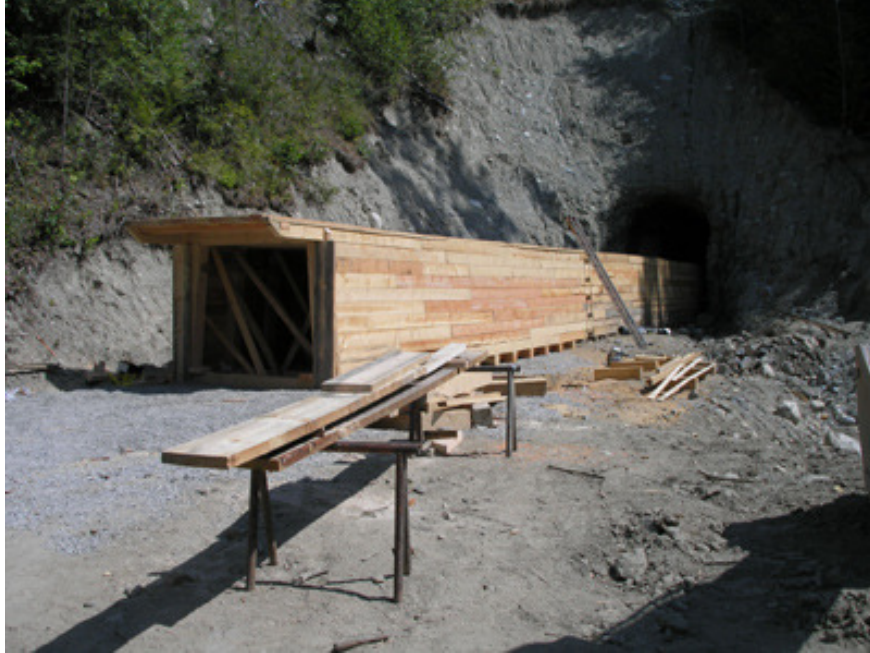
The adit construction completed with 37 sets on 3' centers, covered with 3" x 8" planking ready to be buried. The interior is cross-braced to prevent movement while being filled.

Over 4000 cubic meters of slough was excavated, stockpiled, and reused for backfill. 37 sets on about 1 meter centers composed of 20cm x 20cm (8" x 8") and 25cm x 25cm (10" x 10") timbers were used with a total of 272 kilograms (600 lb) of 15cm (6") and 18cm (7") nails were used to fasten the planking to the sets. The total length of the reconstructed portal is 40 meters. The structure was covered with 20 mil poly sheet and backfilled.

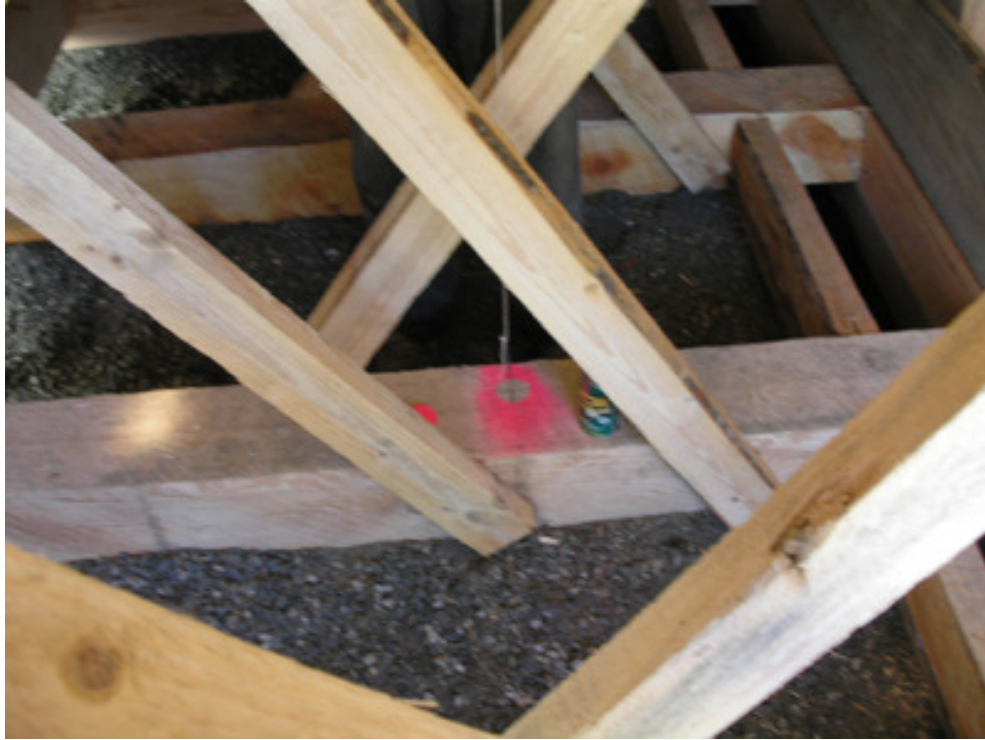
Three plumb lines, one at each end and one in the center, were established to check for movement by backfilling.

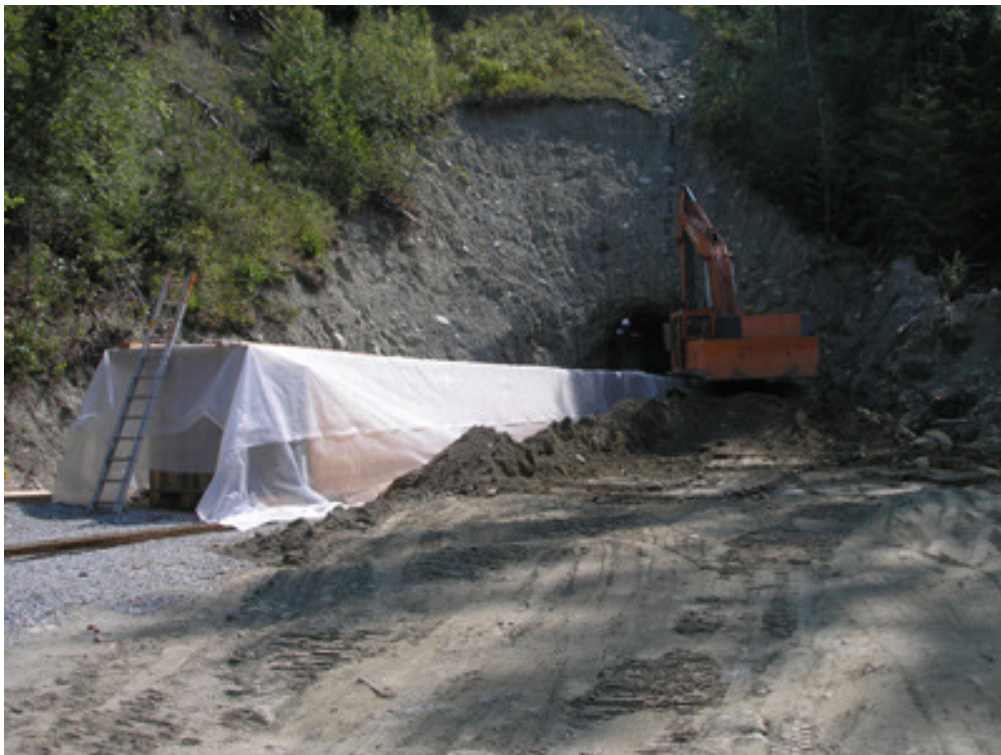
Security doors were hung and the adit covered with 2 layers of 10 mil polyethylene sheeting to seal the wood from fill creeping through cracks in the 3" x 8" lagging.

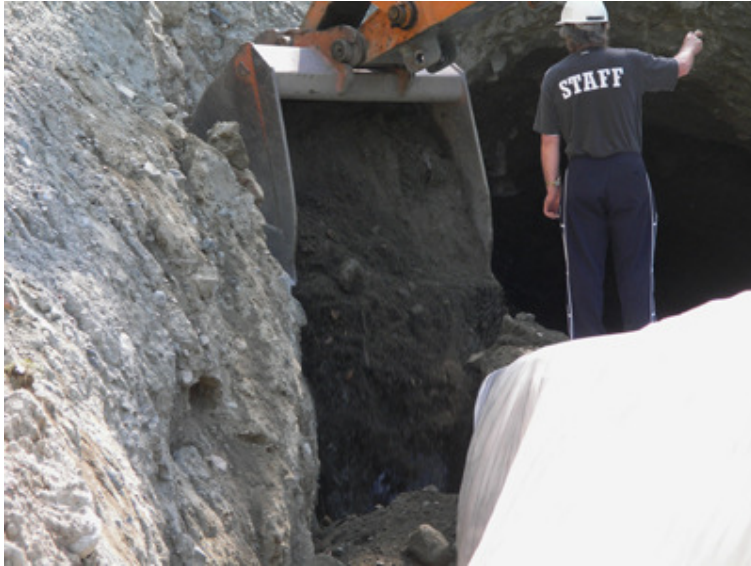
Fill was placed carefully not to disturb the timbers. The dispersal of fill must be evenly placed on both sides of the structure so as not to move it.

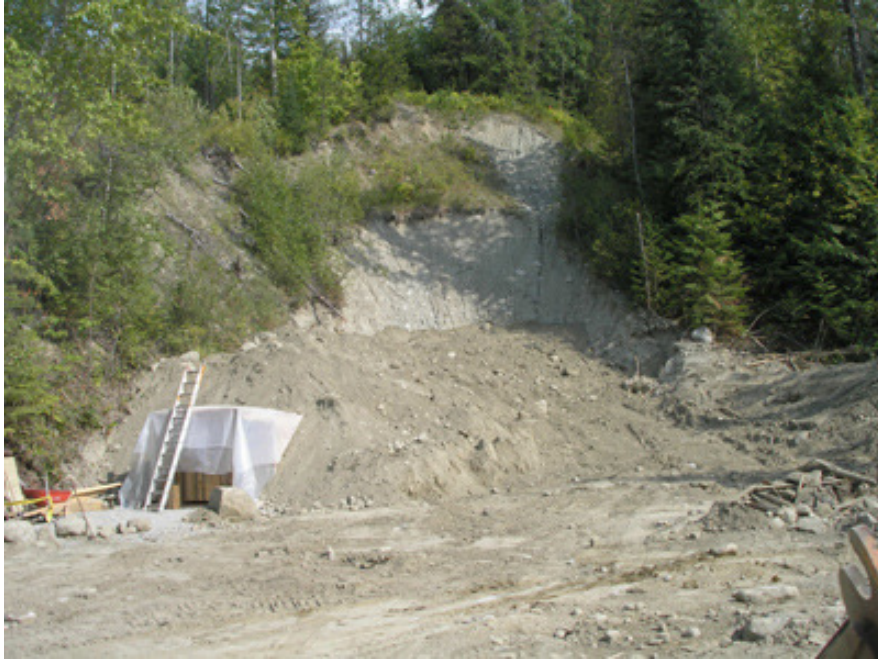
Tuesday August 22, 2006 Backfilling is complete and ready for inspection. The yard was cleared of backfill and leveled.
