BC Geological Survey  
Assessment Report  
34284

# Sampling, Testing and Development of Preliminary Acid Rock Drainage (ARD) and Metal Leaching (ML) Monitoring Program, Coastal Construction Aggregates, Tasu Quarry, Haida Gwaii

**Report Number:** 1214760060-001-R-Rev0

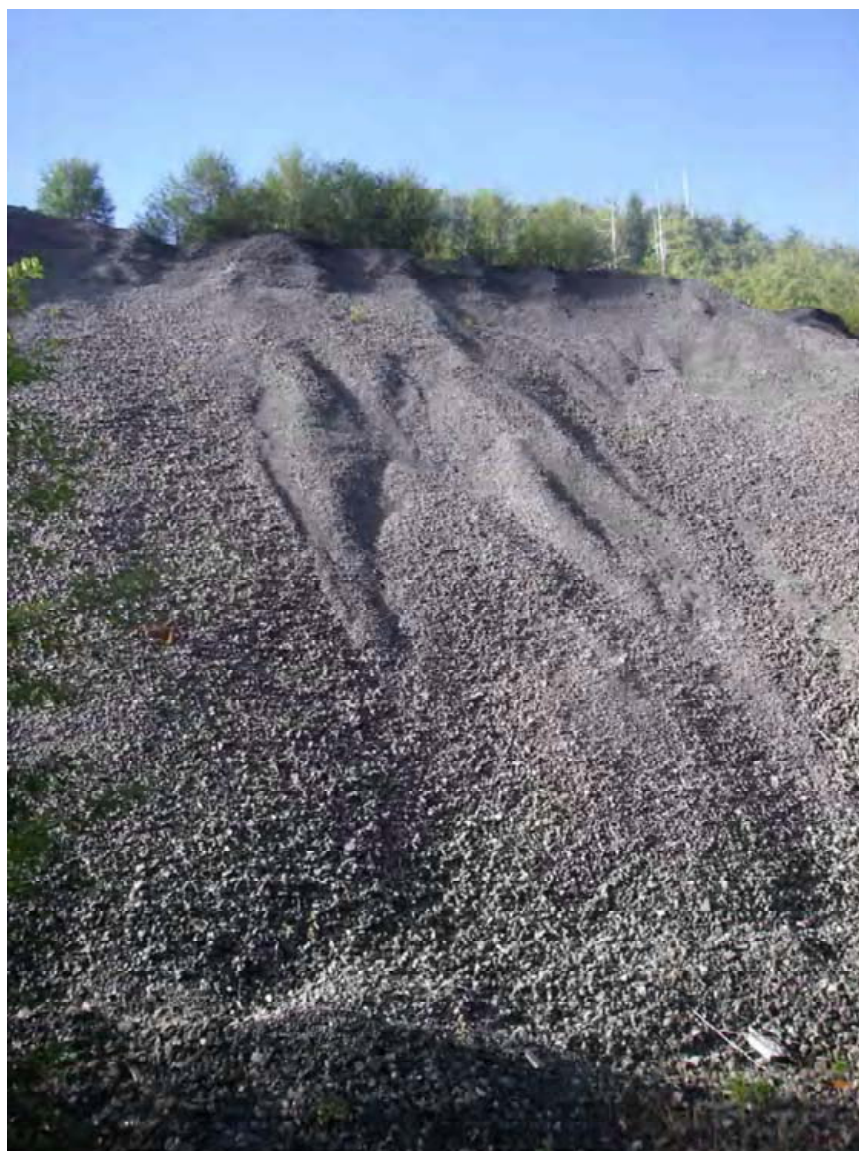
*Photograph 1: Profile of Cobber reject rock stockpile showing small failures which expose areas of higher fines content in the stockpile. Rock is estimated to approximately 150 mm minus material (visual assessment).*

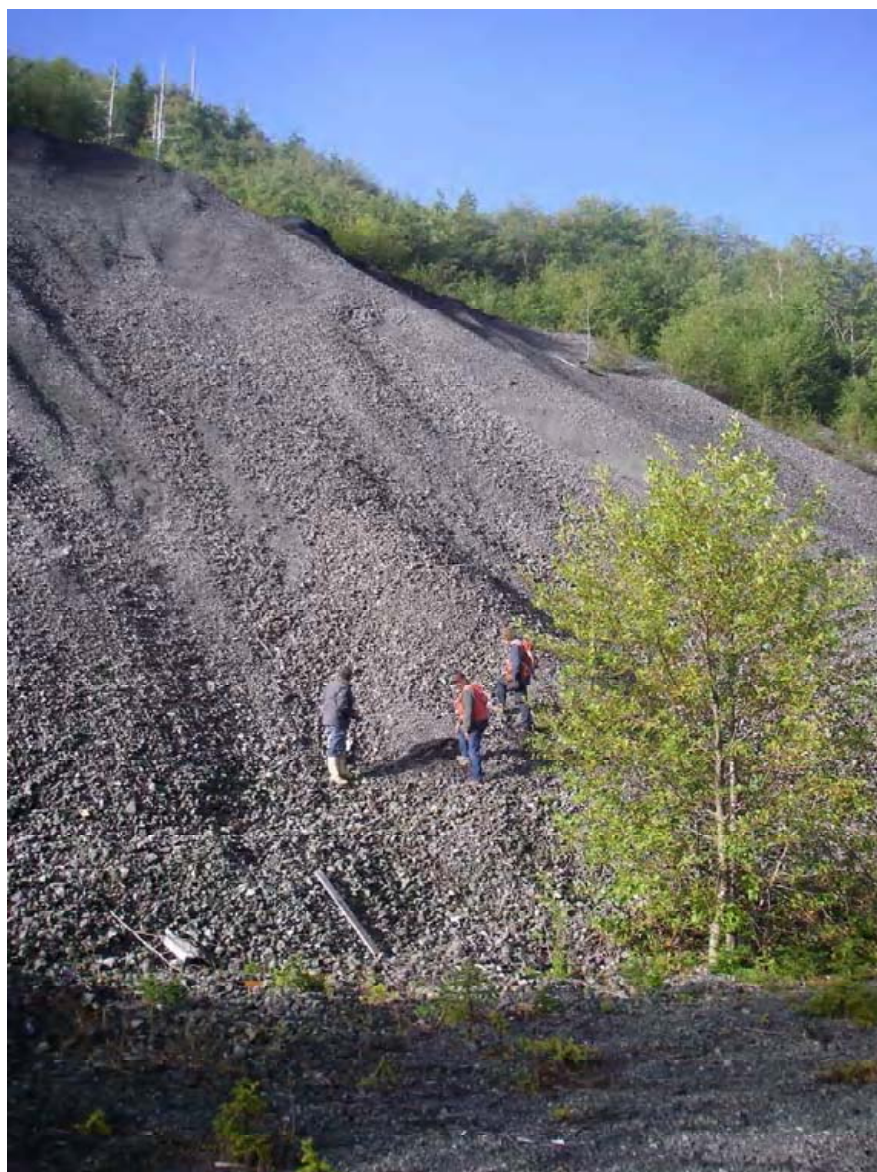
*Photograph 2: Profile of northwest portion of the Cobber reject rock stockpile. Slope is approximately 30 m in height and stockpile volume was estimated at over 1,000,000 m<sup>3</sup> in total.*

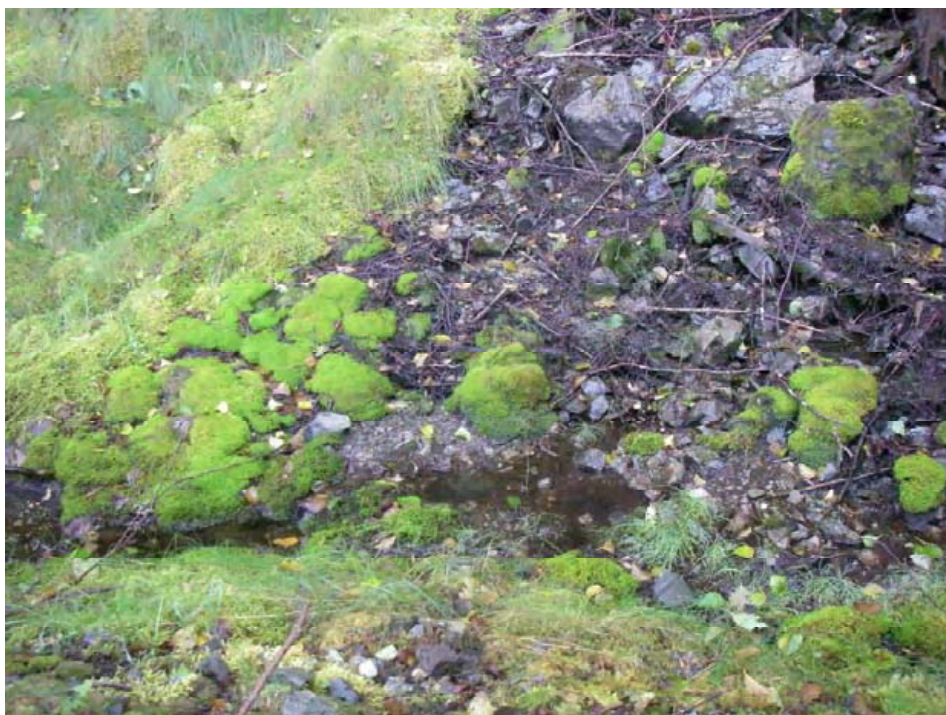
*Photograph 3: Shows stream flowing on the northwest end of the Cobber reject rock stockpile.*

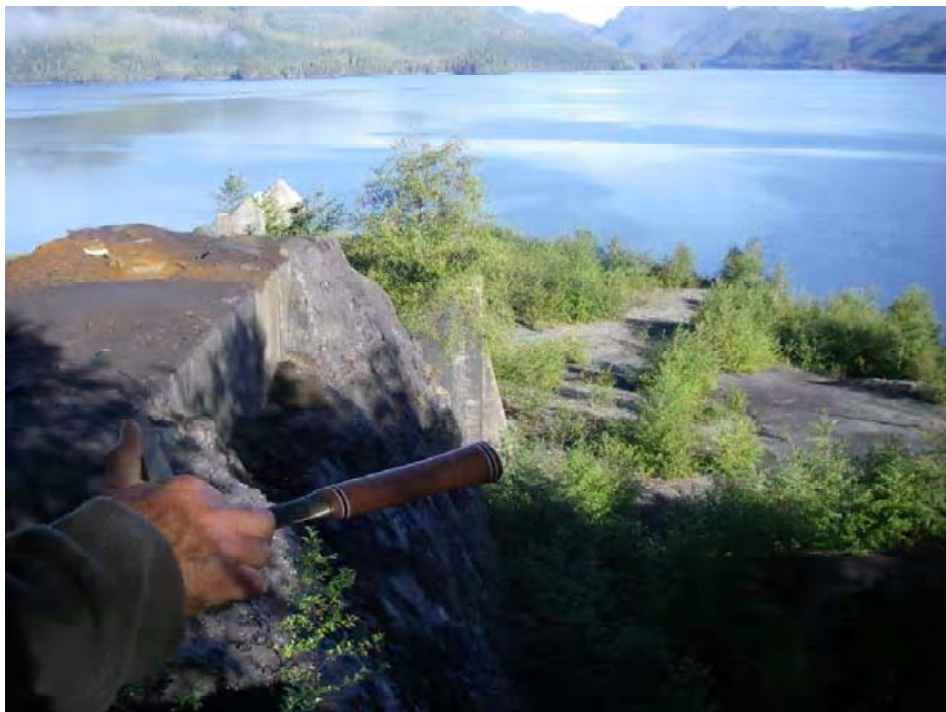
*Photograph 4: View looking north at Magneson Point. Ramp on left leads to old storage shed for concentrate. Area to the right in photo is old stockpile site and where marine berth facilities would be located.*

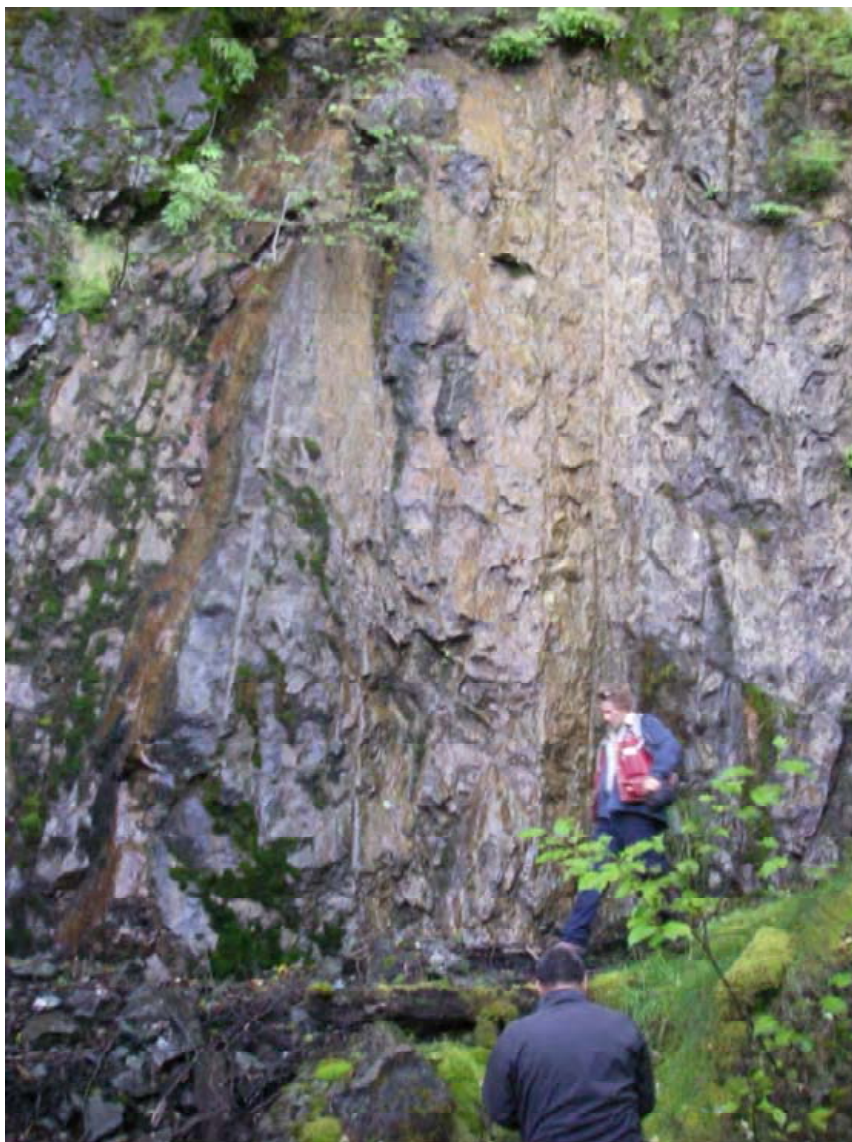
*Photograph 5: Shows old bedrock face that has been blasted below Pit No. 1 on road access. Seepage over the face is forming a carbonate rich coating on the rock.*

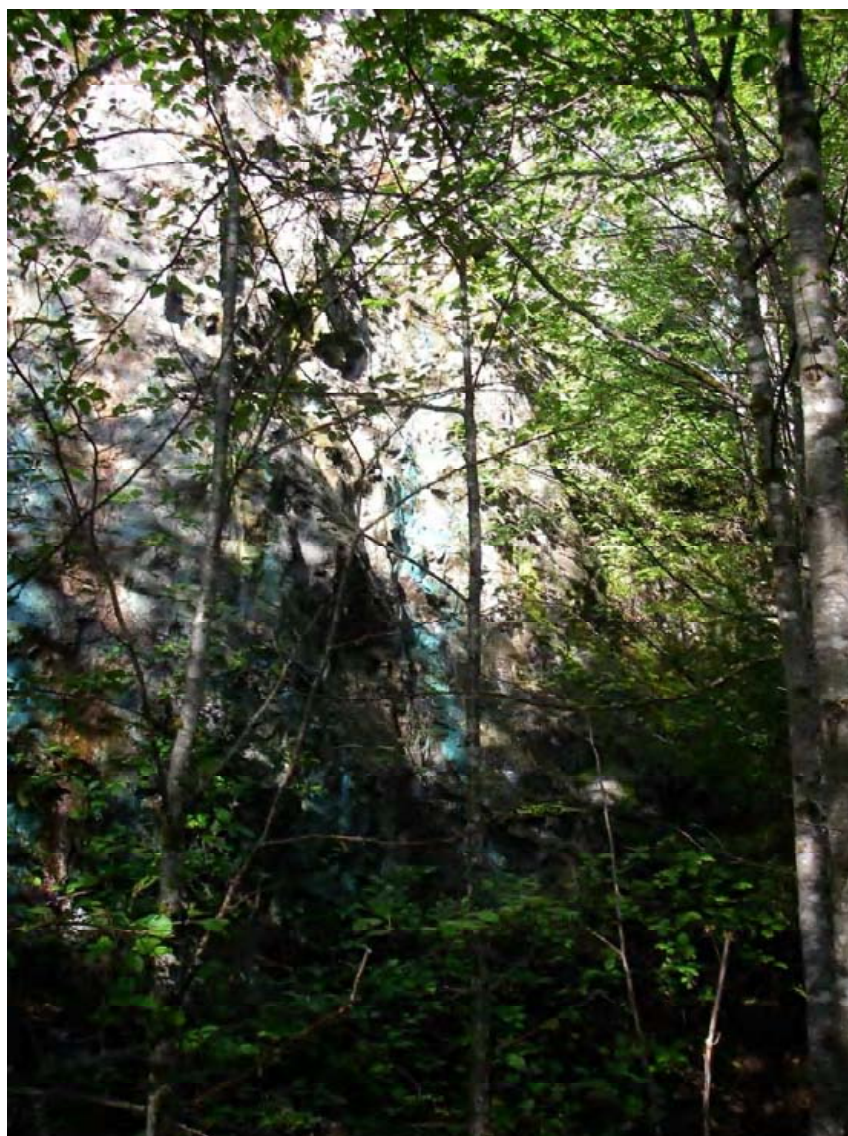
*Photograph 6: Copper rich precipitate has formed on bedrock face where seepage is occurring. This is located on rock face above access road up to Pit No. 1.*

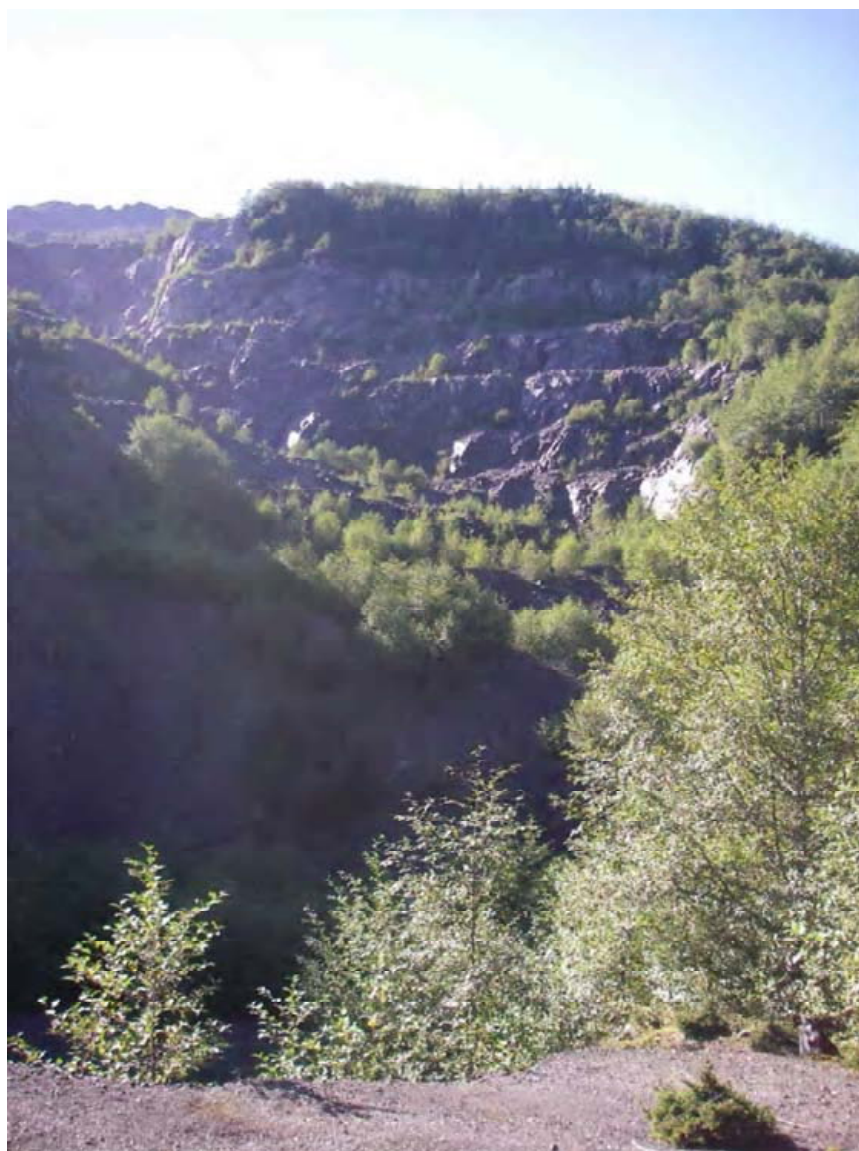
*Photograph 9: Looking upslope from Pit No. 1 area at old mine workings in Pit No. 2 area. This is flat area with 15 m deep excavation immediately in front of photo location.*

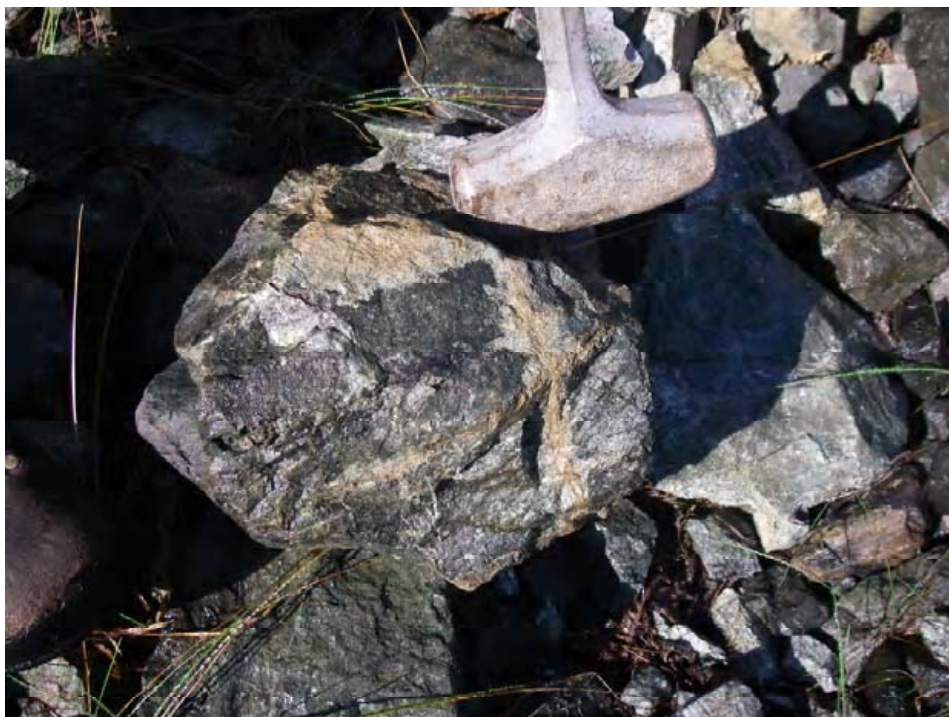
*Photograph 10: Typical rock found in Pit No. 1 area with calcite veins in basaltic rock.*

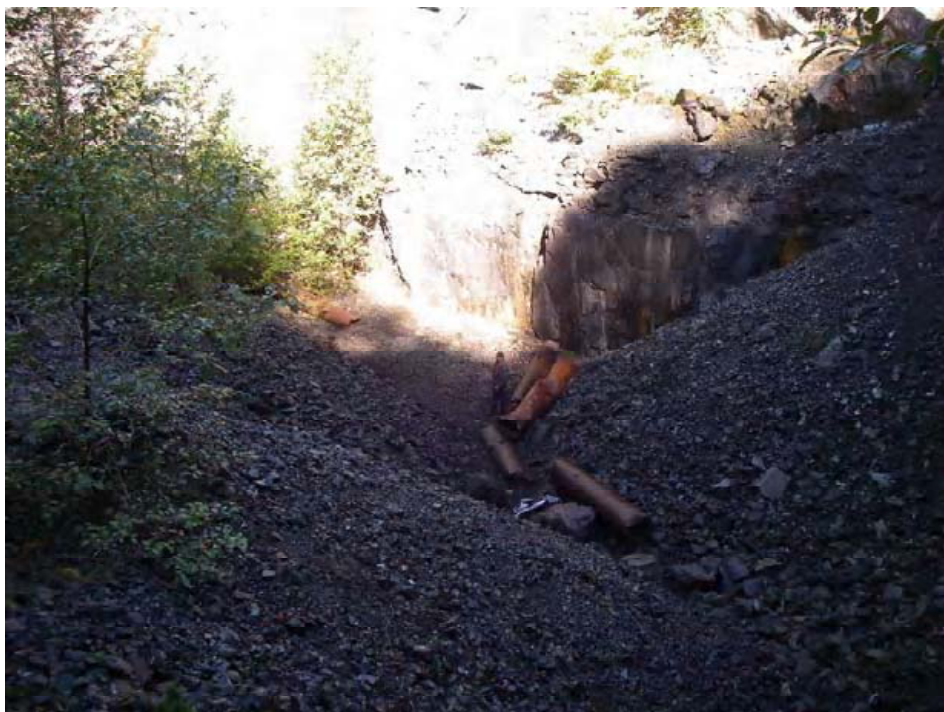
*Photograph 11: View into bottom of Pit No. 1. Old underground opening is to the left of photo but has been buried under waste rock to prevent entrance into the workings.*

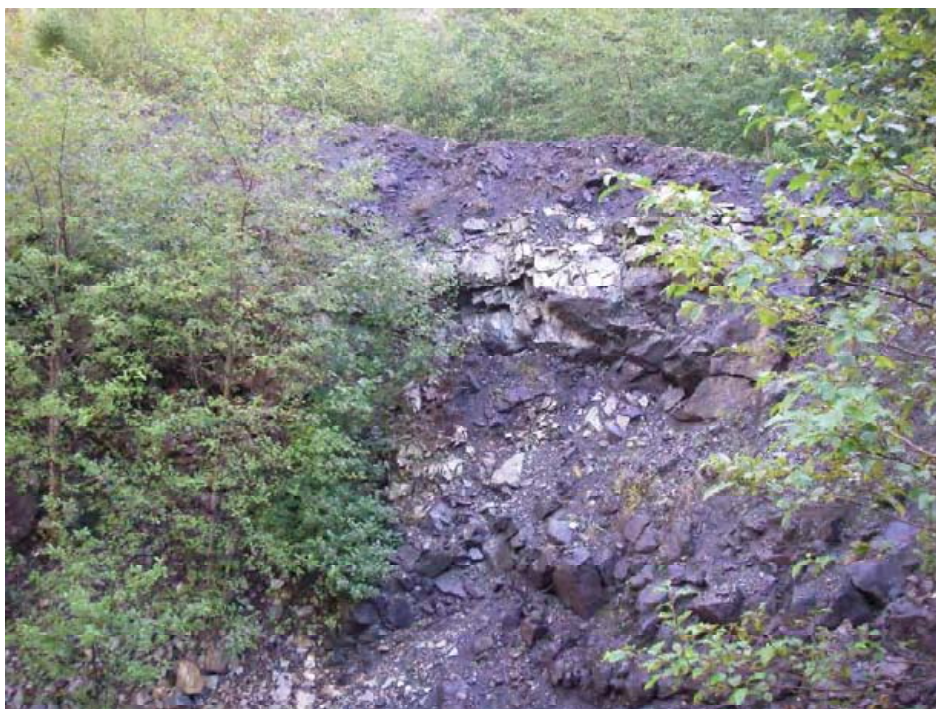
*Photograph 12: Typical bedrock formation in walls of Pit No. 1 (basalt with some limestone lenses).*

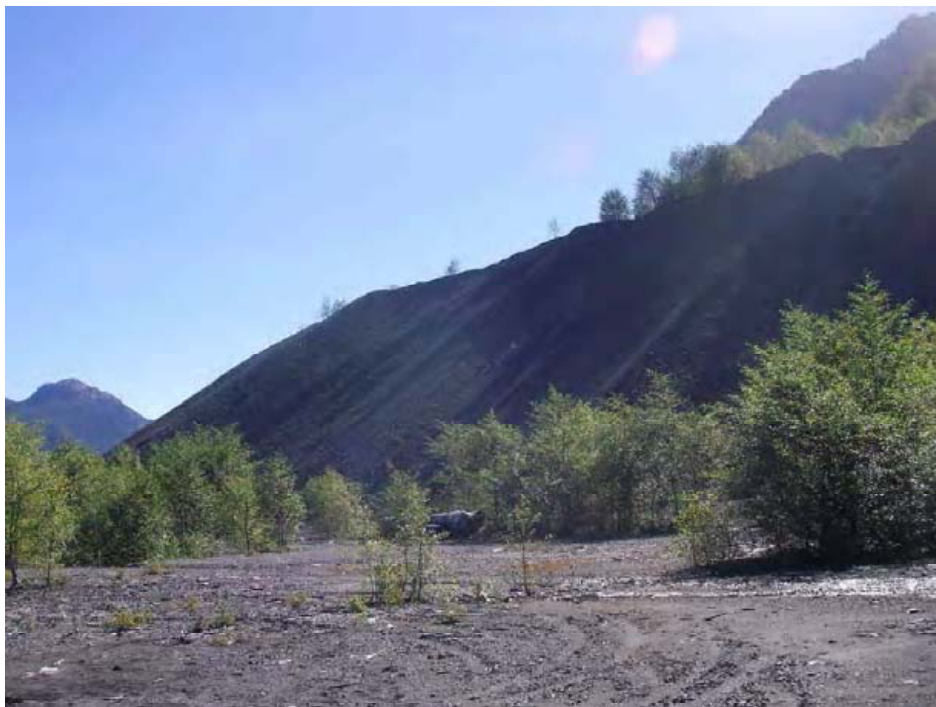
*Photograph 13: Flat area at north end of Cobber reject rock stockpile is proposed to be processing site for production of rock products from the stockpile and Pit No. 1.*

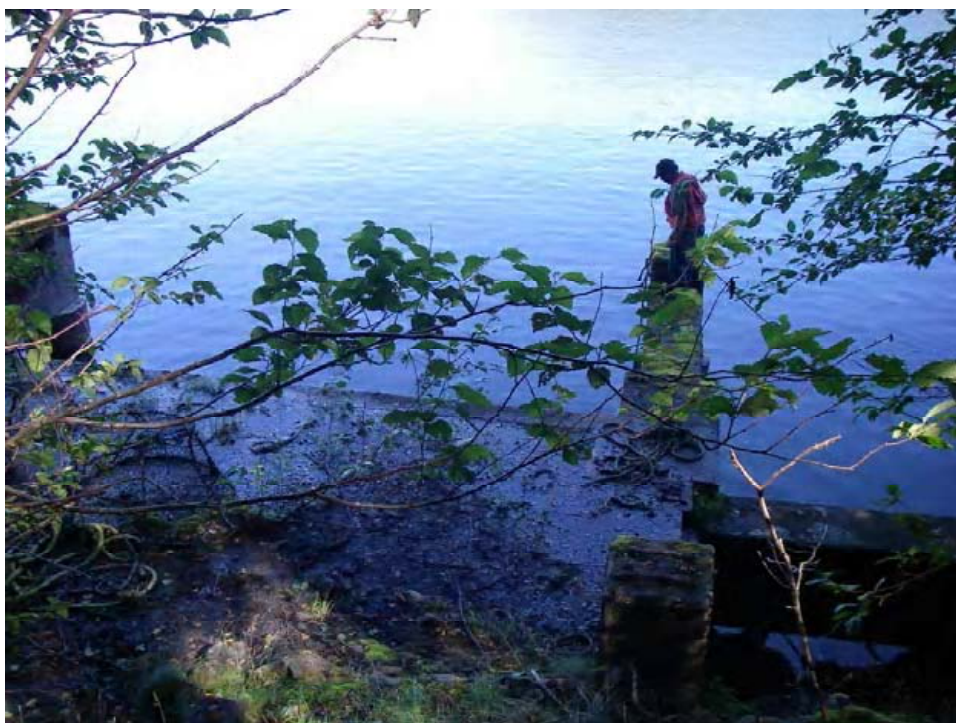
*Photograph 15: Remnant marine berthing facilities on Tasu Sound, northwest of proposed processing site.*

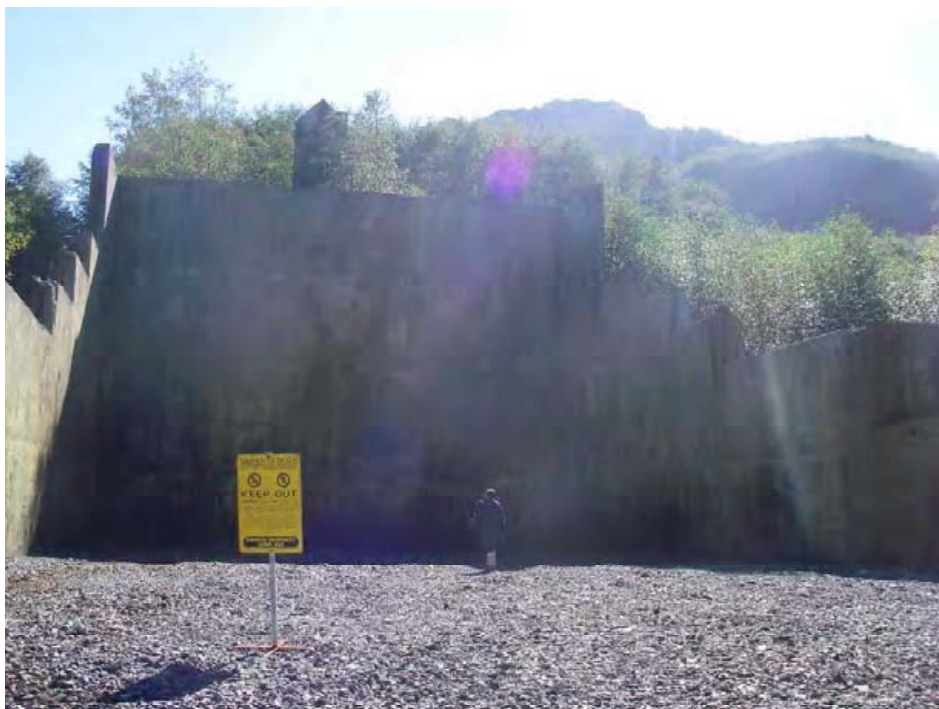
*Photograph 16: Foundation walls for old concentrate storage building near proposed marine berthing location.*

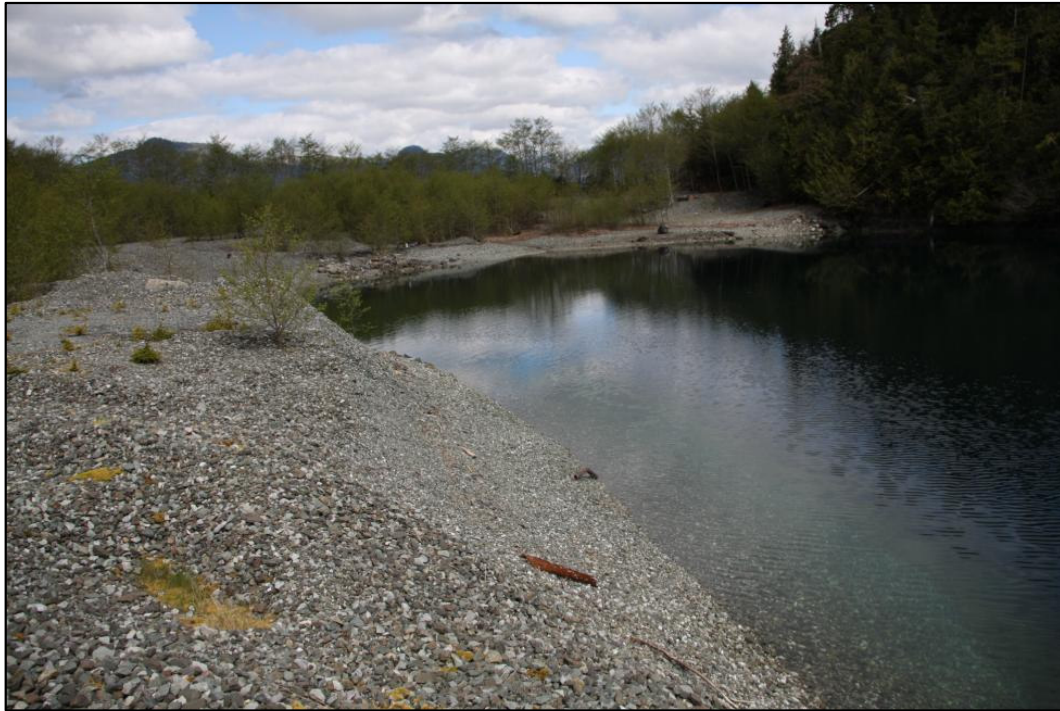
Review of photographs of the shoreline at the project site shows five inch minus surface materials that would not preclude pile driving, *Figure 2*, however, the size of material at depth is unknown. The feasibility of installing steel pipe piles to the required penetration by conventional methods such as impact or vibro-hammer is likely but not assured. Contractors undertaking to install the piles should also have other contingencies for advancing the pipe in case of obstructions. Other means might include an under-reamer hammer or churn for example. A minimum of three steel pipe piles would be required to create the berth face and one steel pipe pile would be required for a stop dolphin on the shoreward end of the berth. Five piles would be required to support the runway deck.

**Figure 2:** Upper Foreshore in the Area of the Proposed Stacker Runway.

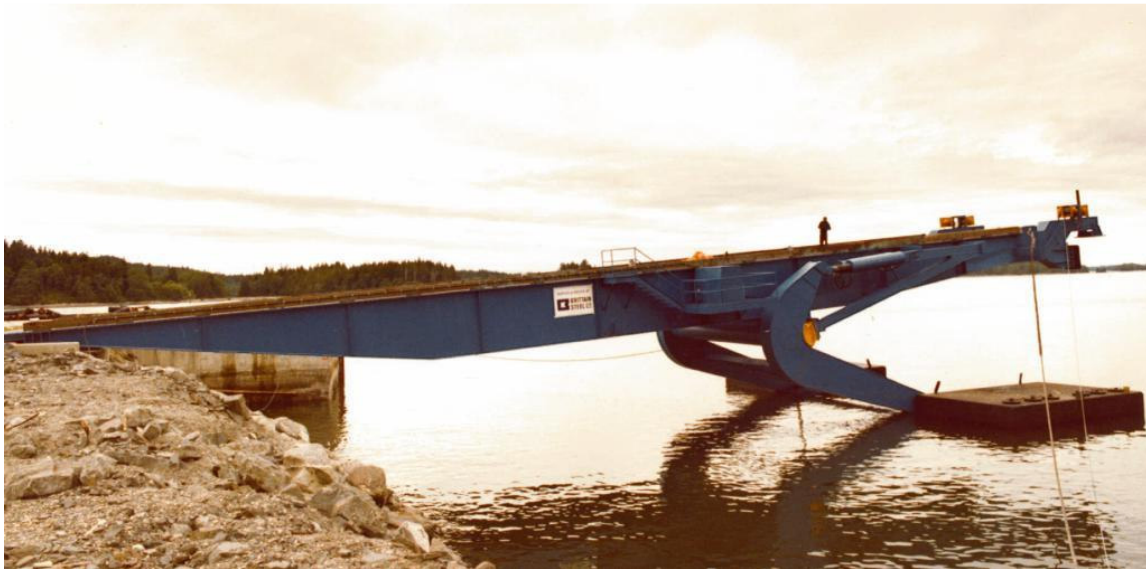
A floating RO-RO ramp is proposed for armour rock load-out. A large front end loader such as a Caterpillar 988 with rock forks would be required for the job. Use of crane with an orange peel grapple was investigated but it was found the reach and capacity requirements would preclude practical crane sizes at this site. The 4.5 m tidal range at Hunger Harbour suggests a RO-RO ramp length on the order of 20 m or longer would be required to keep the ramp at an acceptable slope most of the time. The ramp would require a high load capacity to handle the loads imposed by the loaded machines. The imposed axle loads are estimated to be on the order of 100 tonnes. The existing floating RO-RO ramp at Fairview Terminals in Prince Rupert is an example of a high capacity ramp although it is much longer than would be required for RO-RO operations at Tasu Sound. The Fairview Terminals ramp is illustrative of a floating ramp design comprised of dual plate girders with buoyancy tanks, *Figure 3*.

**Figure 3:** Example of a High Capacity Floating RO-RO Ramp, Fairview Terminals.

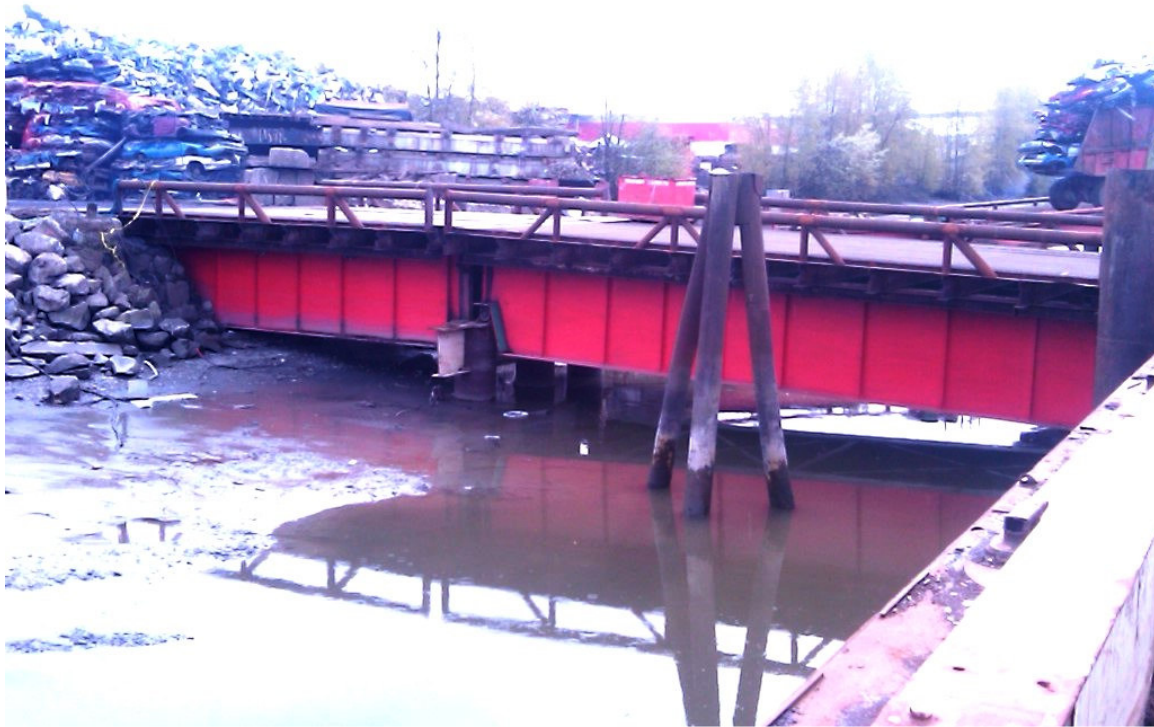
**Figure 4:** Example of Pitt River Bridge girder deployed in an access ramp application.

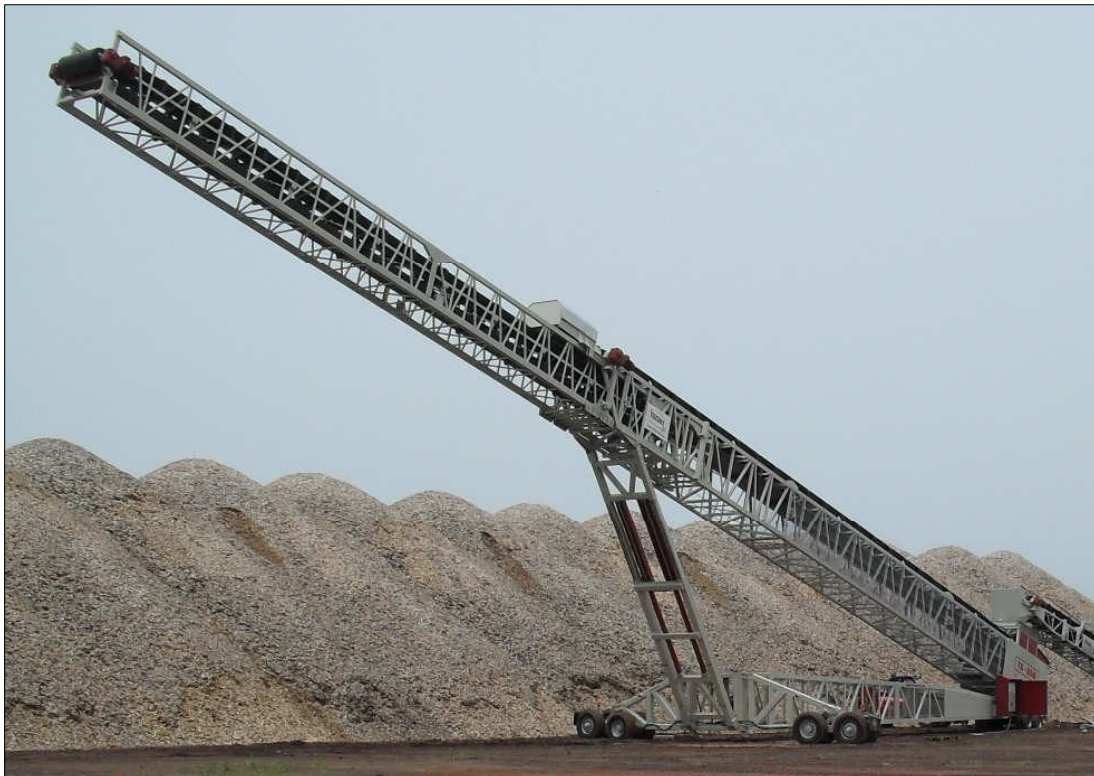
**Telestack TS 1550 Radial Telescopic Conveyor**

## **TS 1550 Radial Telescopic - Technical Specification**

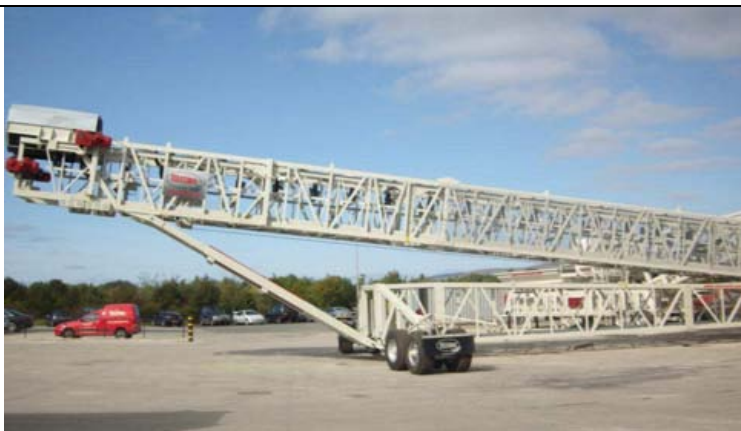
- Main "outer" frame is constructed from 150 x 150 x 12mm heavy structural angle.

- The telescopic extendible "inner" lattice truss is constructed using 200x100x6mm and 150x100x6mm Rectangular Hollow Section (RHS).

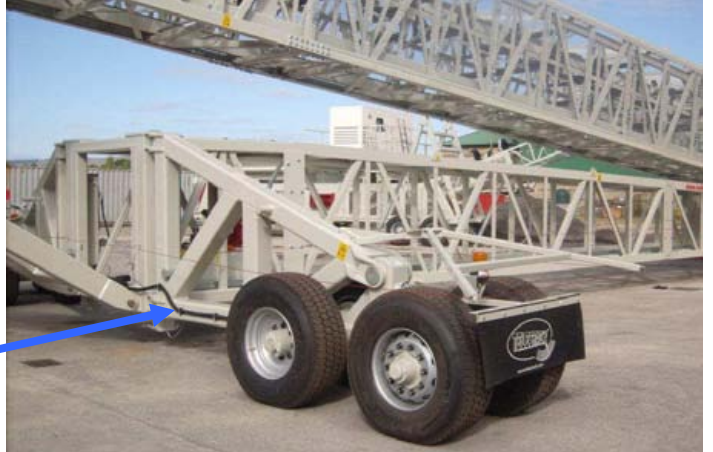
- The forward support frame ("Hydraulic Under Carriage") is constructed of 250 x 250 x 10mm hollow section and the rear support frame ("Under Carriage") is fabricated from 200 x 200 x 8mm heavy structural angle. The forward support is hydraulically raised and lowered.

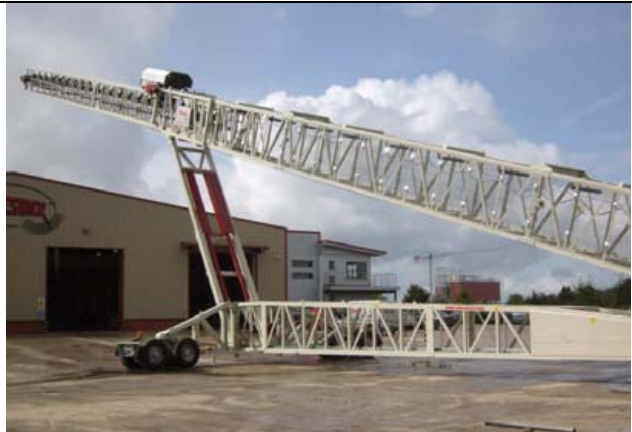
- King, pin, counterweight and side plate assemblies are designed to allow ample turning clearance for most 5<sup>th</sup> wheel tractors. Safety guards at all pinch points are standard.

- Standard accessories include loading hopper, (stone box, or tapered chute) 1900mm (6' 2") wide x 2120mm (6' 11") long, fabricated from 8mm (1/3") plate with rubber skirting.

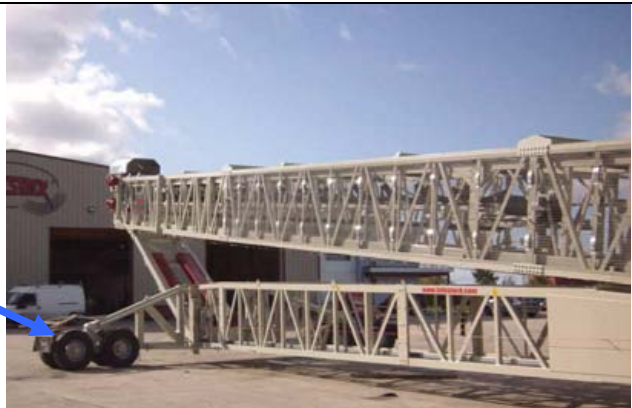
- The conveyor mid section is hydraulically raised to allow the wheels to swing from travel mode to radial position. Wide wheelbase in radial position offers great stability during operation while the closed travel position allows for safe transportation.

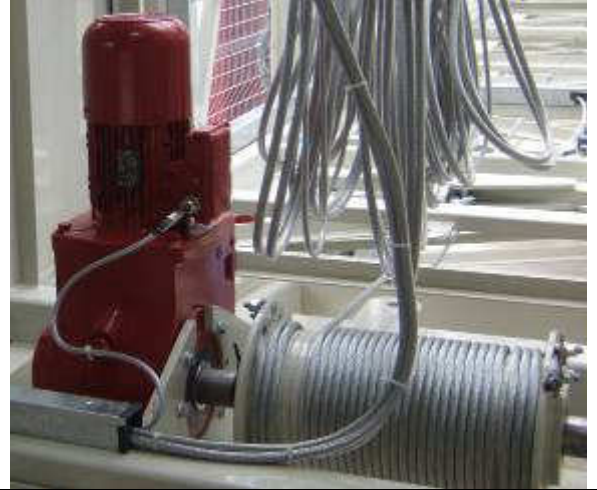
- Telescopic action is activated by a 325mm (1') dia drum (3.0 KW motor) and 16mm (5/8") cable winch package, which moves the conveyor, approximately 14 ft/min (0.07 m/s) (5252Nm, 3.1 Tonnes pull).

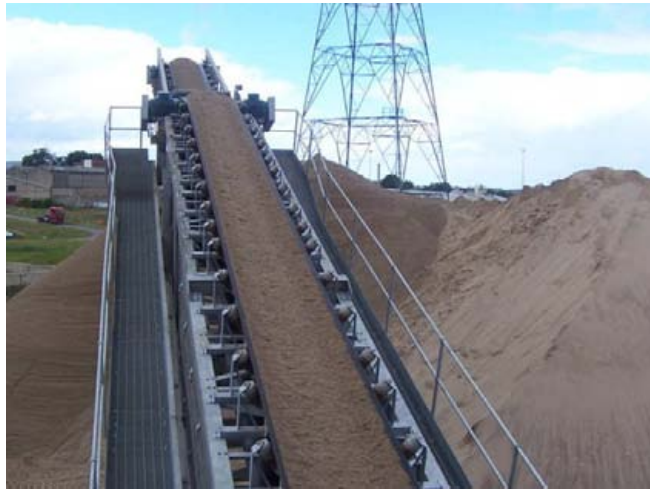
- Inner conveyor – EP630 / 4ply, 6mm top 2mm bottom cover

Belting is premium quality, high tensile strength, to support the load and the designed horsepower. Standard covers are 6mm x 2mm 4 ply EP630 with vulcanised splice (if available in local area) or clipped belt for container transport

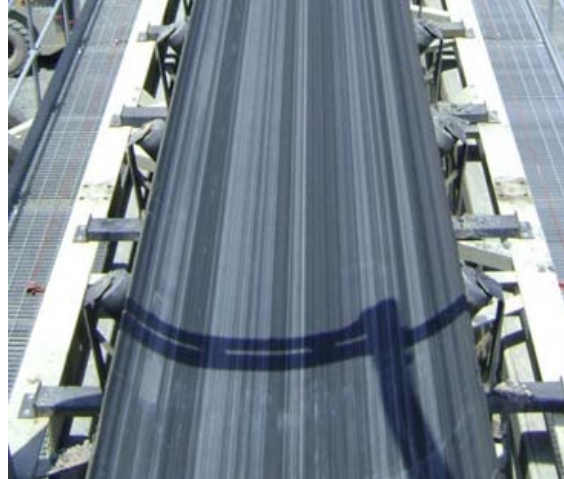
- Troughing Rollers 133mm (5") dia troughing at 50 degrees 4 roll set
- Return Rollers Spiral rollers 102mm (4") dia 1200mm (40") belt 1 of at head and Tail of conveyor 102mm (4") plain rollers between spiral rollers
- Both the main conveyor and the telescopic conveyor utilise 133mm (5") steel idlers with 50 degree troughs;

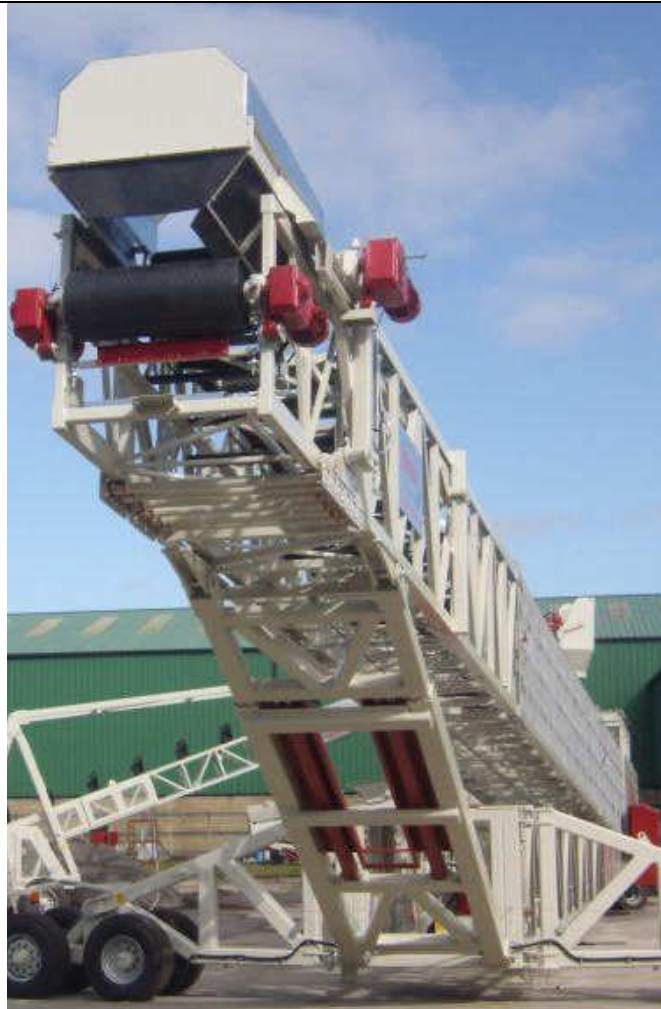
- Outer conveyor head drum and shaft 520mm (21") x 1280mm (50") drum, 120mm (5") x 2625mm (103") shaft
- Outer conveyor tail drum and shaft 520mm (21") x 1280mm (50") drum, 120mm (5") x 1818mm (72") shaft
- Inner conveyor head drum and shaft 457mm (18") x 1280mm (50") drum, 100mm (4") x 2625mm (103") shaft
- Inner conveyor tail drum and shaft 457mm (18") x 1280mm (50") drum, 100mm (4") x 1818mm (72") shaft.

All end drums are welded steel, crowned faced, secured by Fenlock hubs on high strength (EN8) steel shafts. All head drums are diamond lagged. (50") shaft

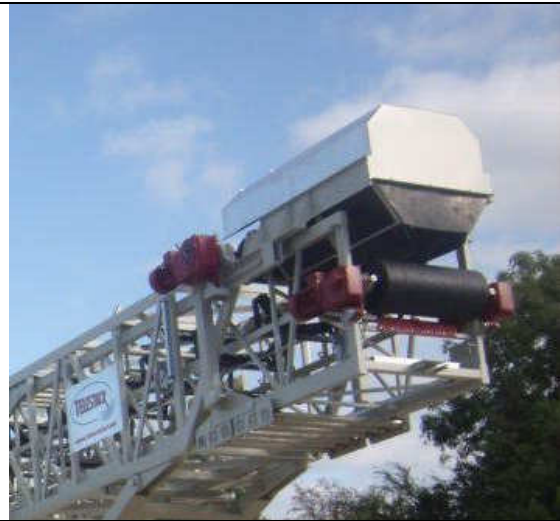
- Outer conveyor direct drive  
14.61:1 shaft mounted gearbox
- Inner conveyor direct drive  
13.45:1 shaft mounted gearbox
- Winch direct drive  
348.91:1 shaft mounted gearbox

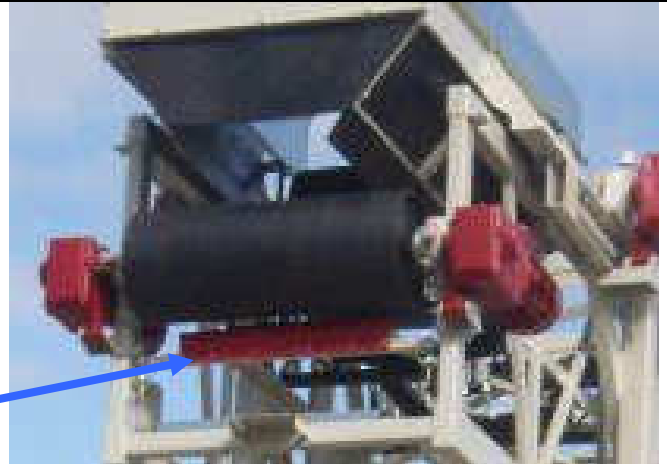
Carbide tungsten tipped finger scraper to suit 1200mm (48") belt.

Belt cleaners are situated at the discharge end on both conveyors, cleaning the drive drums below the tangent point of the head pulley.

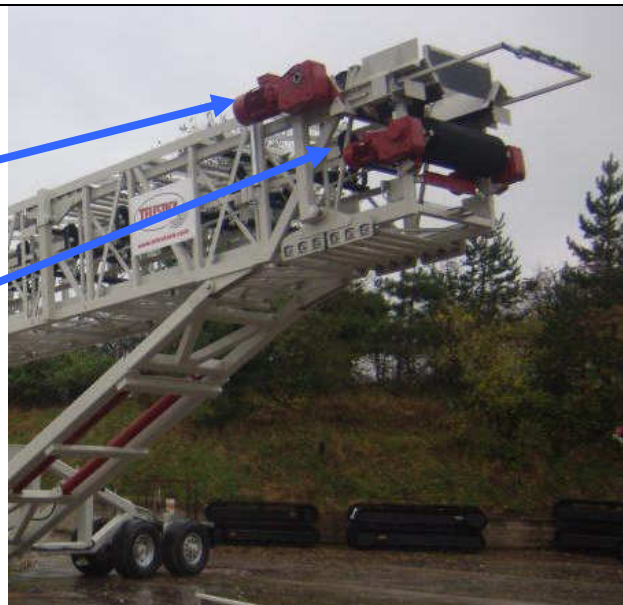
- Outer conveyer motor
  - 2 x 37 kw IP 55 rating
- Inner conveyer motor
  - 2 x 30 kw IP 55 rating
- Winch drive motor
  - 3.0 kw IP 55 rating

- Unit requires 210 Amps of Supply

(Based on operating @ 18 degrees on full load – Note: This will vary depending on angle of operation)

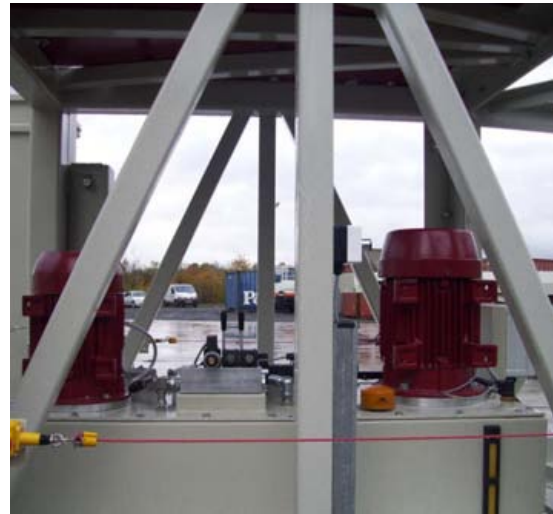
- Jack leg cylinders 112mm bore 400mm stroke
- Telescopic lift cylinders 152mm bore 1830mm stroke fitted with safety check valve
- 11 Kw 4 station Hydraulic Power Pack with 125 lts reservoir Powers a 8.6 litres/min gear pump at 4000psi
- Wheel drive utilises two hydraulic torque hubs

*Note: Electric hydraulic power pack used for all hydraulic functions – Raise / lower conveyor sections, raise / lower under-carriage, radial left / right*

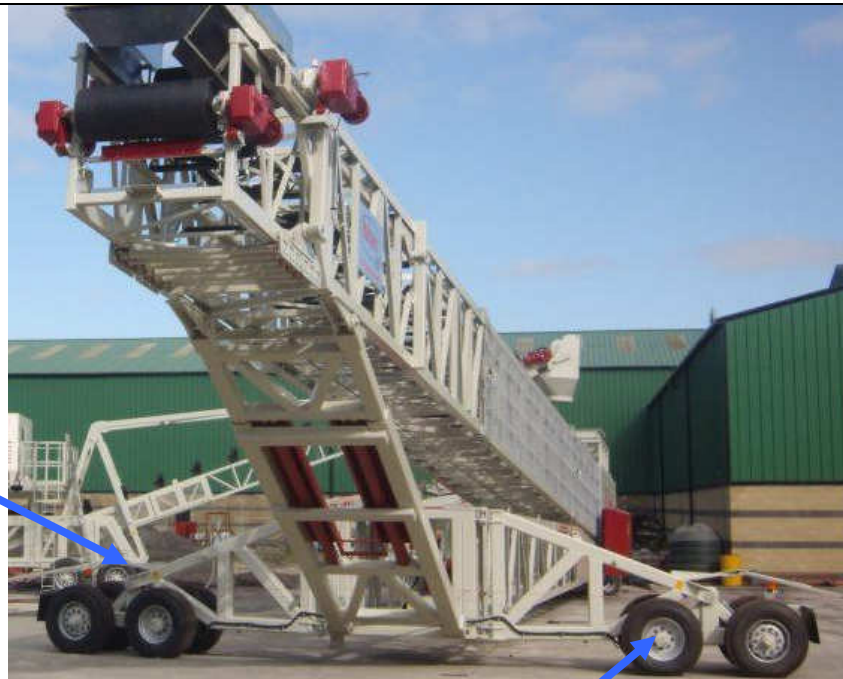
The axle is a specially designed outrigger style framework with 8 x 425 / 65 / 22.5 super single wheels mounted onto standard 10 stud hubs.

This includes 2 x Internal wheels hub drives fro radial left / right.

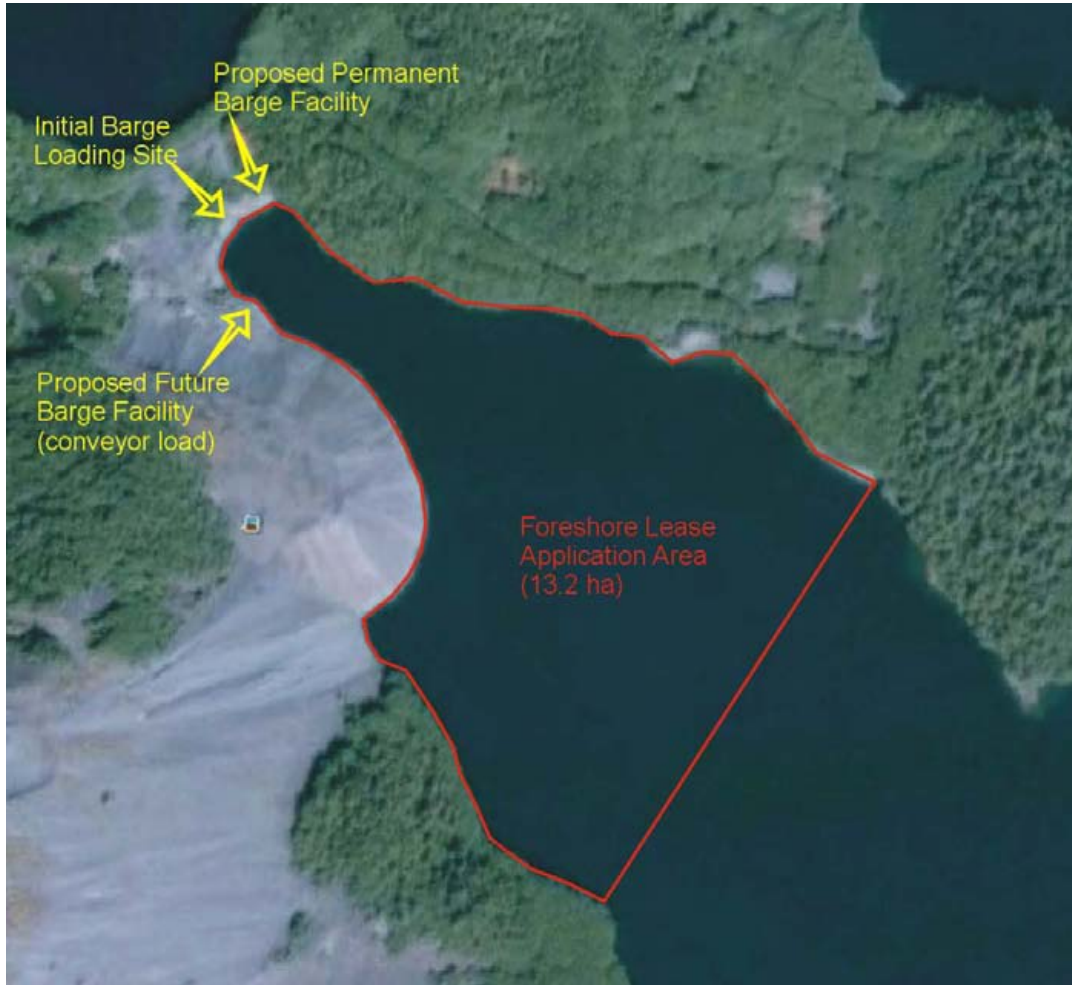
**Figure 2: The site of Coastal Construction Aggregates Inc. showing the locations of the proposed foreshore facilities and the foreshore lease application area.**

The components of the proposed development that will affect the foreshore are the initial barge loading site, a permanent barge-loading site and a conveyor-assisted barge-loading site (see **Figure 2**). On-site discussions suggest that the installation of these will have minimal effect on the existing foreshore (Ray Carrier, pers.com., 2012). The reader is advised that no detailed engineering drawings have been drawn at this time. The following comments are made on the basis of on-site discussions with Ray Carrier.

The initial ramp barge-loading site will be situated at the center of the head of the bay. Subsequently, once the operation is reasonably established, a permanent barge facility would be developed on the north-east side of the head of the bay. The initial ramp barge-loading site will require no alteration of the foreshore and the permanent barge facility should require minimal physical alteration of the existing foreshore. Future development would include a conveyor assisted barge facility on the south side of the bay, which should require minimal physical alterations to the foreshore.

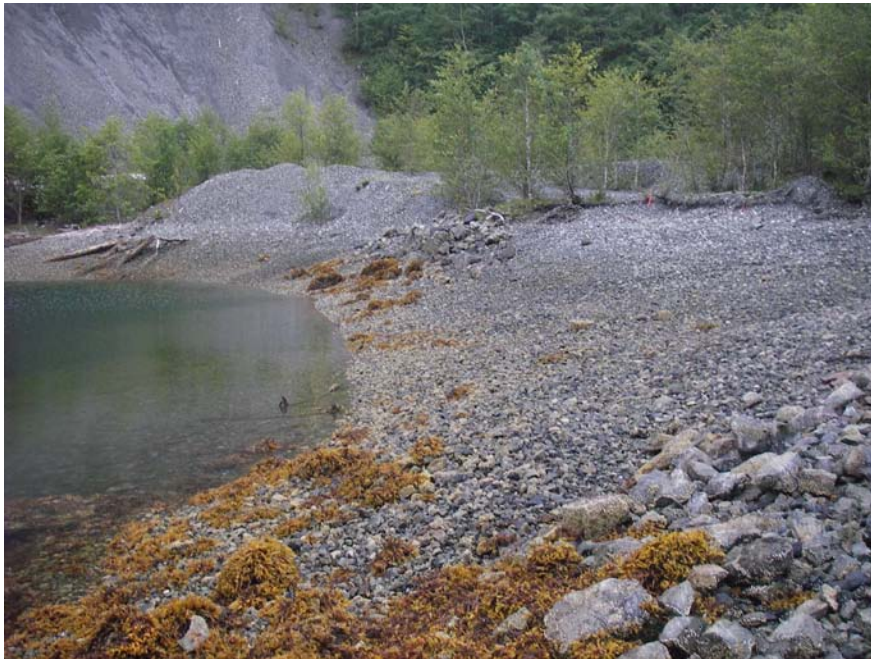
**Photograph 1** shows the inter-tidal slope at the head of the bay. This is the east shore of the causeway and it appears that most of the material on the foreshore here is waste rock from the mine workings.

**Notes:** The photograph is taken from the north end of the causeway (the proposed permanent barge facility location) looking across the initial barge site.

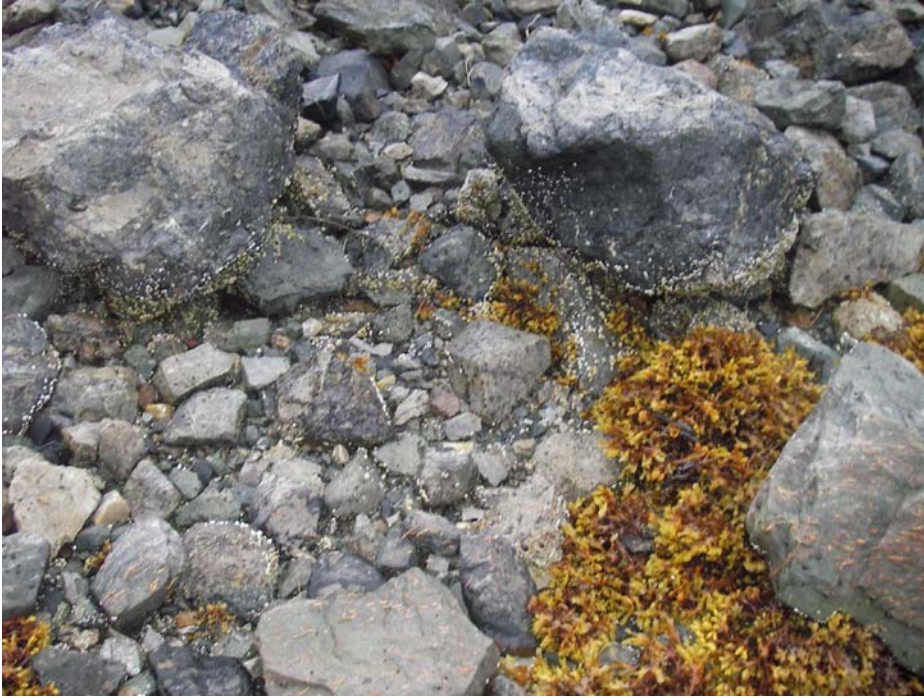
**Photograph 2:** A typical view of the mid inter-tidal zone boulder/cobble substrate at the head of the bay.
