BC Geological Survey  
Assessment Report  
34284

# Sampling, Testing and Development of Preliminary Acid Rock Drainage (ARD) and Metal Leaching (ML) Monitoring Program, Coastal Construction Aggregates, Tasu Quarry, Haida Gwaii

**Report Number:** 1214760060-001-R-Rev0

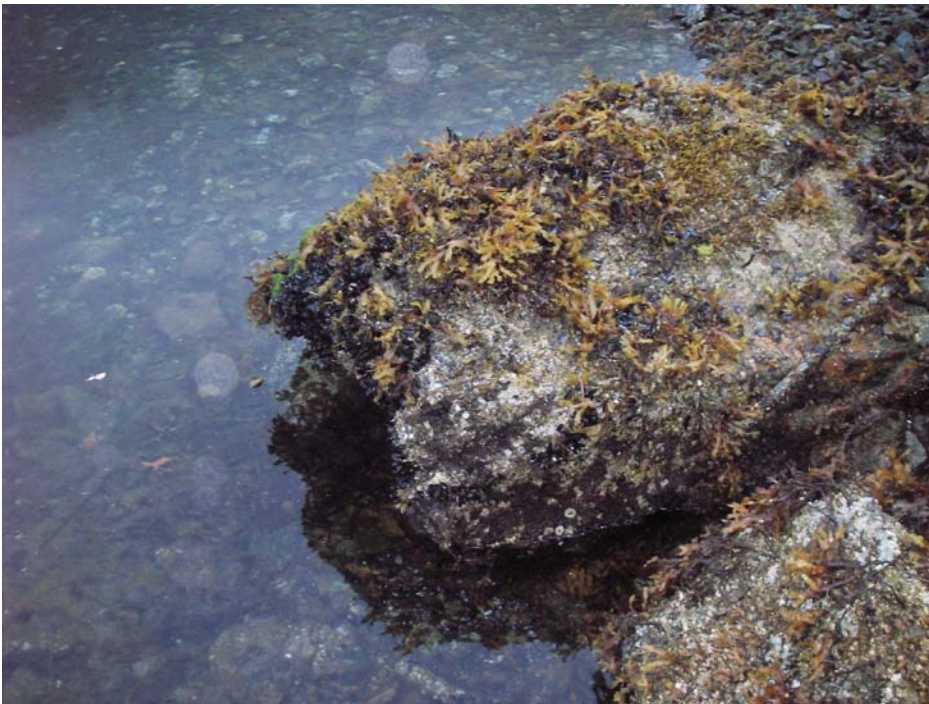
The only place I saw large mussels (i.e. multi-year) was on a single large boulder near the north east end of the causeway (**Photograph 3**). Also observed were hairy hermit crabs (*Pagurus hirsutiusculus*), red rock crabs (*Cancer productus*) and polyclad flatworms (likely *Notoplana sanguinea*).

**Notes:** This boulder is situated near the proposed permanent barge facility site, on the north east side of the causeway.

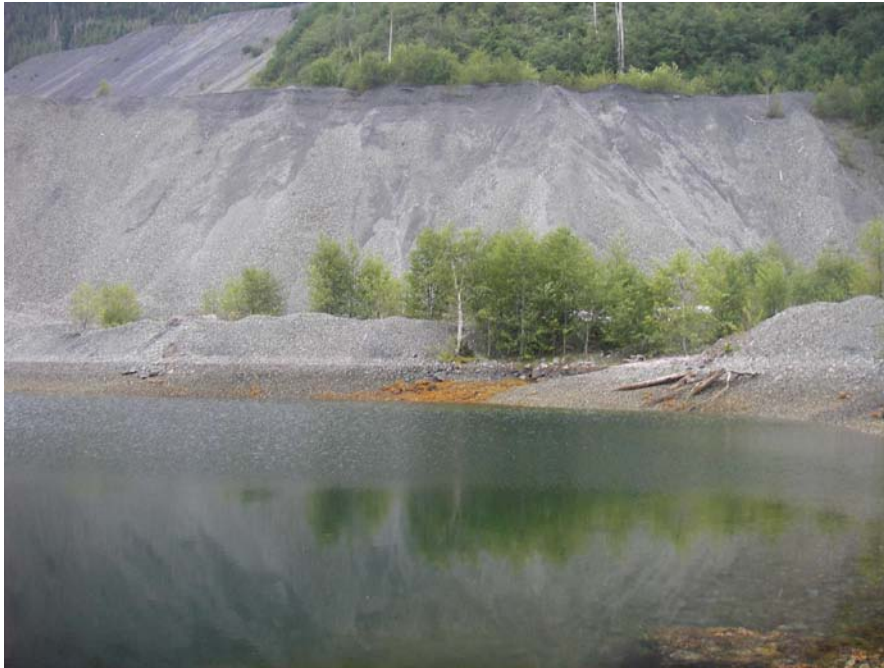
The substrate was often comprised of uniform material in the cobble/gravel size range with some fines. **Photograph 1** shows that there are large areas that are sparsely colonized but there are also areas where the degree of colonization is more typical of unaffected shorelines in Haida Gwaii. These better-colonized areas often (but not always) appear to be associated with larger substrate material (**Photograph 4**).

**Notes:** there was relatively luxuriant growth of rockweed on cobble substrate in the center of the photograph as compared with the limited growth on similar substrates to either side.
