ASSESSMENT REPORT

BC Geological Survey
Assessment Report
35182

TYPE OF REPORT [type of survey(s)]: Geochemical, Geophysical and remote aerial survey

PROPERTY NAME: Cox Station Quarry (6850 Cox Rd. Abbotsford)

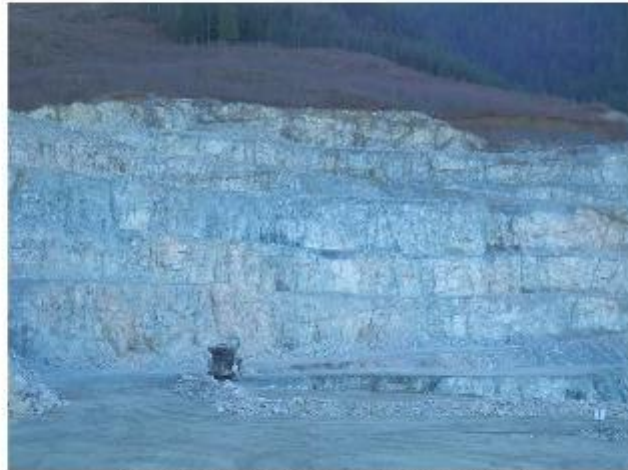
Photo #1 Overview of active quarry face

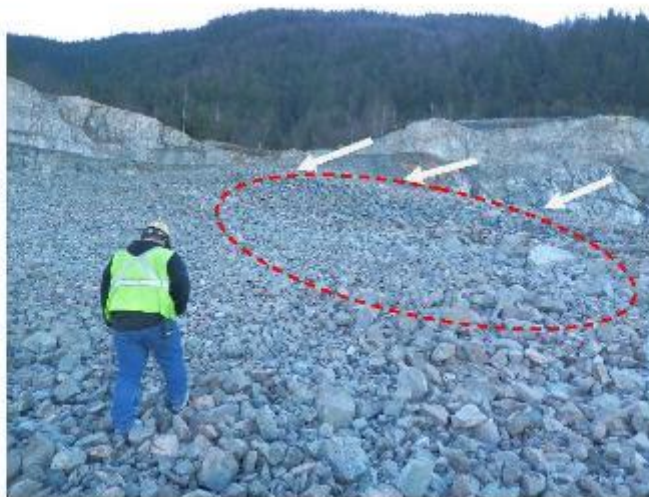
Photo #2 Newly blasted face materials including a narrow band (dike/vein inside red circle).

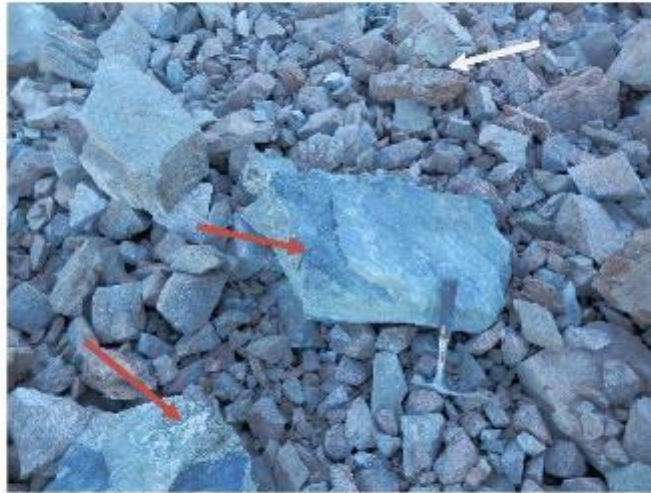
Photo #3 Massive granitic rocks containing k-feldspar (white arrow-top), with andesitic (dike) rocks (red arrows left) prior to further processing.

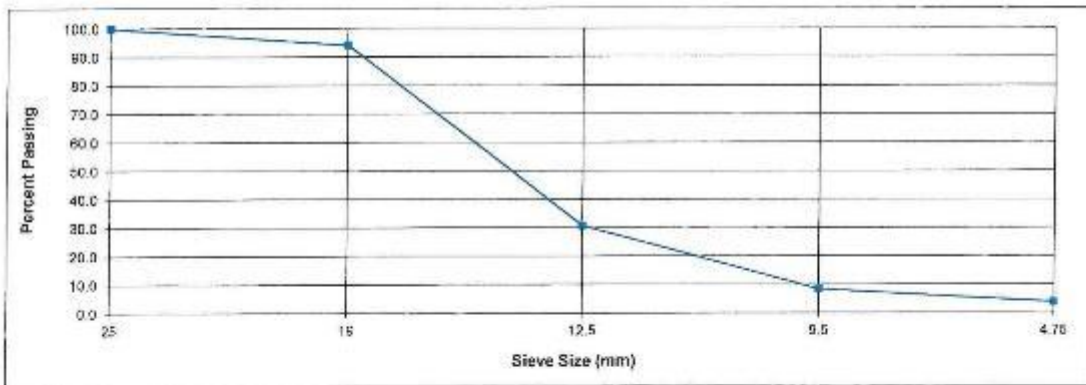
SIEVE ANALYSIS					MATERIAL SPECIFICATION:	
Sieve Size (mm)	% Retained	% Passing	Individual % Retained (Split values)			
			+ 4.75	- 4.75		
25	0.0	100.0	0.0			
19	5.8	94.1	6.1			
12.5	63.4	30.7	65.9			
9.5	22.2	8.5	23.1			
4.75	4.6	3.8	4.8			
PAN	3.8	0		100.0		
Total	100.0		100.0	100.0

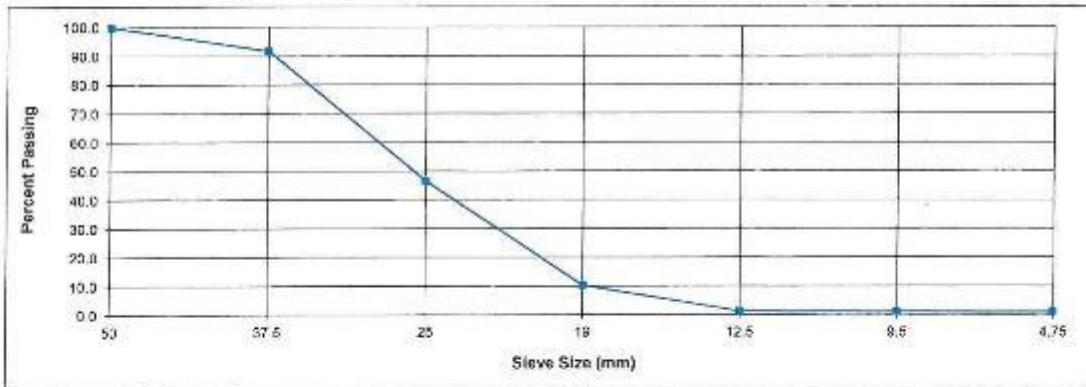
SIEVE ANALYSIS					MATERIAL SPECIFICATION:
Sieve Size (mm)	% Retained	% Passing	Individual % Retained (Split values)		
			+ 4.75	- 4.75	
50	0.0	100.0	0.0		
37.5	8.2	91.8	8.3		
25	45.2	46.6	45.7		
19	38.2	10.4	36.6		
12.5	9.0	1.4	9.1		
9.5	0.2	1.2	0.2		
4.75	0.1	1.1	0.1		
PAN	1.1	0		100.0	
Total	100.0		100.0	100.0

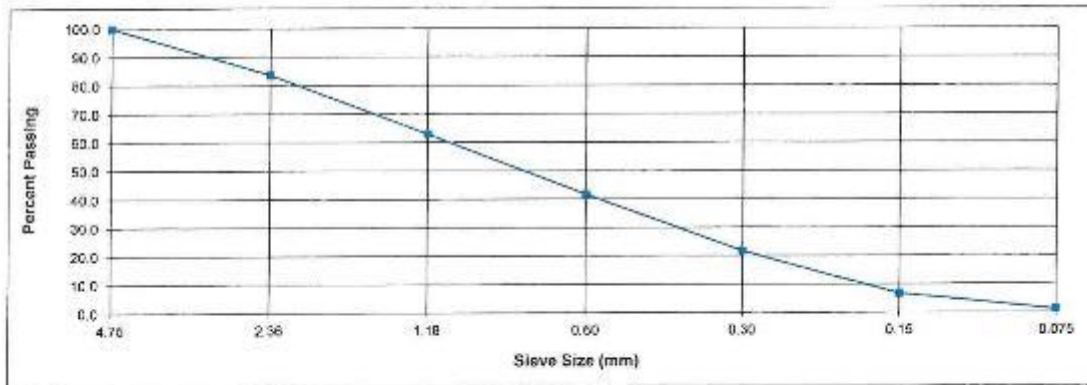
Sieve Size (mm)	% Retained	% Passing	Individual % Retained (Split values)		MATERIAL SPECIFICATION:
			+ 4.75	- 4.75	
			4.75	0.0	
2.36	16.3	83.7		16.3	
1.18	20.8	63.0		20.8	
0.60	21.2	41.7		21.2	
0.30	20.0	21.7		20.0	
0.15	14.9	6.8		14.9	
0.075	5.9	1.3		5.5	
PAN	1.3	0		1.3	
Total	100.0			100.0

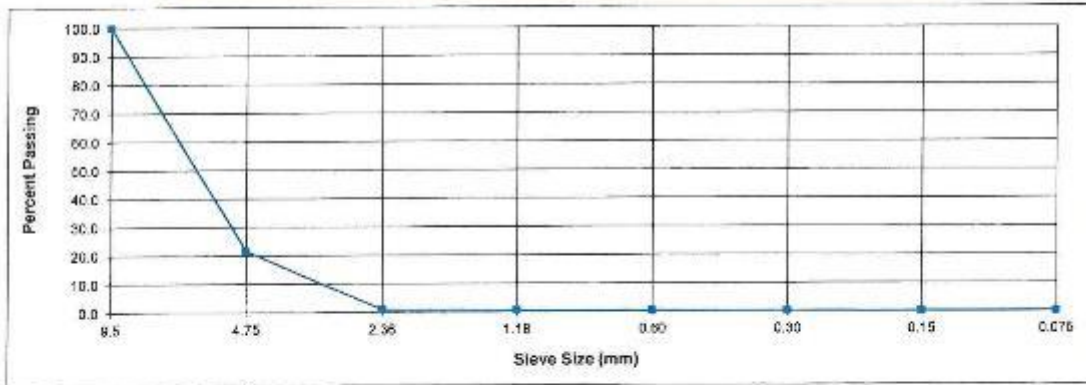
Sieve Size (mm)	% Retained	% Passing	Individual % Retained (Split values)		MATERIAL SPECIFICATION:
			+ 4.75	- 4.75	
			9.5	0.0	
4.75	78.3	21.7	100.0		
2.36	20.7	1.0		96.5	
1.18	0.4	0.6		1.7	
0.60	0.2	0.4		1.1	
0.30	0.1	0.2		0.7	
0.15	0.1	0.2		0.3	
0.075	0.0	0.1		0.1	
PAN	0.1	0		0.7	
Total	100.0		100.0	100.0

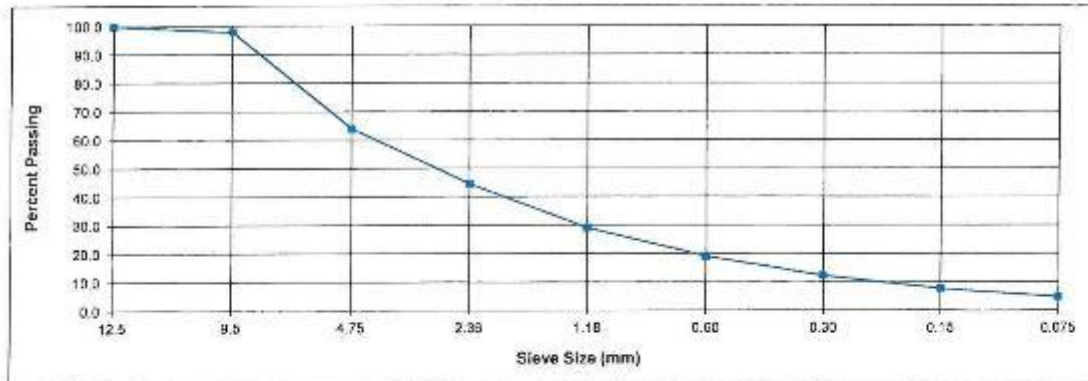
Sieve Size (mm)	% Retained	% Passing	Individual % Retained (Split values)		MATERIAL SPECIFICATION:
			+ 4.75	- 4.75	
			12.5	0.0	
9.5	2.0	98.0	5.7		
4.75	34.1	63.9	94.3		
2.36	19.4	44.5		30.3	
1.18	15.5	29.1		24.2	
0.60	10.0	19.1		15.6	
0.30	6.8	12.3		10.7	
0.15	4.5	7.7		7.1	
0.075	2.9	4.8		4.5	
PAN	4.8	0		7.5	
Total	100.0		100.0	100.0

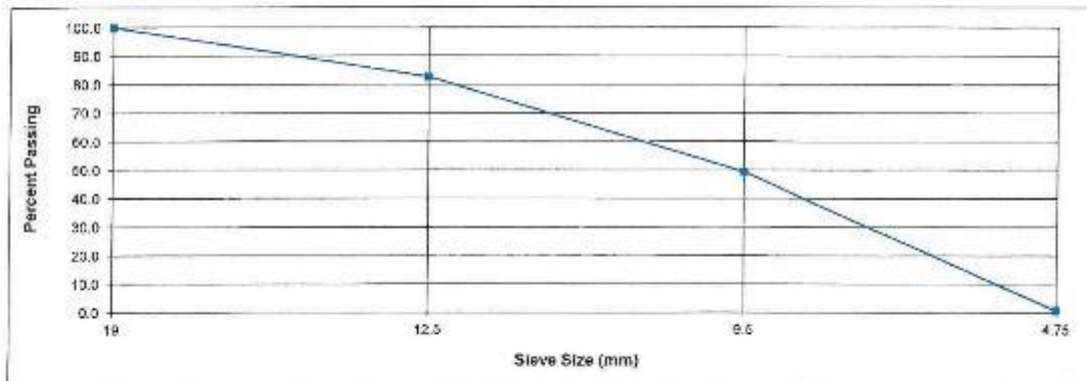
Sieve Size (mm)	% Retained	% Passing	Individual % Retained (Split values)		MATERIAL SPECIFICATION:
			+ 4.75	- 4.75	
			19	0.0	
12.5	17.3	82.7	17.4		
9.5	33.4	49.3	33.6		
4.75	48.6	0.7	49.0		
PAN	0.7	0		100.0	
Total	100.0		100.0	100.0

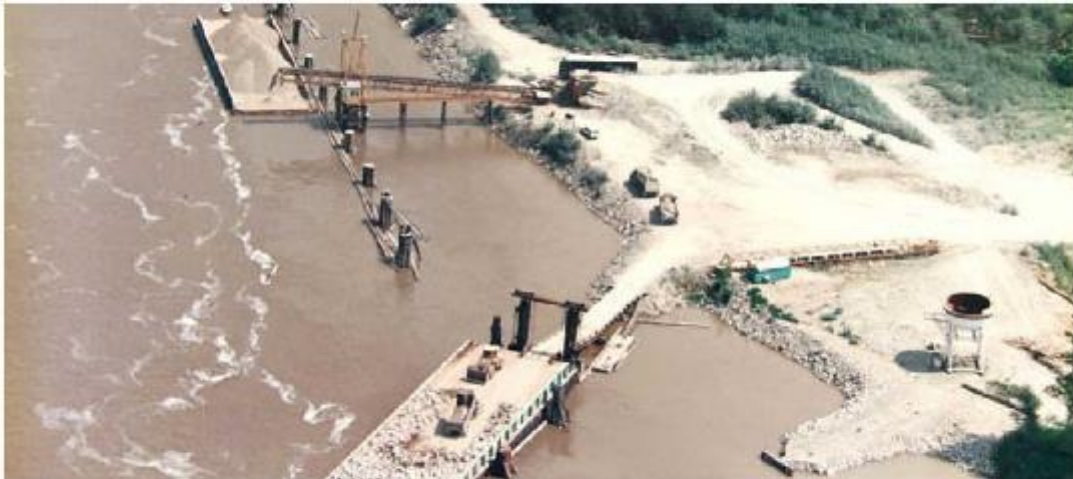
1

Aero View of Cox Station Quarry

On January 20, 2013 and January 28 Valley Testing Services Ltd. received three (3) aggregate samples of 75 mm minus, 40mm Clear Crush and 25 mm minus crushed aggregates from Cox Station Quarry, located in Abbotsford, BC (see photo below). All samples were extracted from stockpiles of the Quarry by the Client.

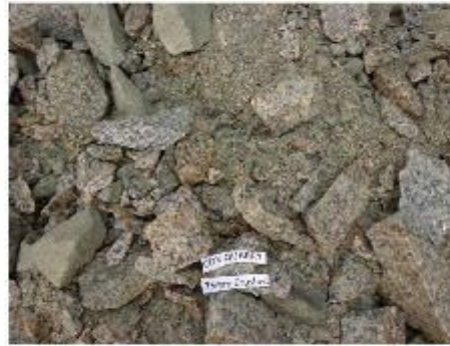
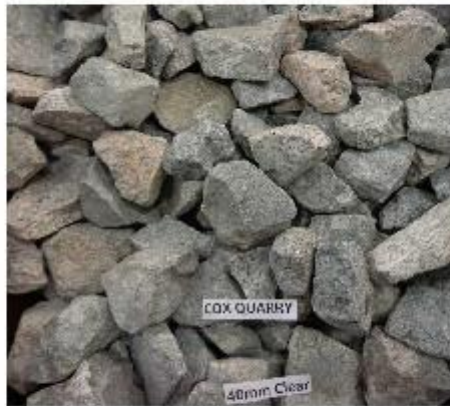
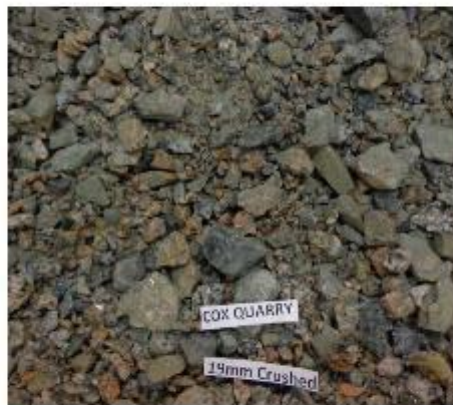
Photos of Aggregate Samples for Visual Reference
