**TAILINGS DAM INSPECTION
CAROLIN MINES
HOPE, BRITISH COLUMBIA**

Athabaska Gold Resources Limited
#200 - 1185 West Georgia Street
Vancouver, B.C.
V6E 4E6

October 27, 1995

952-1483

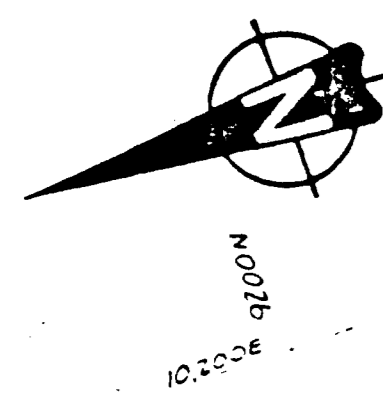
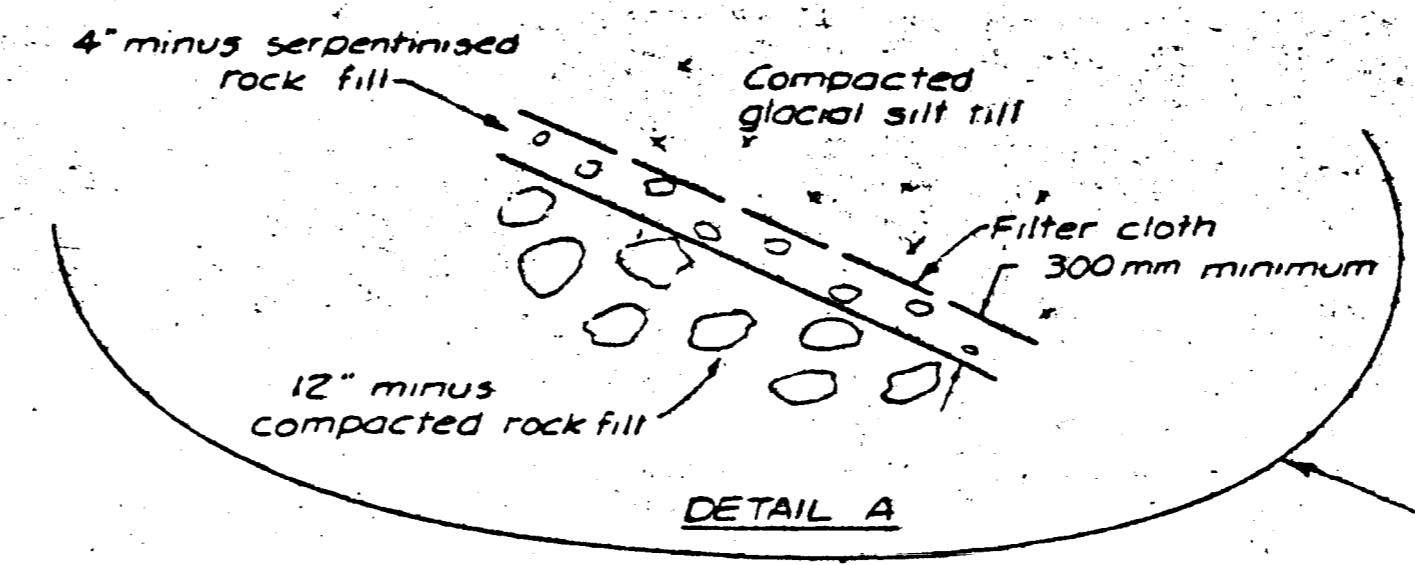
There is presently insufficient piezometric detail to fully define the seepage conditions within the dam. This has resulted because of the destruction of piezometer leads on the dam crest. We recommend that four additional piezometers be installed at this time from the dam crest. This work would be undertaken by means of a percussion drill rig using casing and drilling fluid. The piezometers would be installed to replace piezometers numbered 5825, 5827 and 5828.
