ASSESSMENT REPORT 20446

ASSESSMENT REPORT

OVERBURDEN DIAMOND DRILLING
MBX 1-29 PLACER CLAIMS
MT. MILLIGAN PROPERTY

OMINECA MINING DIVISION

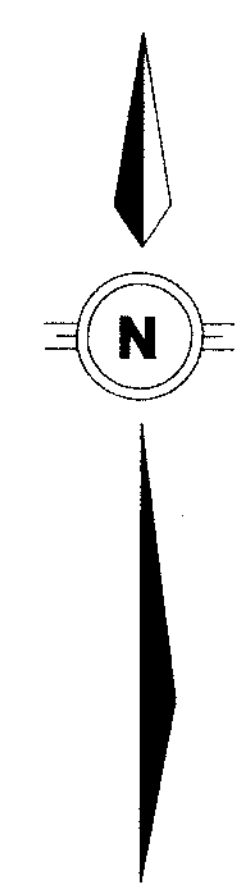
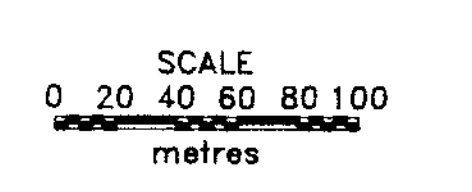
CONTINENTAL GOLD CORP. MT. MILLIGAN	
MBX 1-29 PLACER CLAIMS OVERBURDEN ISOPACH MAP	
SCALE: 1 : 2500	FILE: PLAN\08THICKP
DATE: 18/10/90	DWG. NO.: 3
DRAWN BY: D.M.C.	REVISED:

CONTOUR INTERVAL = 5m

<u>Following Page</u>
Figure 1	Claim Map	2
Figure 2	Location Map	3
Figure 3	Overburden Isopach Map	In Pocket
Figure 4	Bedrock Surface Contour Map	In Pocket
