REPORT
on the
ENGINEER GOLD MINE

ATLIN MINING DIVISION
BRITISH COLUMBIA

Jan (Swede) Martensson and Warren Arnholtz
Ampex Mining
Box. 5634, Whitehorse, Yukon
Y1A 5H4
February, 18, 1996

Geology prepared by:
Robert S. Hewton, P.Eng.
September, 29, 1993

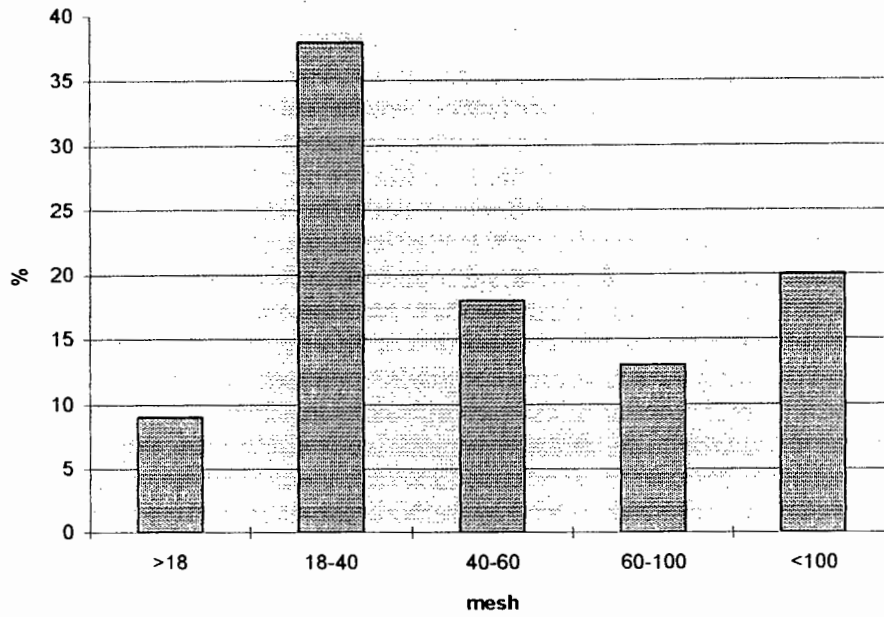
Grind @ 1.5 tons per hour

During the course of the milling season we were able to experiment with feed rate to the ball mill and observe the effect on the grind. The following charts are the results of two tests.

These two factors will dictate the production rate of the mill. It will be necessary to adjust the feed rate to the grindability of the mill feed depending on the content of argilite.

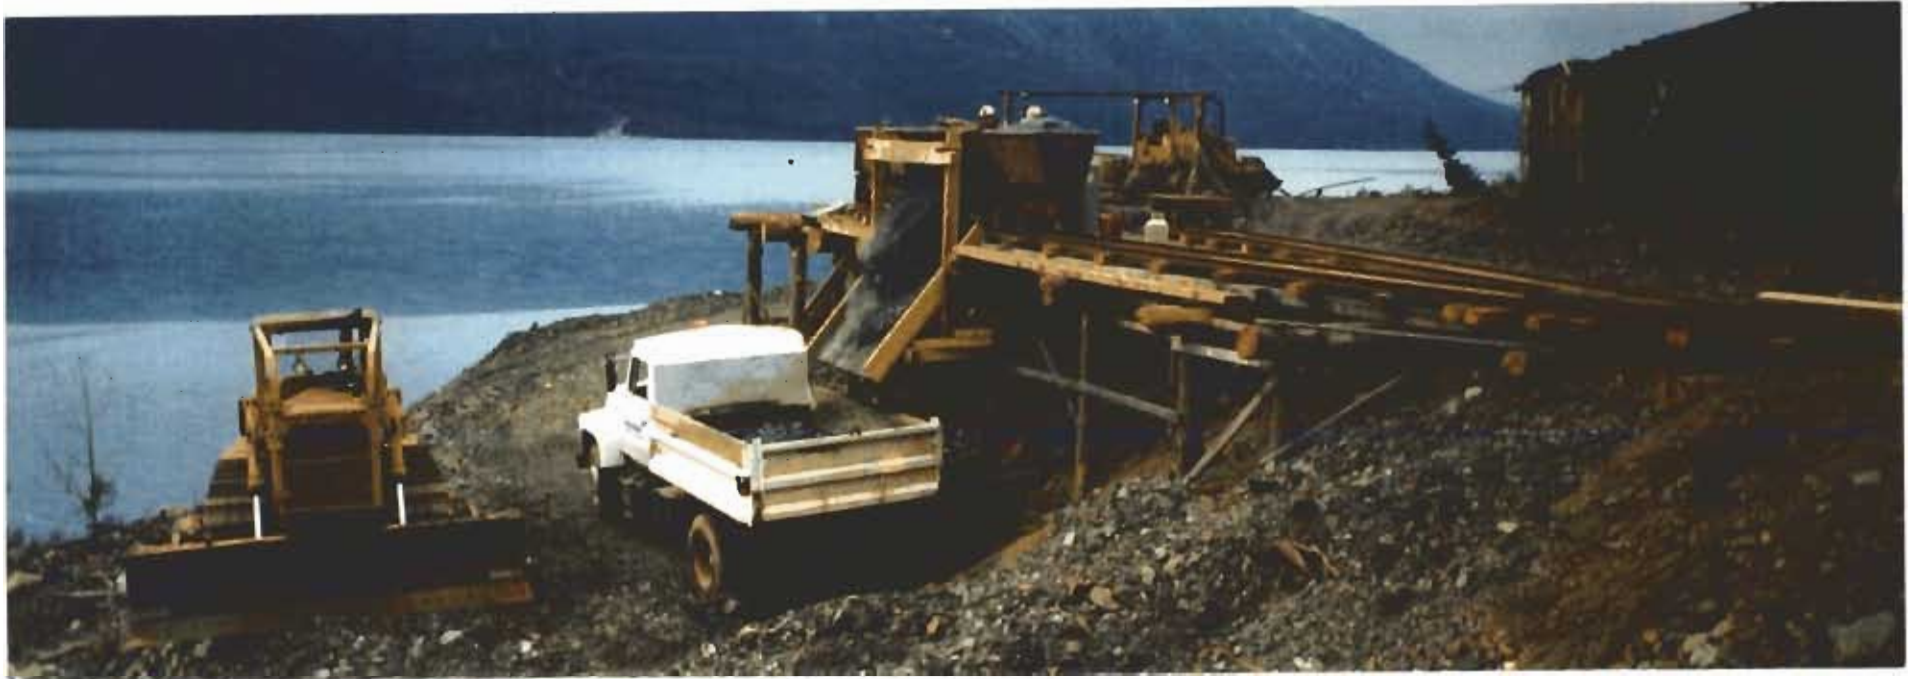
Picture above: Shows the new loading ramp to accommodate track mining.

The Following is a summary in chronological order of the 1995 season underground activities, as well as some small amount of surface testing for ore at the Engineer mine. To accommodate the change to track mining , we also had to build a new outside dumping ramp in close proximity to the 5 level portal. All areas mentioned are clearly indicated on the attached underground map.

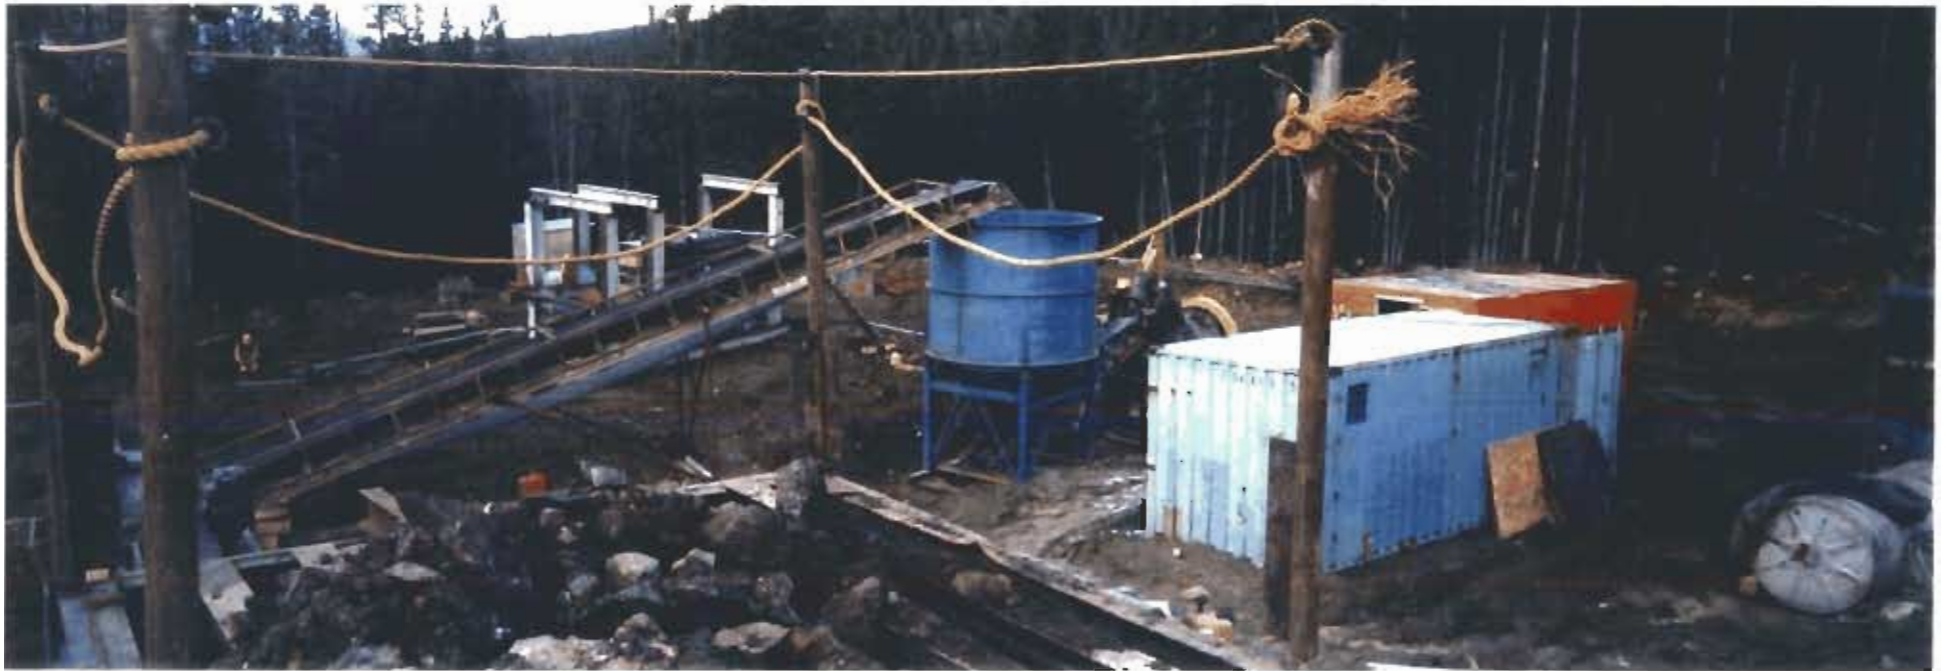
Picture above: Shows our mill setup taken from the course ore bin.
