**RED MOUNTAIN PROJECT**  
**2003 FIELD INVESTIGATIONS**

**Assessment Report**

**Steffen Robertson and Kirsten (Canada) Inc. (SRK Consulting)**

**Results of 2003 Field Investigation  
Red Mountain Project  
British Columbia**

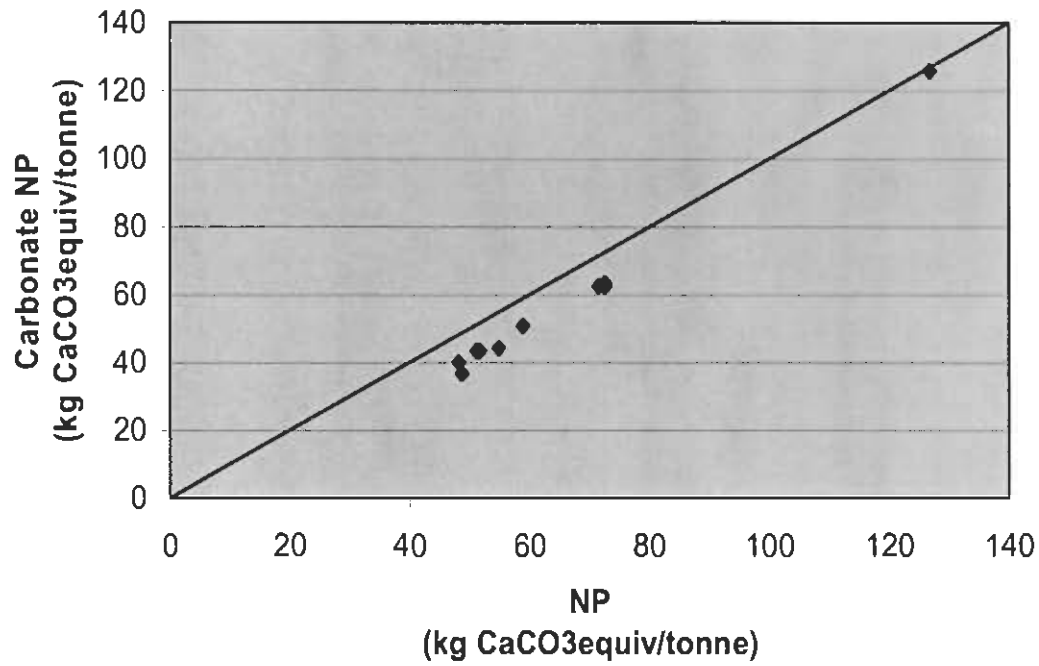
Figure 4. Relationship between NP and carbonate NP.

Samples tested had NP's ranging from 48.6 to 126.9 kg CaCO<sub>3</sub> eq/tonne, with carbonate NP's ranging from 36.7 to 125.8 kg CaCO<sub>3</sub> eq/tonne. This includes one sample that had an anomalously high carbonate content. By removing the anomalous sample, the upper limit of the NP range becomes 72.6 kg CaCO<sub>3</sub> eq/tonne, while the upper limit of the carbonate NP range becomes 63.3 kg CaCO<sub>3</sub> eq/tonne. Figure 4 shows the relationship between NP and carbonate NP for the 10 samples which underwent ABA testing. Carbonate NP was strongly correlated with the Sobek NP, indicating that carbonate NP is a reasonable surrogate for NP for the waste rock dump material.

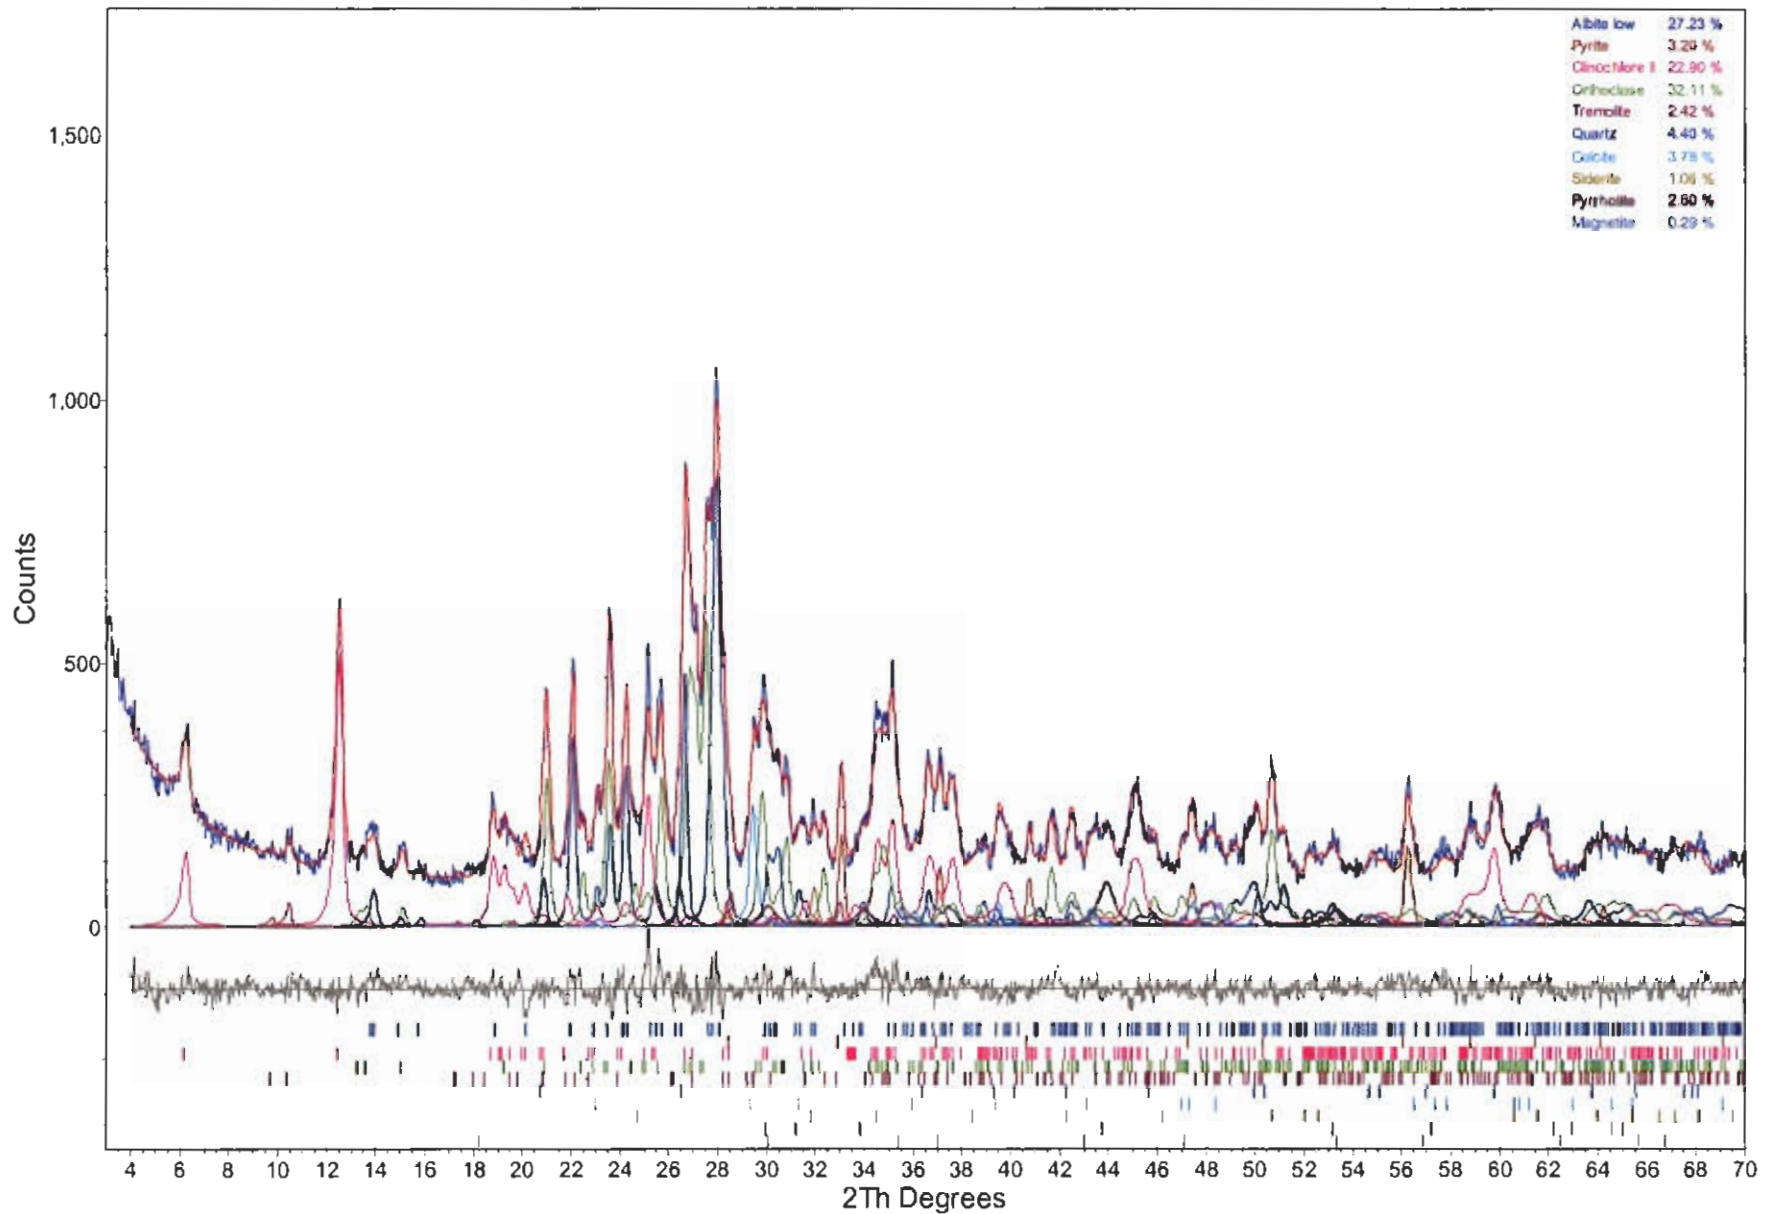
Figure 1: . Rietveld refinement plot for sample "SRKTP031" (blue line - observed intensity at each step; red line - calculated pattern, solid grey line below - difference between observed and calculated intensities; vertical bars, positions of all Bragg reflections. Coloured lines are individual diffraction patterns of all phases.

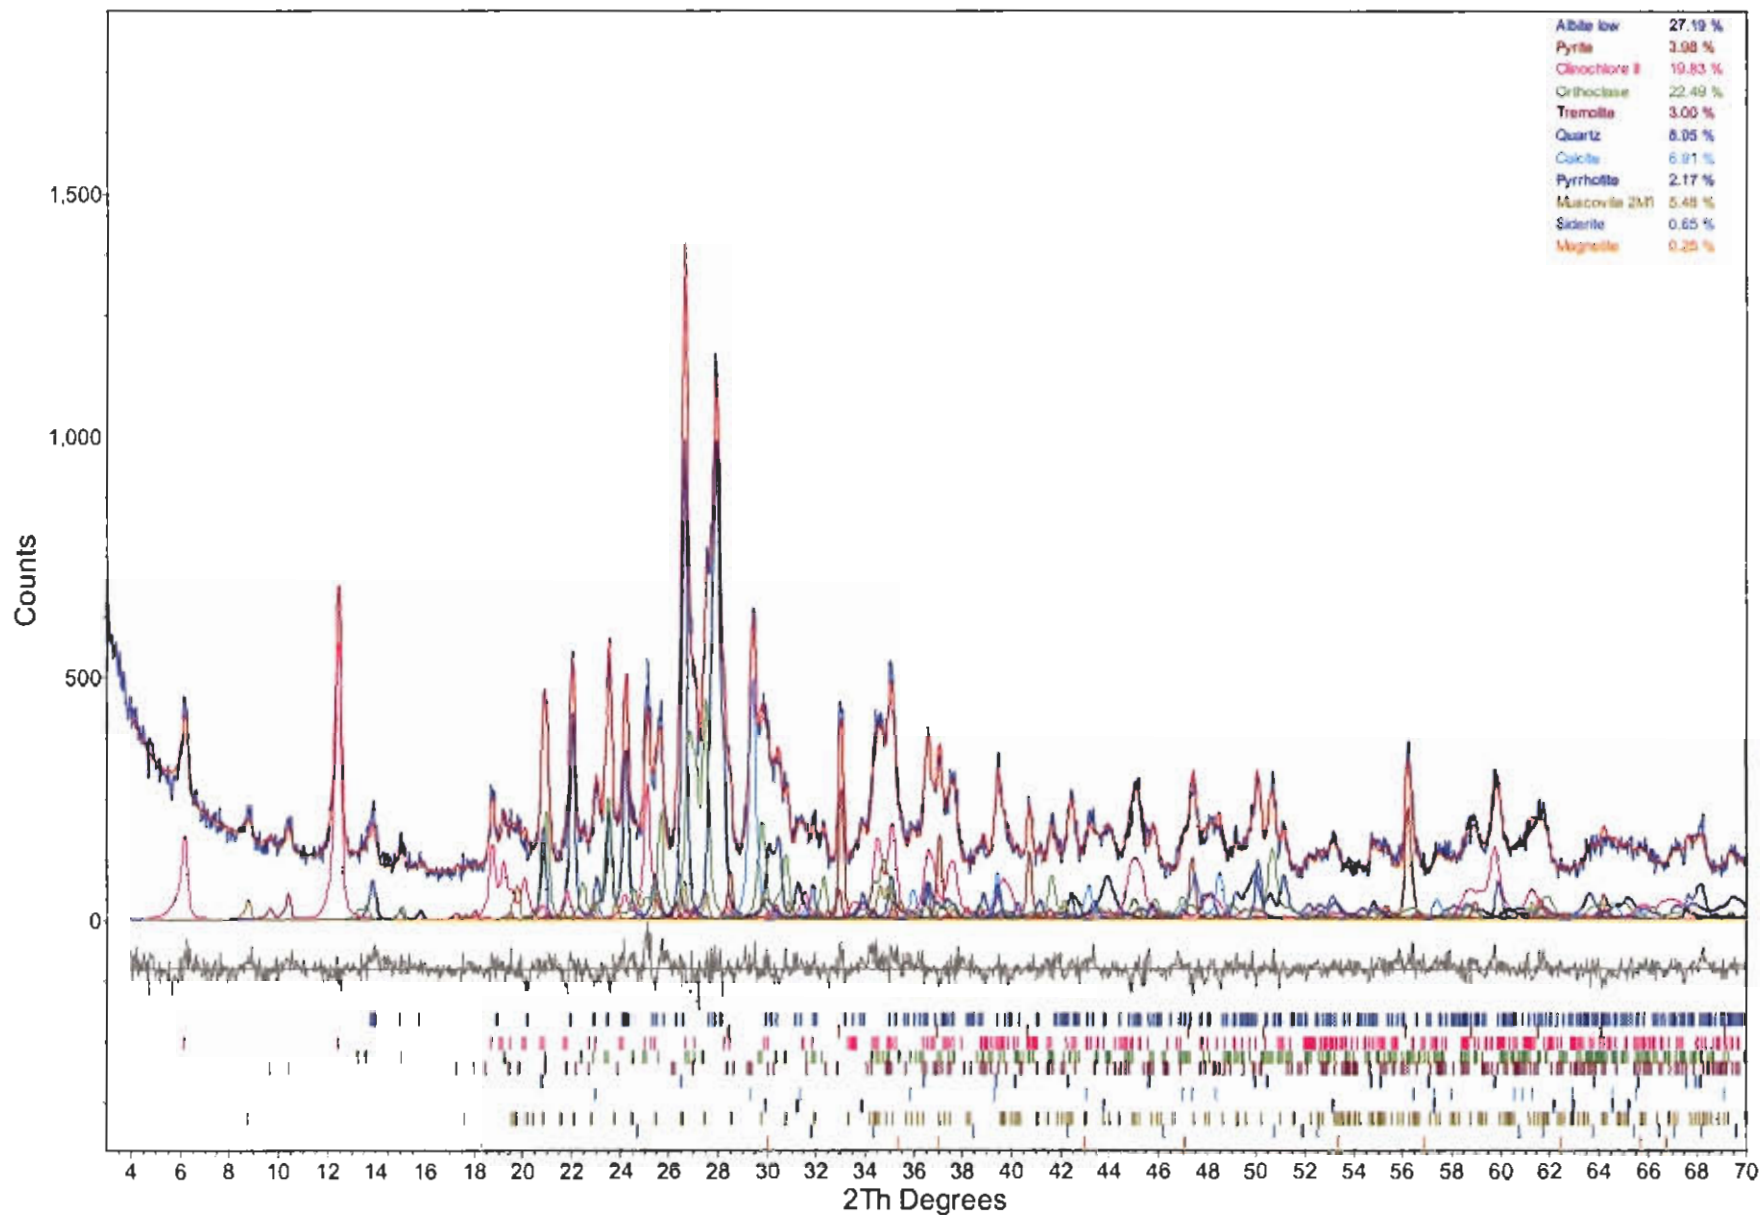
Figure 2: . Rietveld refinement plot for sample “SRKTP036” (blue line - observed intensity at each step; red line - calculated pattern, solid grey line below – difference between observed and calculated intensities; vertical bars, positions of all Bragg reflections. Coloured lines are individual diffraction patterns of all phases.

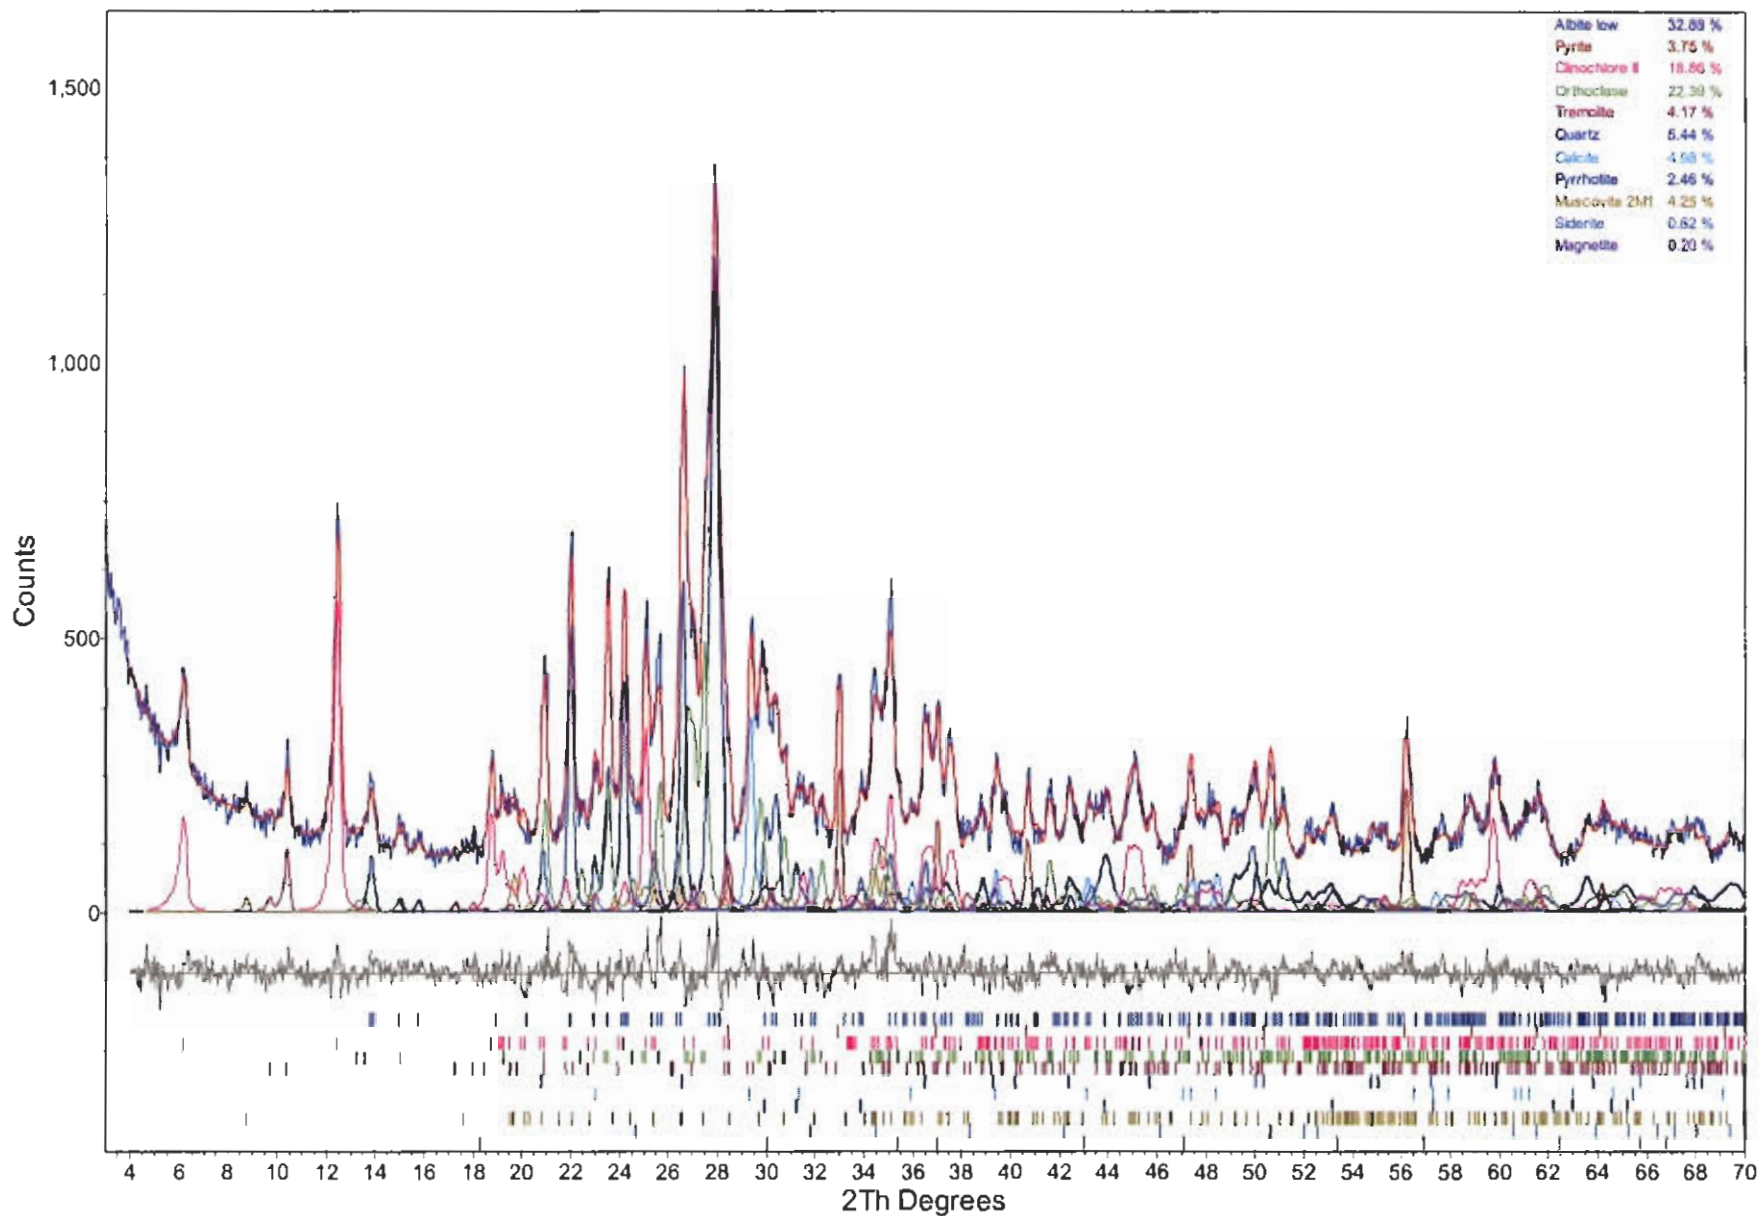
Figure 3: . Rietveld refinement plot for sample “SRKTP037” (blue line - observed intensity at each step; red line - calculated pattern, solid grey line below – difference between observed and calculated intensities; vertical bars, positions of all Bragg reflections. Coloured lines are individual diffraction patterns of all phases.

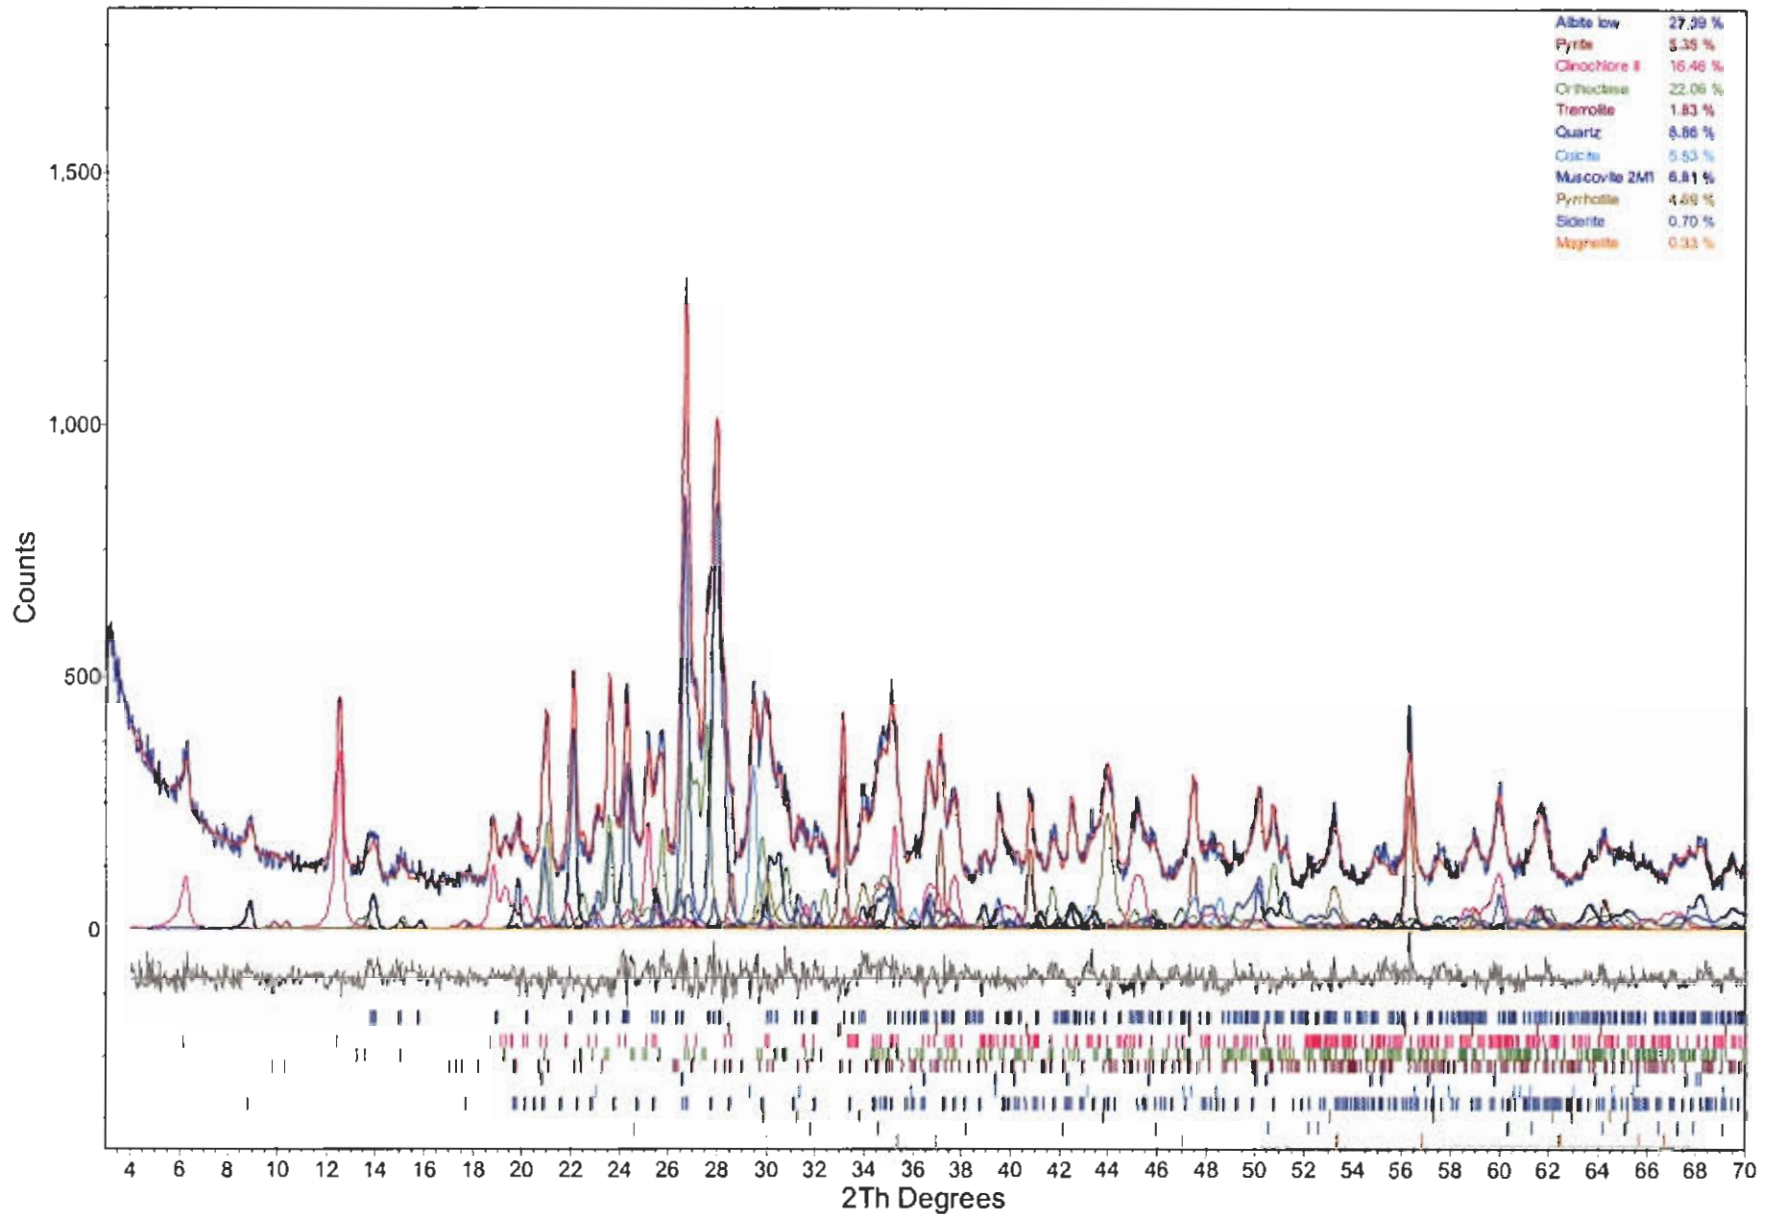
Figure 4: . Rietveld refinement plot for sample "SRKTP0314" (blue line - observed intensity at each step; red line - calculated pattern, solid grey line below - difference between observed and calculated intensities; vertical bars, positions of all Bragg reflections. Coloured lines are individual diffraction patterns of all phases.

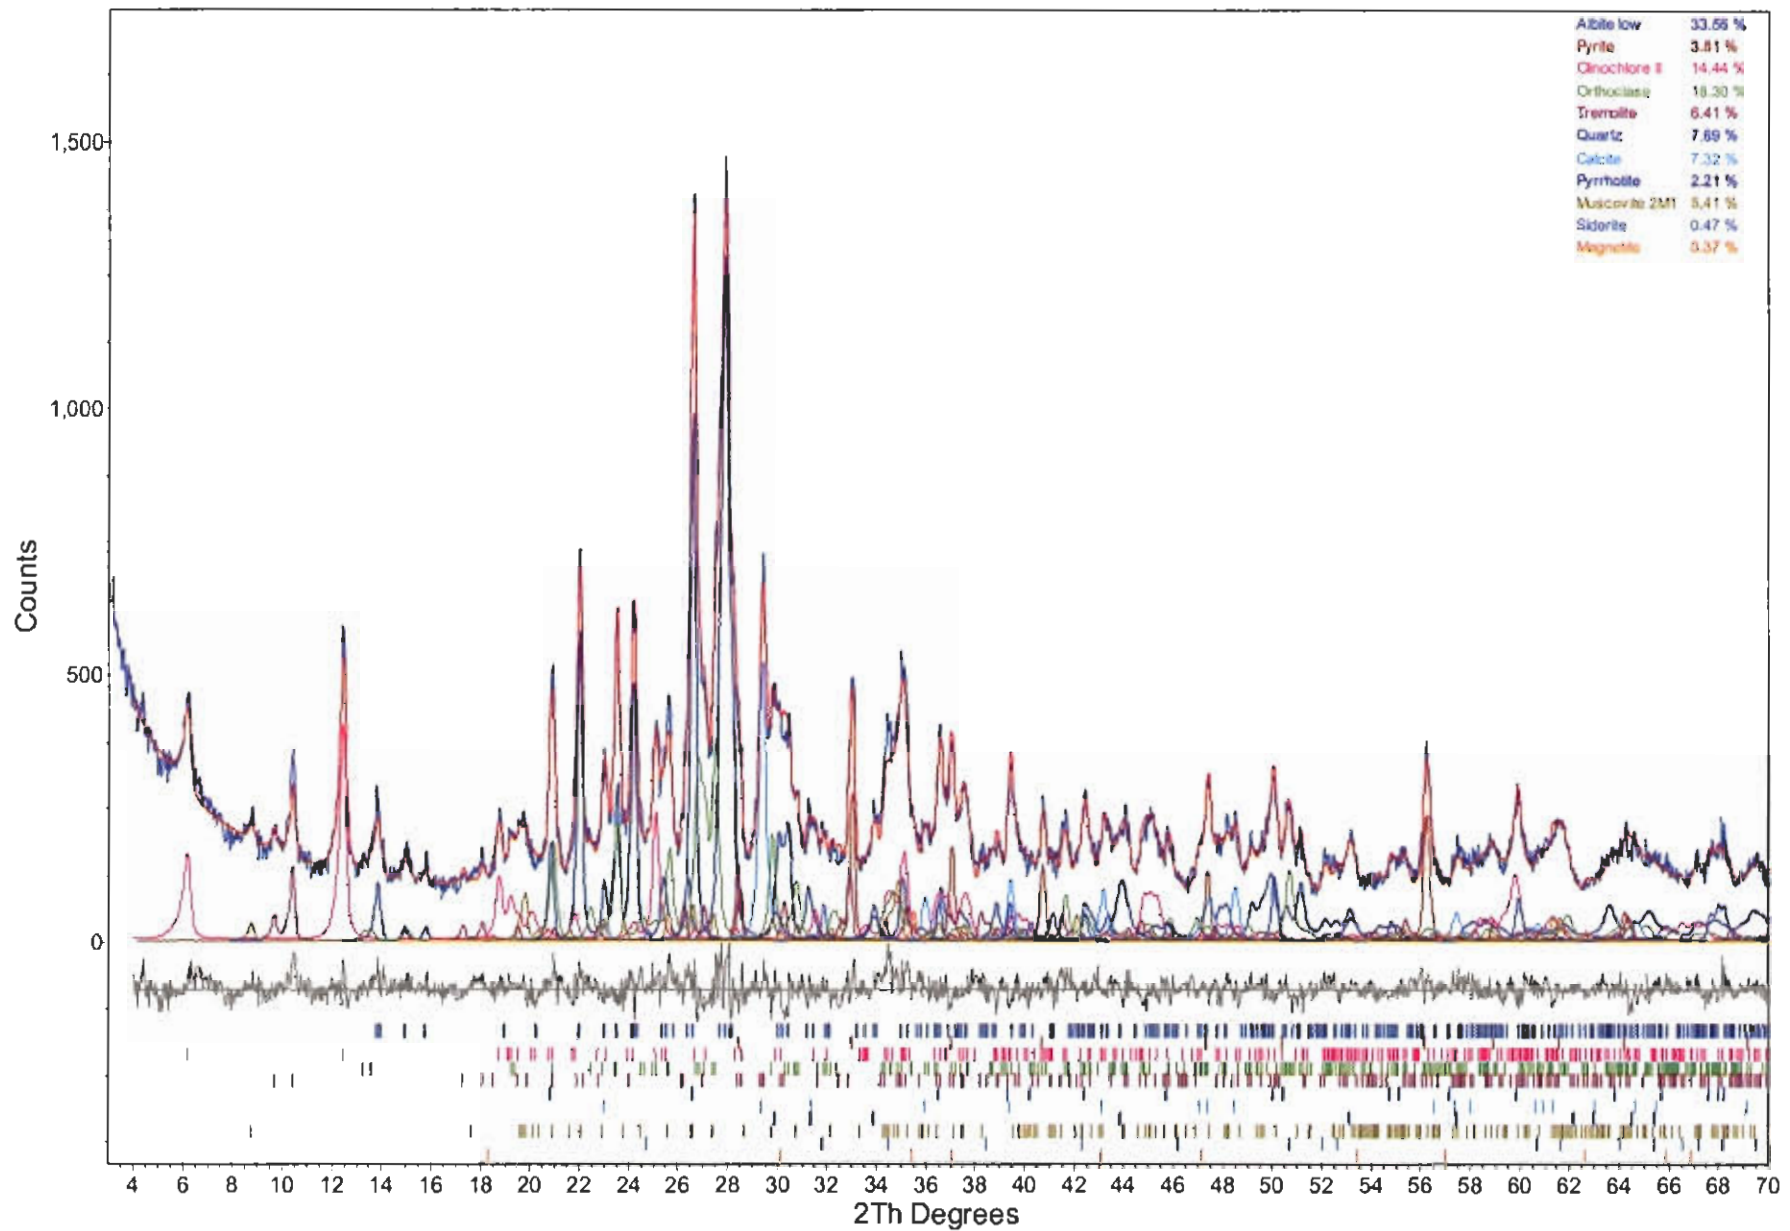
Figure 5: . Rietveld refinement plot for sample “SRKTP0317” (blue line - observed intensity at each step; red line - calculated pattern, solid grey line below – difference between observed and calculated intensities; vertical bars, positions of all Bragg reflections. Coloured lines are individual diffraction patterns of all phases.
