Geochemical, Prospecting, and Technical Assessment Report

The Le Baron Prospecting / Le Baron #3 2009 Vancouver Island, British Columbia

Victoria Mining Division NTS: 092C059 124 degrees -19' - 42" W x 48 degrees - 32' - 13"N Tenure # 574300

BC Geological Survey Assessment Report 31089

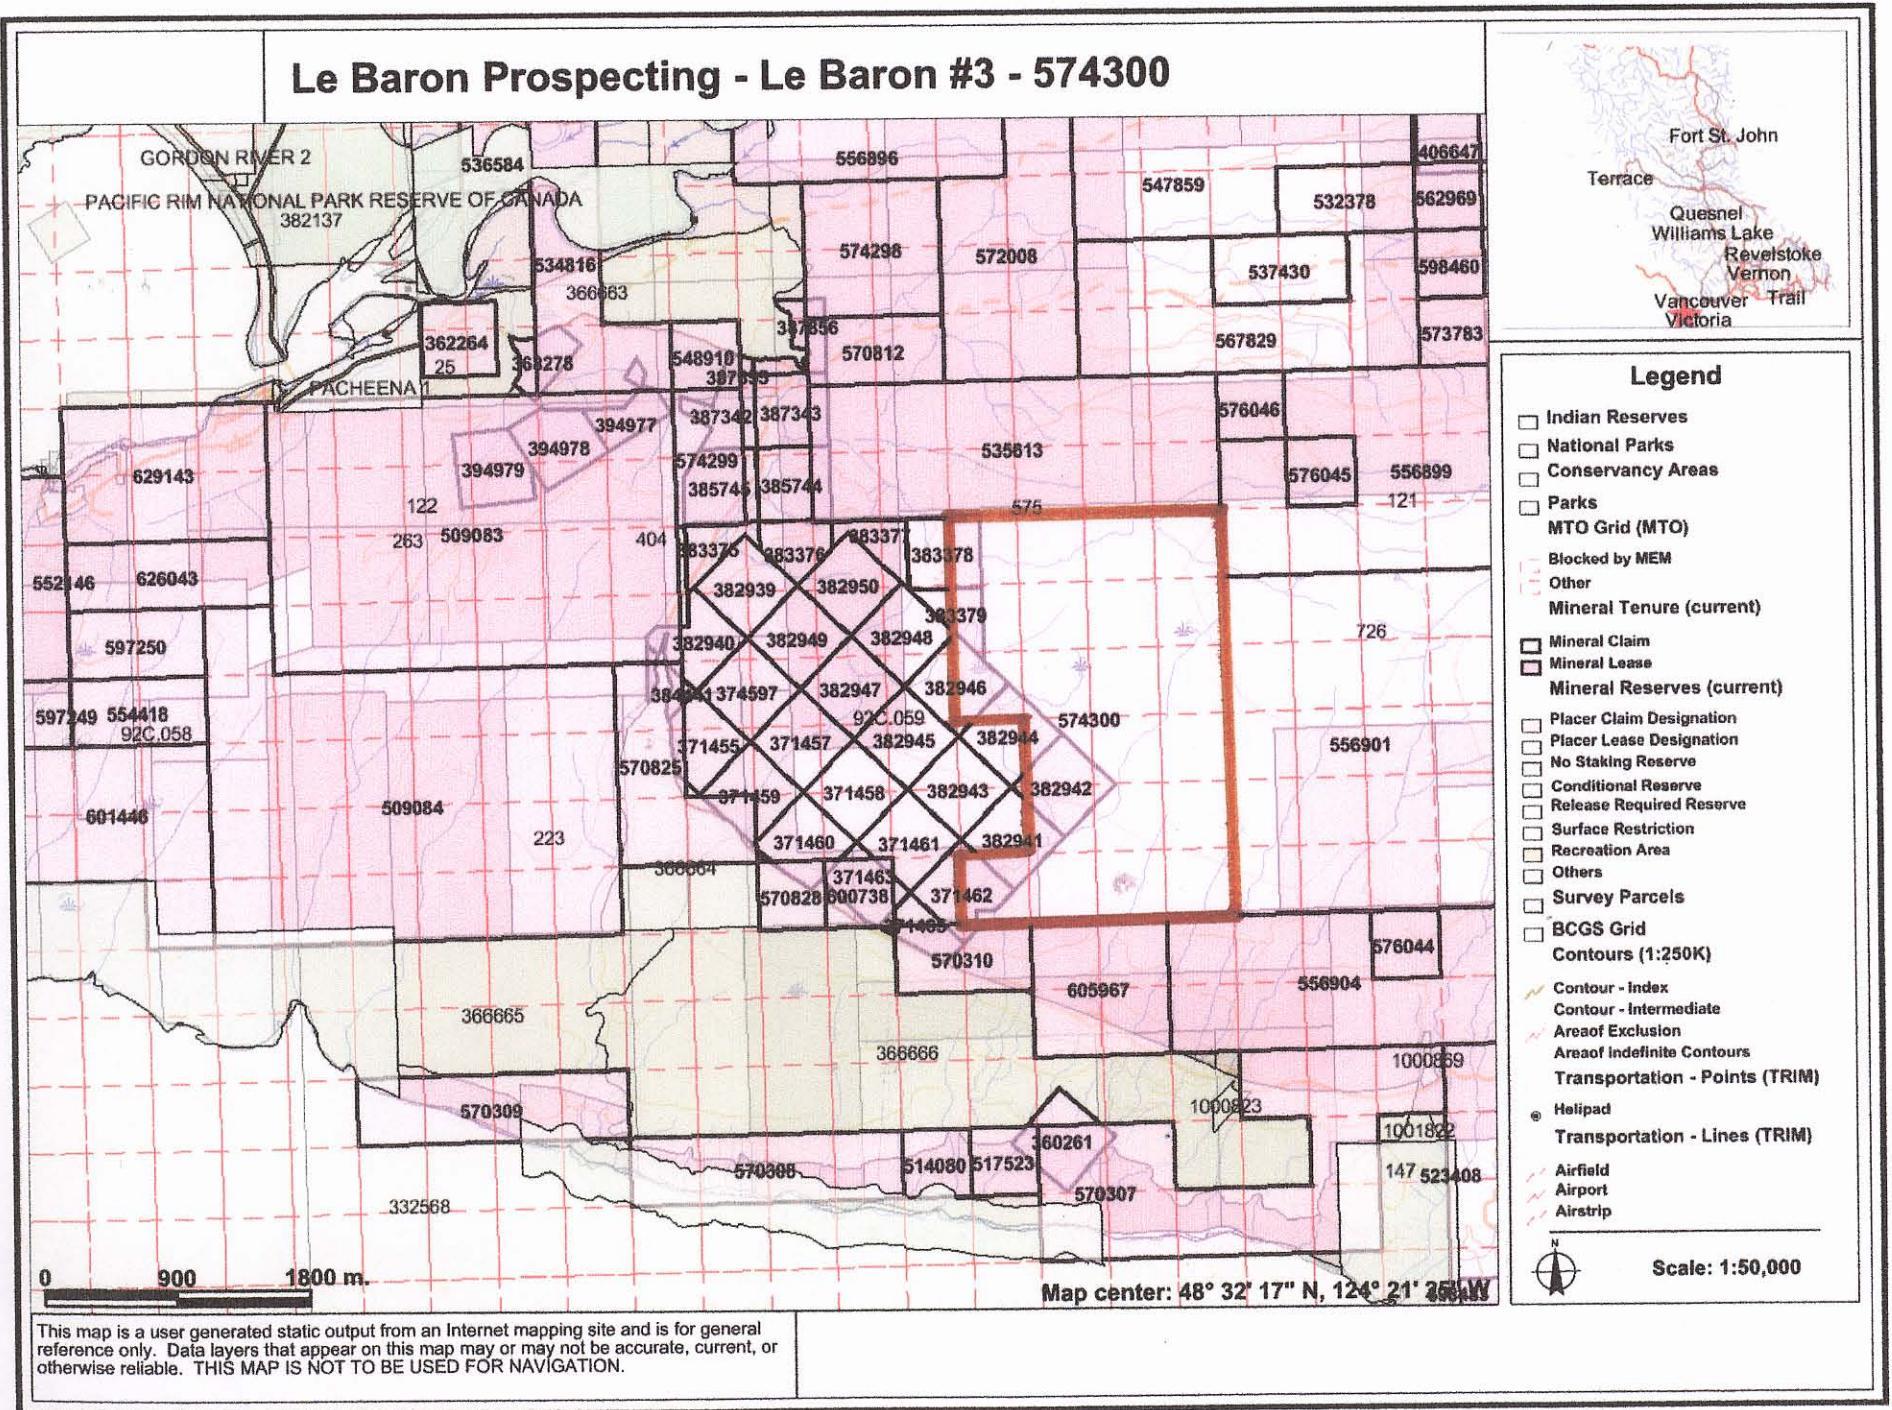
FIGORE MAP A

The Le Baron # 3 tenure is located within the Victoria Mining Division, Southwestern Vancouver Island, BC, Canada. [See Location Map, 1:5,000,000]. The property is located approximately 75 kilometers west of Victoria on the NTS Map # M092C059.

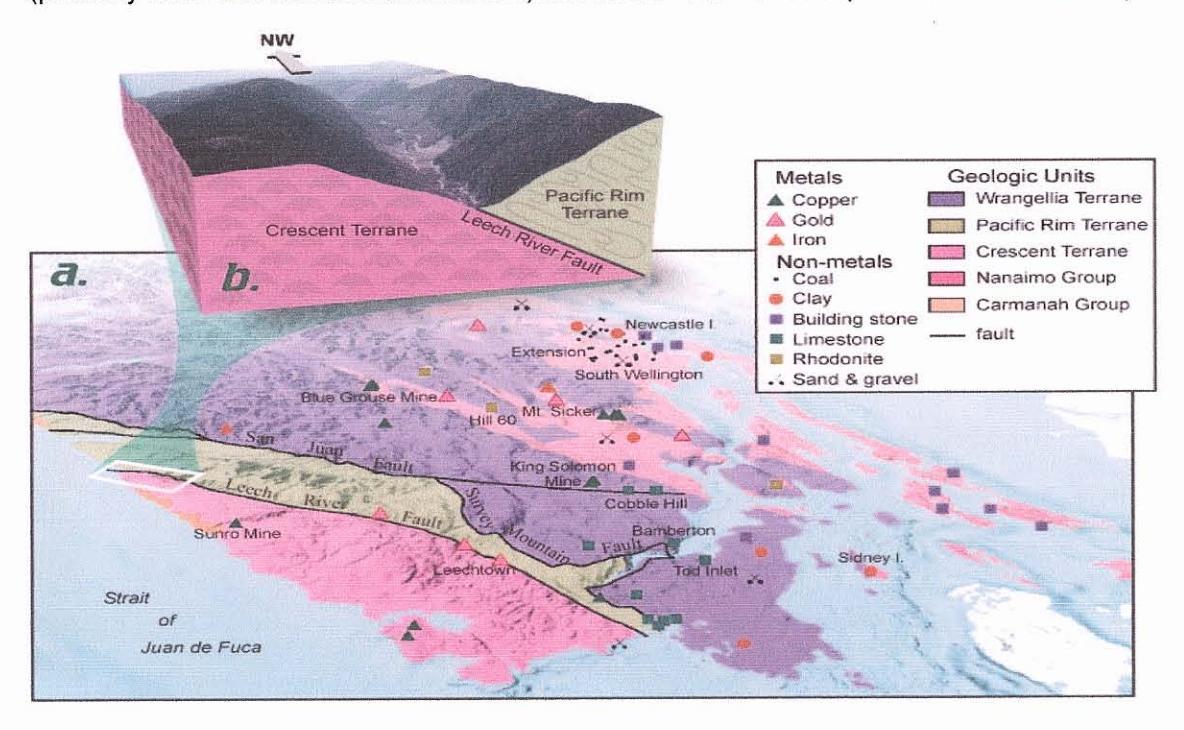
The Le Baron # 3 tenure is underlain by the San Juan River Fault, which is composed of the Leech River Formation to the south and the Bonanza Group Volcanics to the north. The San Juan Fault is best described as a plate boundary fault, where the Leech River Formation is severely interrupted as a subduction complex.

The Leech River Fault is a reverse or thrust fault that strikes east and dips 45-75 degrees north, and is at least 40 miles long. The Leech River Fault is a remarkably linear feature that formed in an active plate margin tectonic regime. As a result, Eocene Leech River Fault movement was coeval with the emplacement of the Metchosin and Sooke mafic volcanic intrusive complex. North of the Leech River Fault, a distinctly more mountainous terrain is underlain by Cretaceous Leech River Formation amphibolite to upper green schist grade metamorphic rocks consisting of biotite-garnet schist, mica-rich phyllite. The Leech River Formation consists of Cretaceous sediments (probably shale and interbeded sandstone) and minor volcanic rocks (intermediate tuffs/flows)

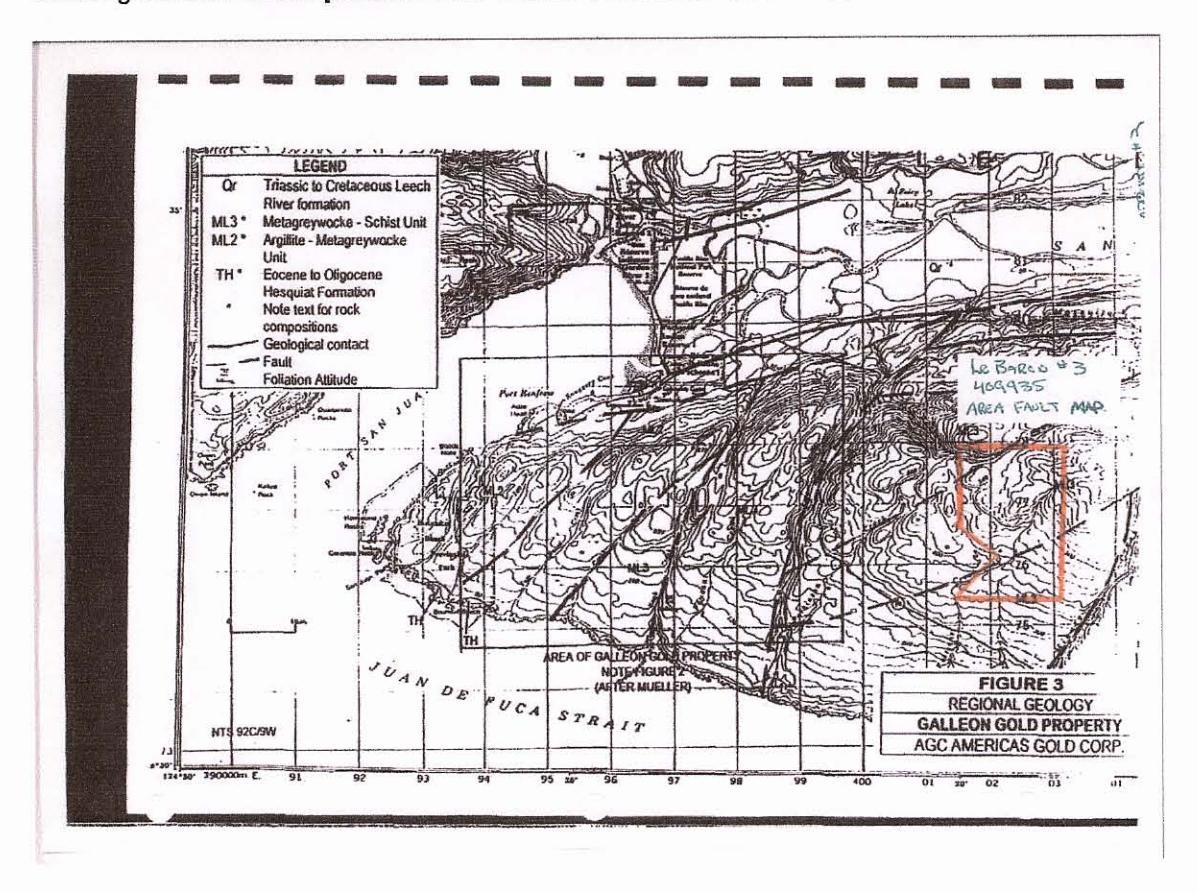
Local Area Faults:

There are several faults within the area as well. The faults are trending a north / eastern pattern and dip 40 to 70 degrees, they join the San Juan River fault in the north. A copy of a map outlining the area faults. [Galleon Gold Tenures, Americas Gold Corp].

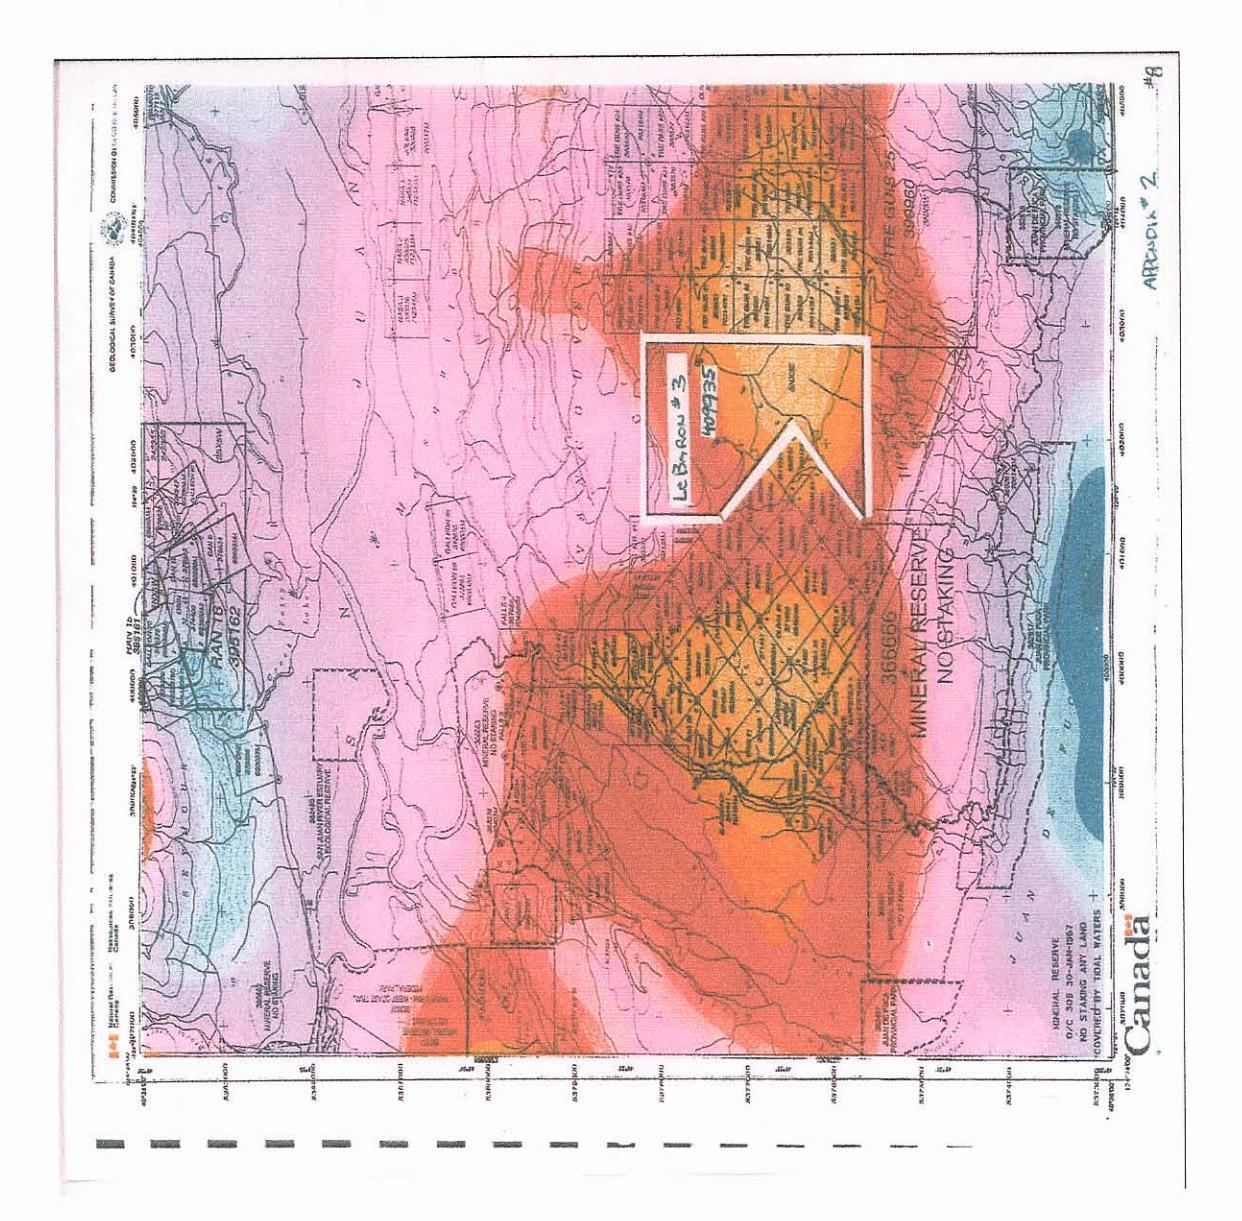
Aeromagnetic Map: Copy of Magnetic Map Courtesy of Tre Guis Minerals Ltd

The Le Baron #3 Mineral Tenure # 574300 (used to be tenure # 409935 prior to conversion to new MTO cell system), located upon a magnetic anomaly.

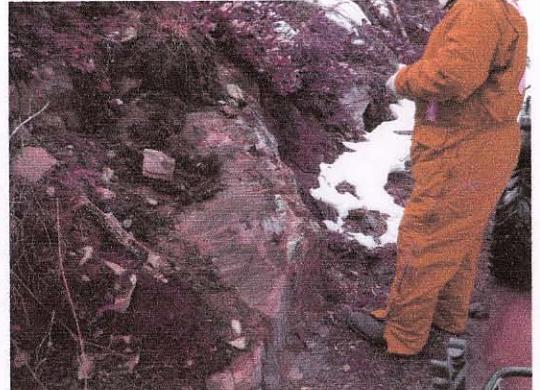
Scott - bedrock exposure

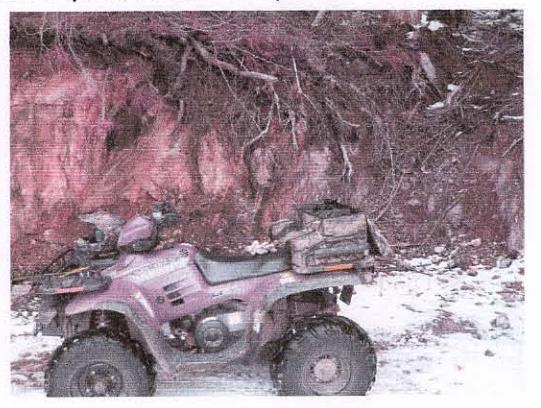
Bob's quad, roadside exposure

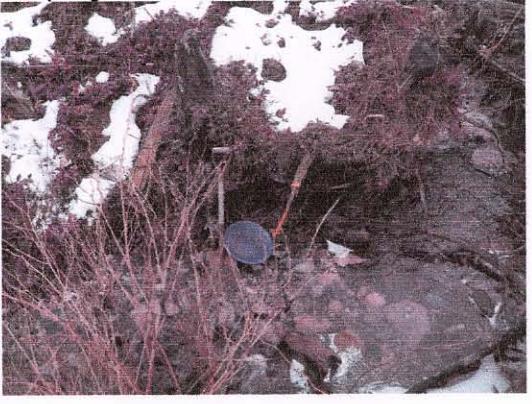
sampling - in creek - snow on ground

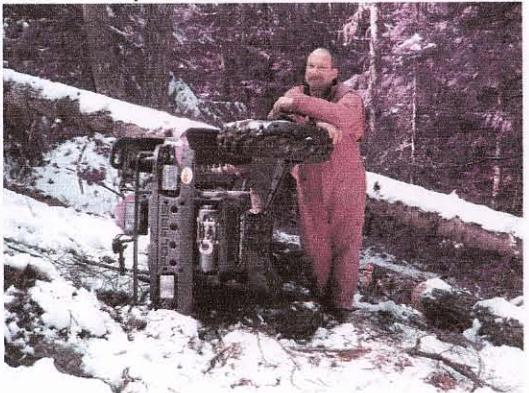
Site CC - quad slid off road down bank

Area Description: Kuitshe Creek Mainline, 4.2 km up, roadside rock quarry, bedrock and geological structure is excellent, with banded formations of slate and quartz veins. This site is similar in structure as Site BB. Quad slipped off of road in this area as the road is very steep. No injuries. (See photos)

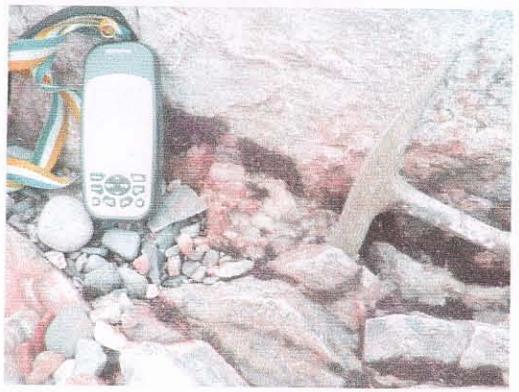
Quartz vein - bedrock, vizable Au

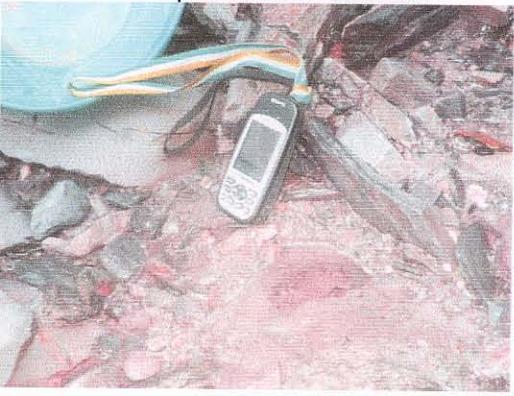
Site # 2 - sample location - in creek

GPS location: 402450 x 5375954 ALS Sample – H031113 Area description: Kuitshe Creek Mainline / first spur road to right – creek / culvert Work: 6 road side rock chip samples 4 moss matt sediment – hand pan – in creek Method of sampling: Hammer and chisel - shovel Sample description: Schist / greywacke with small quartz veins Moss matt, thick with an a lot of heavy magnetic sand, garnets

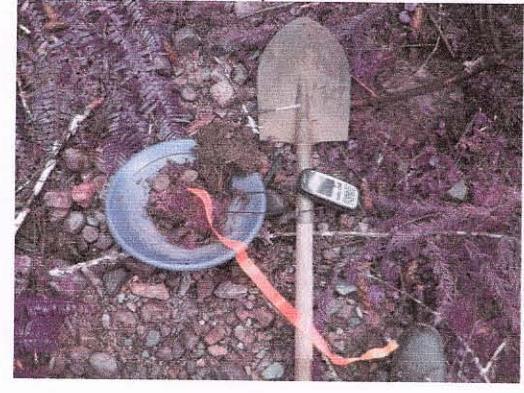
Site # 4 - moss sample

GPS location: 402675 x 5375900 Area description: Kuitshe Creek Mainline / first spur road to right – past 1st creek Work: 2 road side rock chip samples 2 moss matt 1 clay sample Method of sampling: Hammer and chisel, shovel Sample description: Schist / greywacke with small quartz veins Moss matt, thick, from area spring Clay, grayish blue, fine, pure, viscous

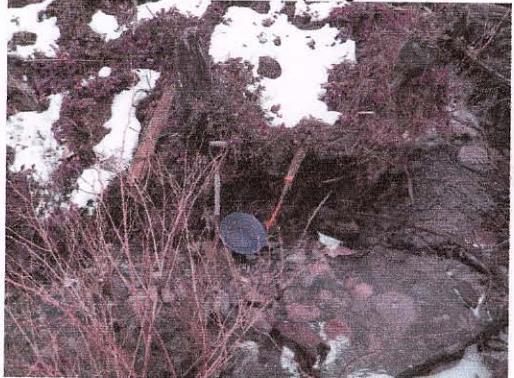
Site # 10 - rock chip samples - quartz

GPS location: 402800 x 5376541 Area description: Kuitshe Creek Mainline / second spur road to right – past spur junction Work: 4 road side rock chip samples Method of sampling: Hammer and chisel, Sample description: Schist / greywacke with small quartz veins Quartz veins, small Au
